Appendices

WYOMING STATE FAIR - MASTER PLAN

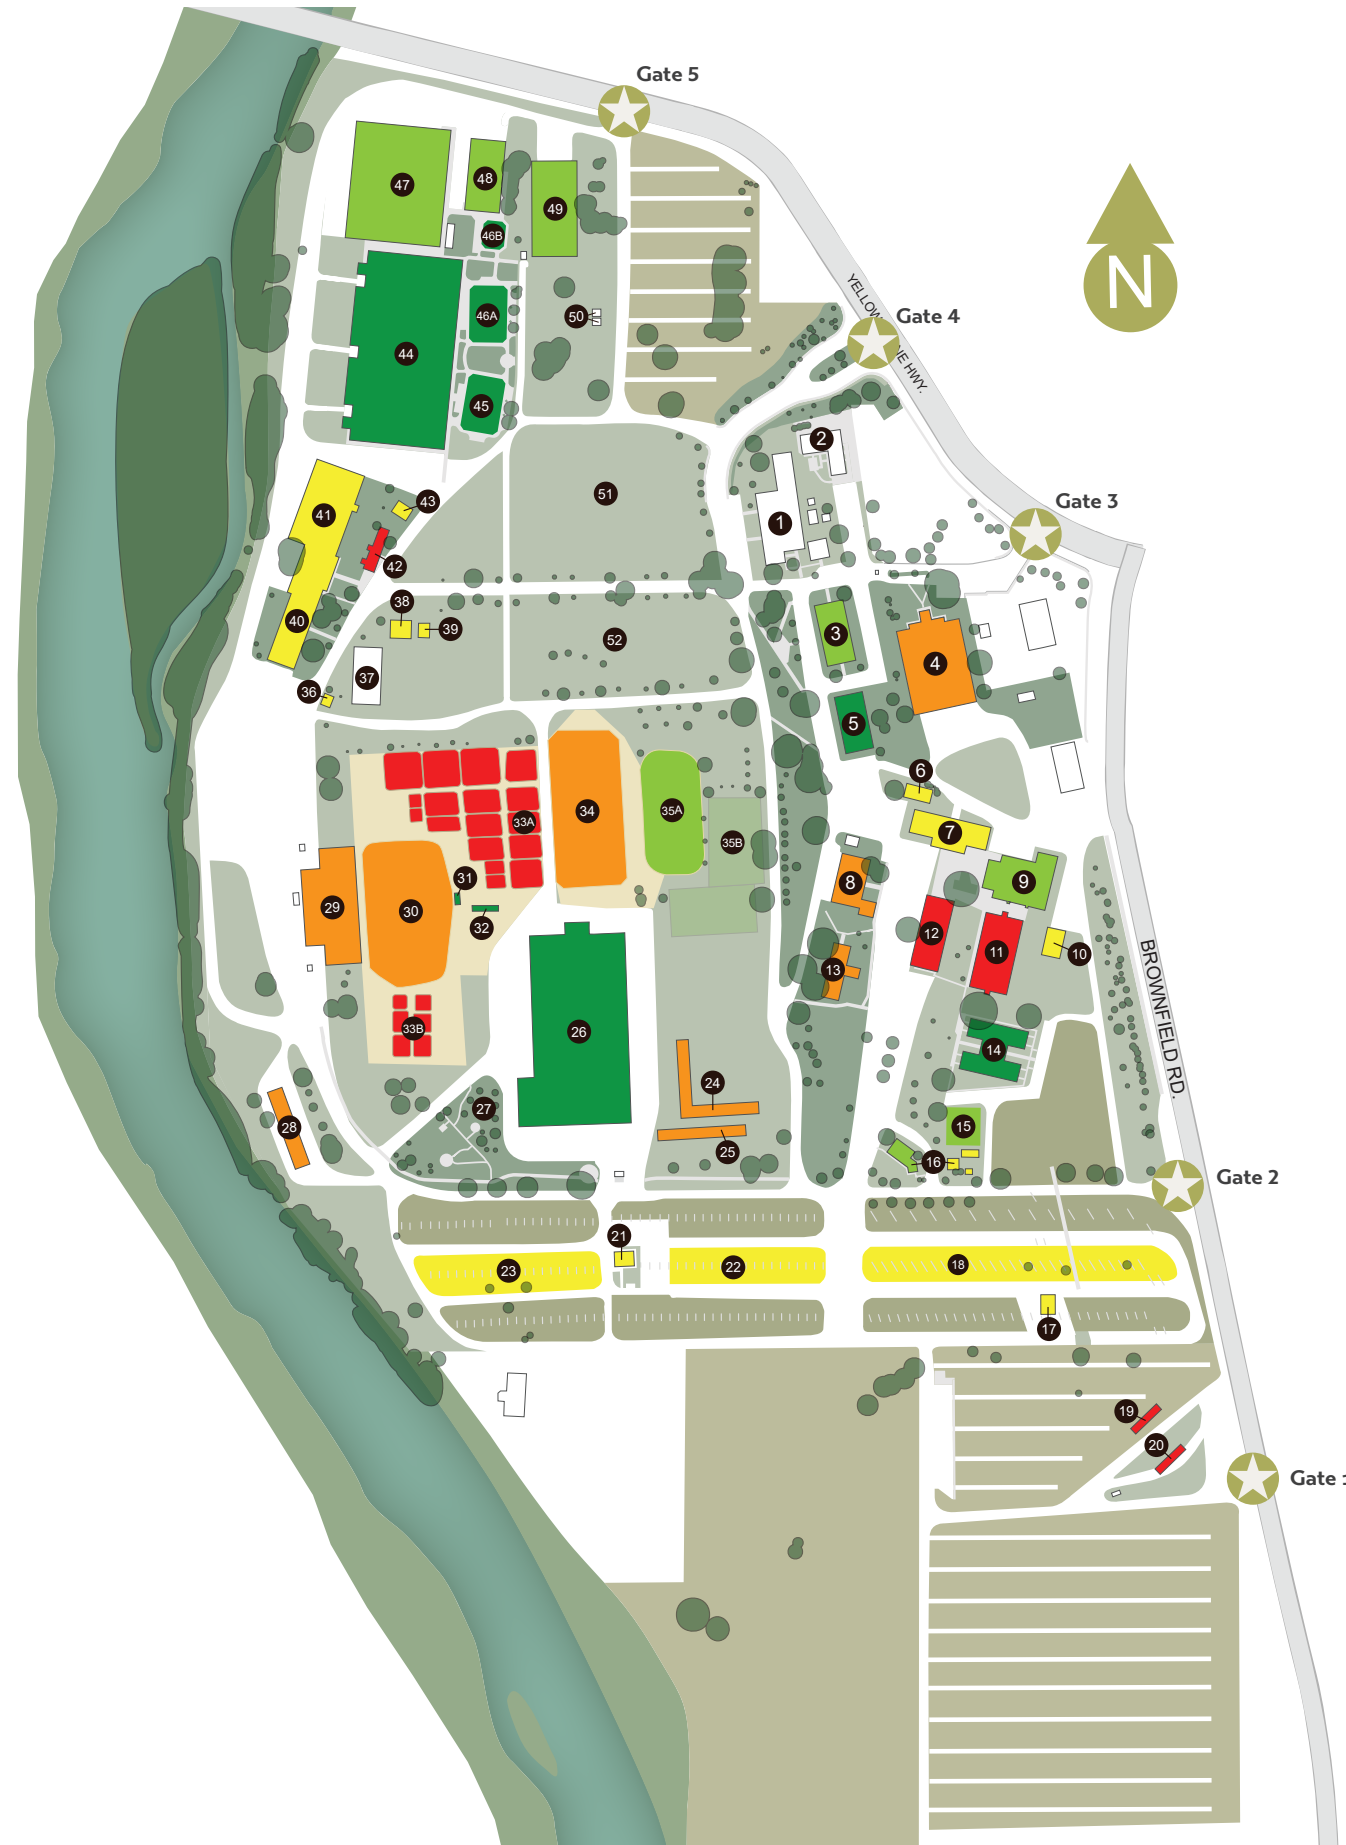
The map to the left shows a conditions assessment of the 52 buildings, structures, and points of interest.

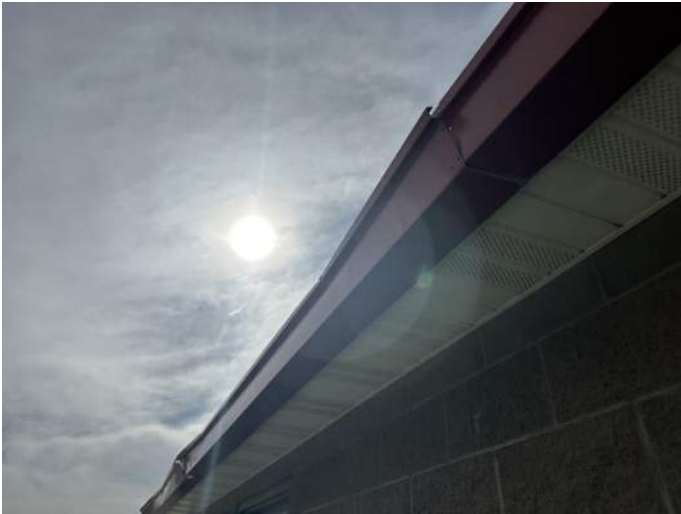
a. Image of damaged rain gutter.

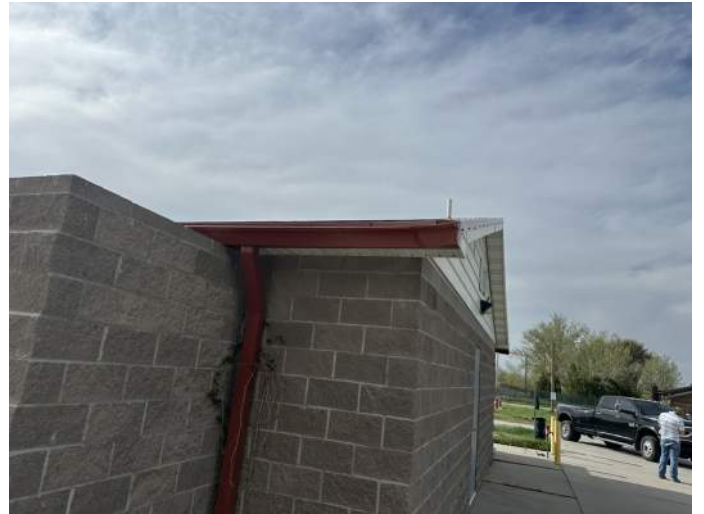
b. Image of damaged rain gutter.

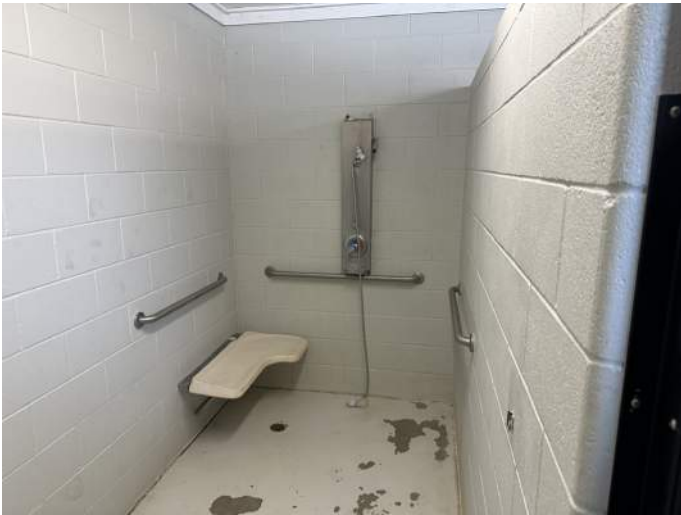
c. Image depicts paint peeling from shower floor.

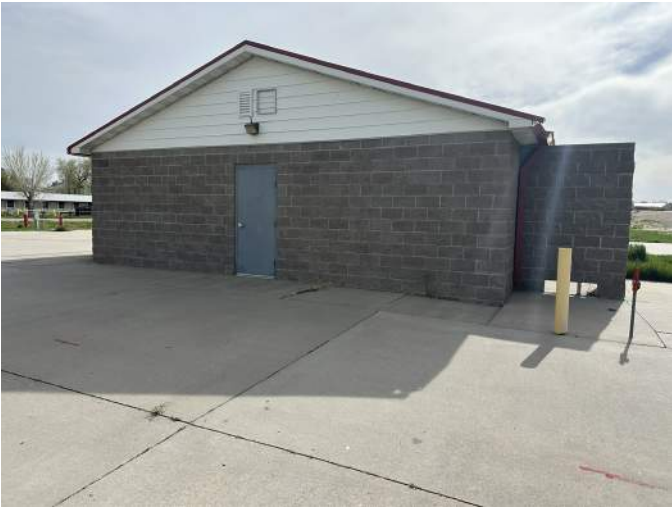
g. Image of damaged rain gutter and fascia.

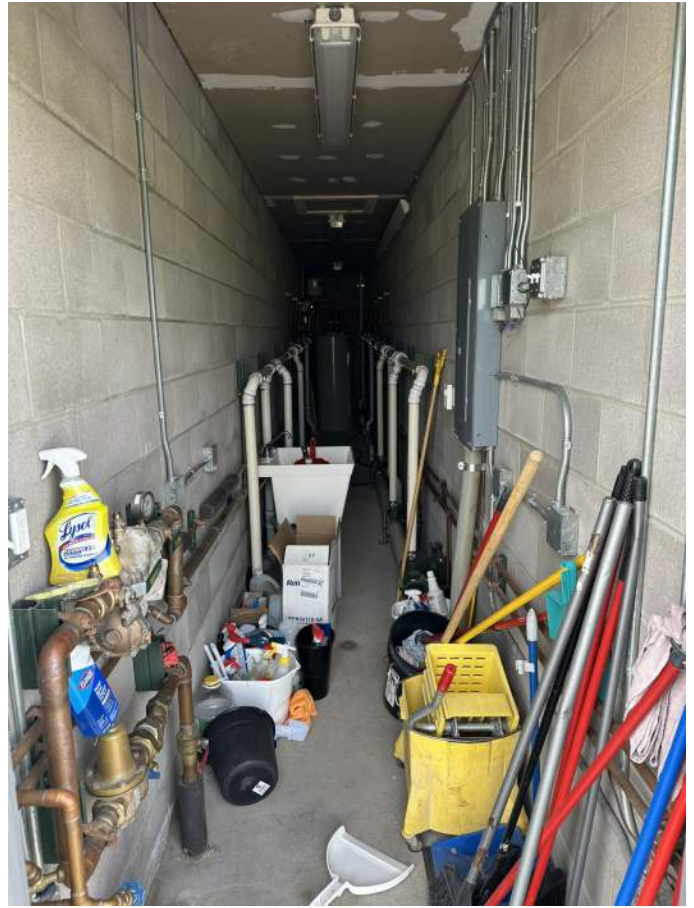
h. Image of plumbing chase and electrical panel.

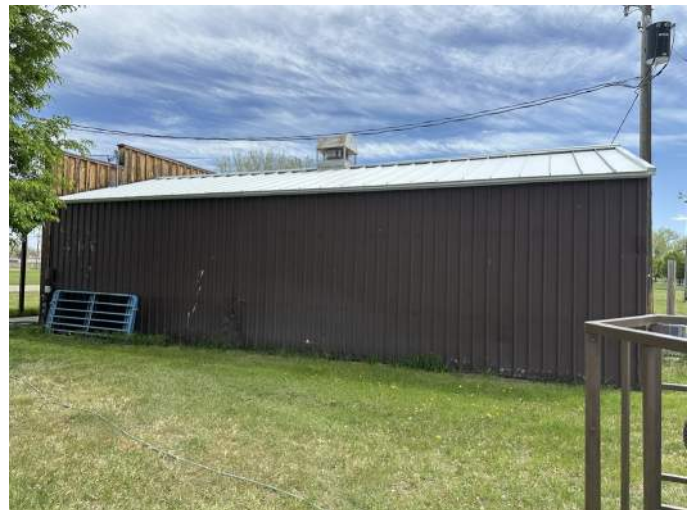
d. Image depicting damage to the PEMB metal wall panel.

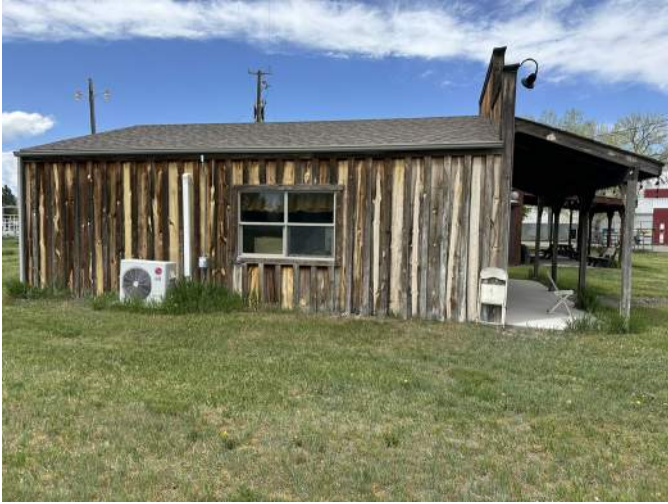
a. Image depicts the East side of the building.

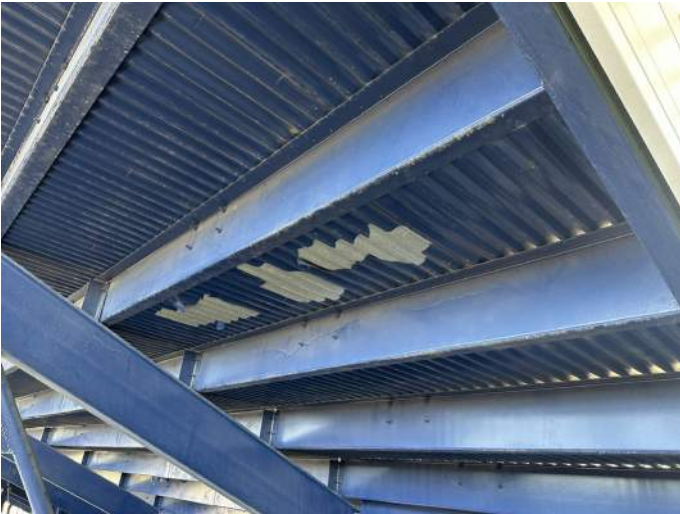
a. Image depicts paint peeling from underside of the Grand Stand structure.

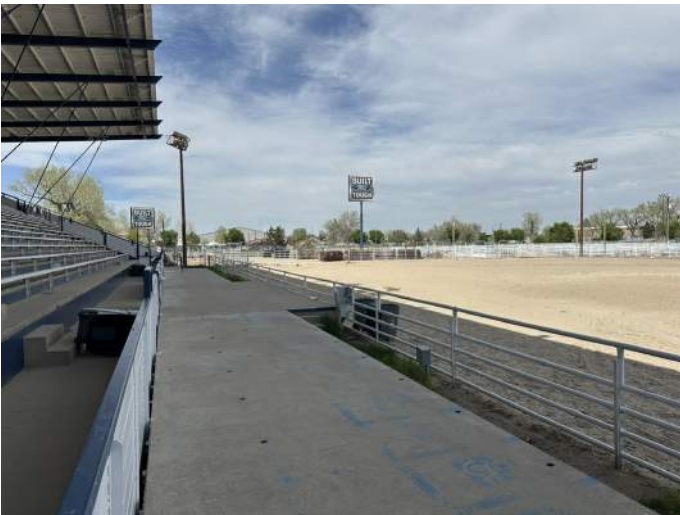
c. Image depicts the existing podium/walk way in front of the grand stands. The required guard rails are missing along the length of the podium.

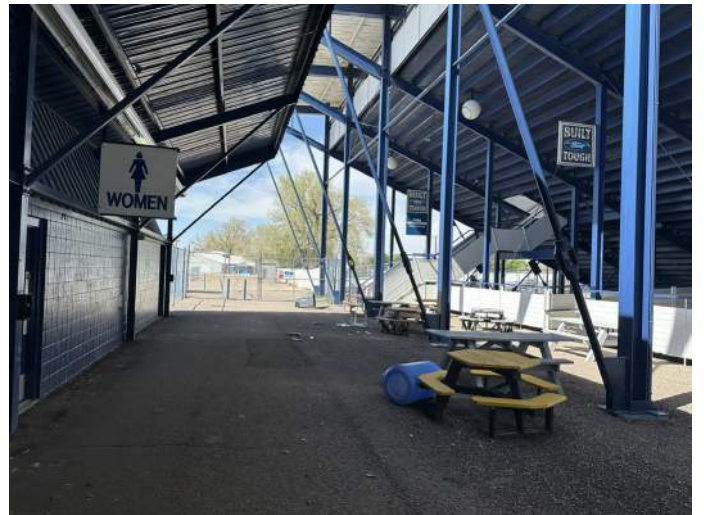
d. Image looking North along the Concourse with the Women's Restroom in the background.

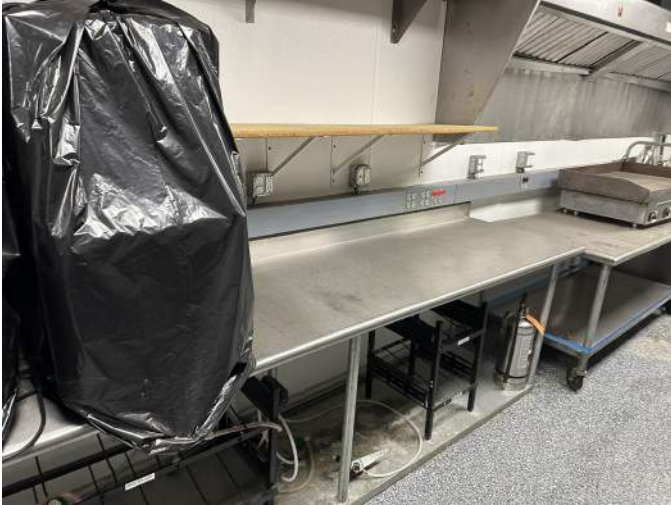
i. The hood shown in the right hand corner of the image appears to need repair. The particle board shelf is a porous material and is unable to be cleaned properly to eliminate mold, mildew, bacteria and viruses. This item should be removed and replaced with a stainless steel shelf from a professional kitchen equipment supplier.

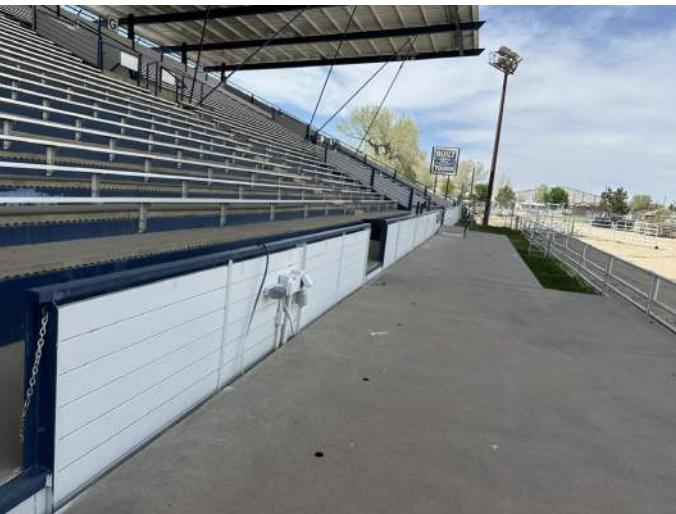
k. Multiple means of egress should be available to spectators and are crucial for ensuring the safety and efficient movement of large crowds before, after, and during events. Chains or ropes across means of egress pathways are concerning, constitute a hazard, and represent a violation of the International Building Code.

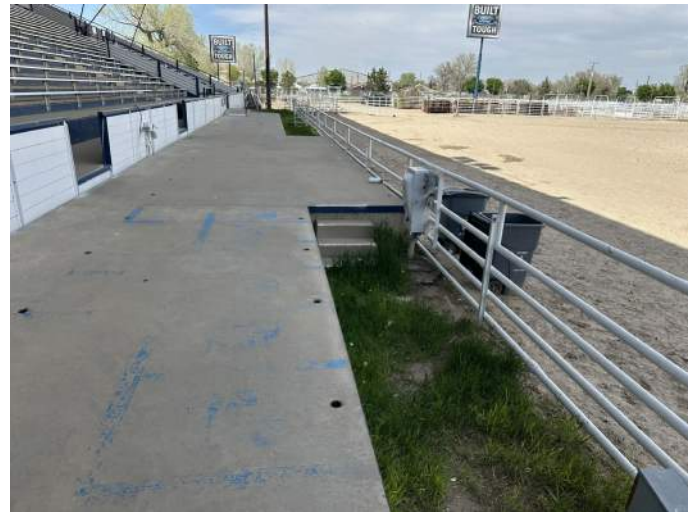
j. See comments for Image C. In addition, the red arrow identified the arena fence. This area should be reviewed further to determine whether it is a good location for ADA Accessible seating. Possible concerns are the proximity to the arena, and height of the railing above the grand stand podium.

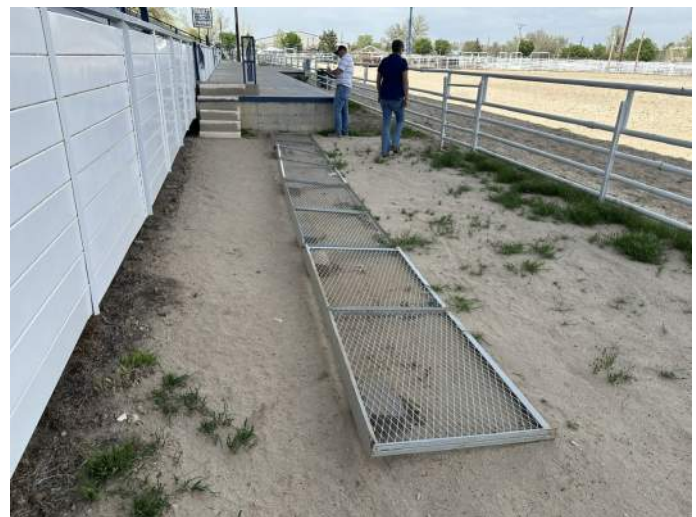
l. This image depicts the following deficiencies at the grand stand podium.

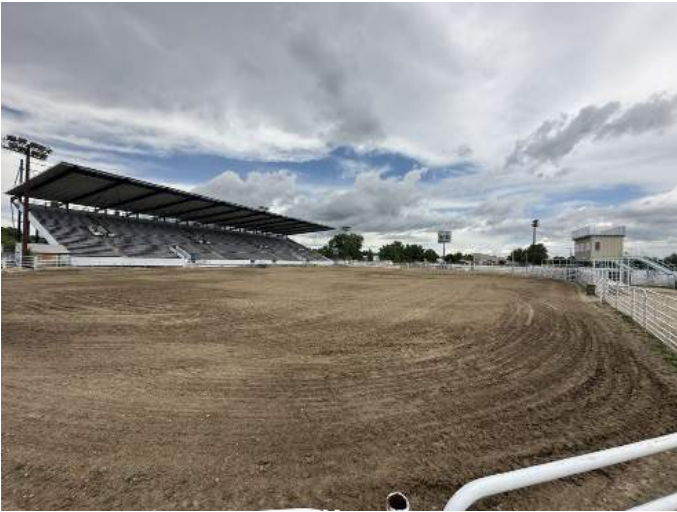
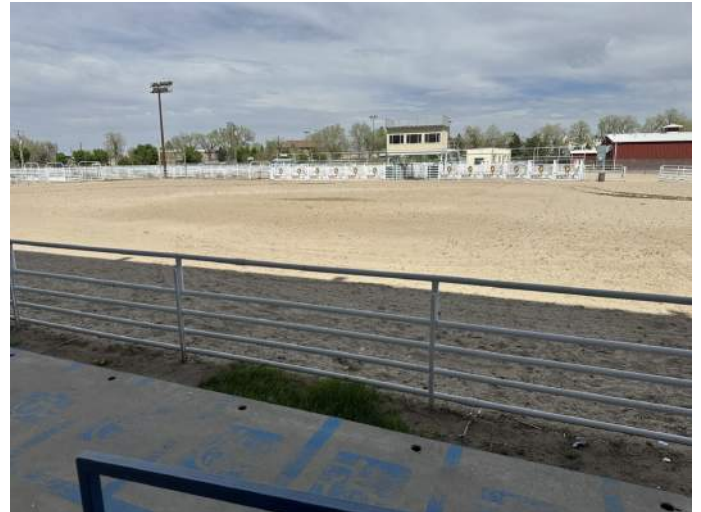
m. These images are of the arena which functions as a multi-purpose venue hosting both competition and performance events. The arena contains the appropriate mix of soil types for both the competition and performance events and appears to be properly maintained.

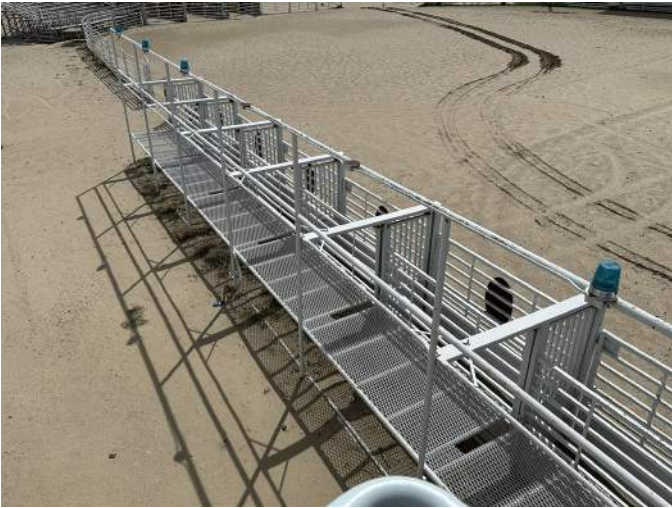
g. Slider gates at the stock chutes require maintenance and or replacement as they are difficult to operate; and can effect the flow of competition events.

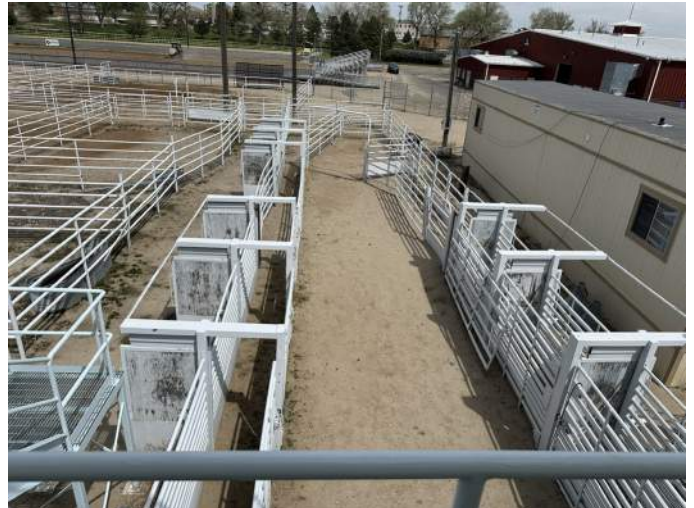
h. Image of stock chutes and slider gates from a different angle.

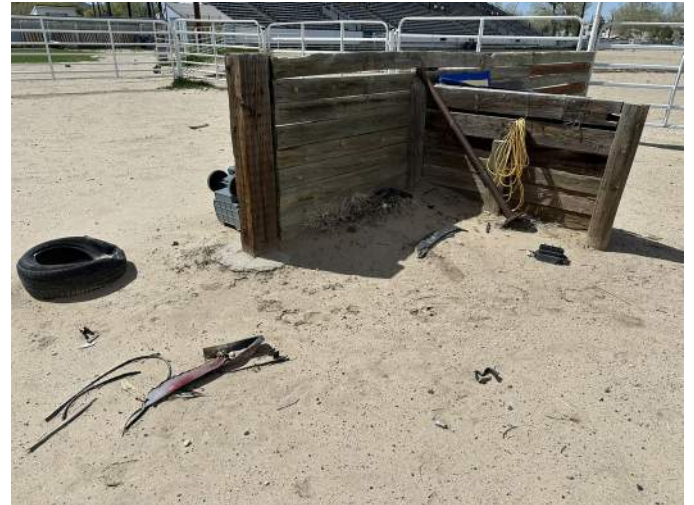
j. Image of debris from the demolition derby. Nails and foreign objects from this and other events were observed in the general area. These items either in and/or outside of the main arena, poses a risk of injury to the equine athletes, stock, and people.

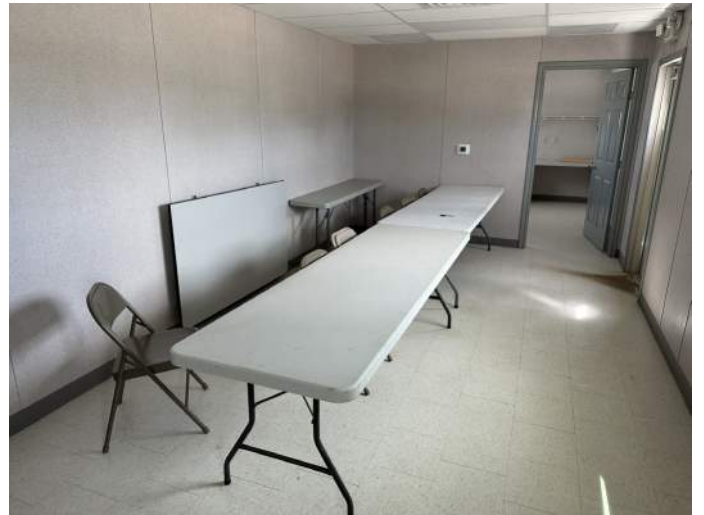
d. Image of the main meeting space at the Rodeo Office. Note the dirt that appears to have blown in under the door. Inspect the seals and sweep where the bottom of the door and sill meet and replace if needed.

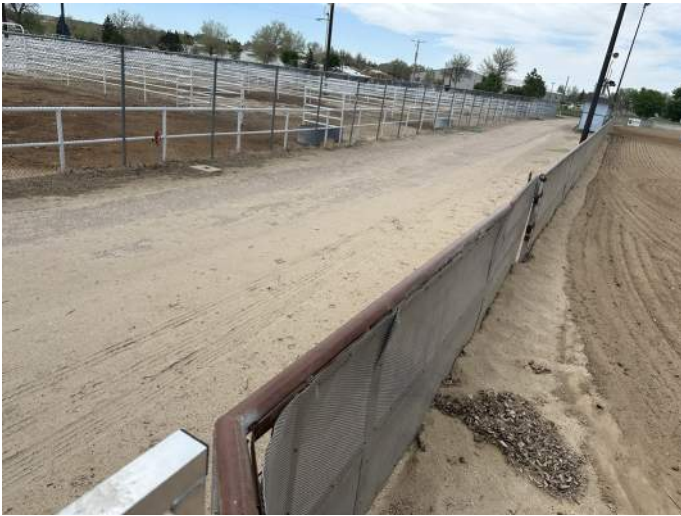
c. Image of damaged perforated aluminum panel .

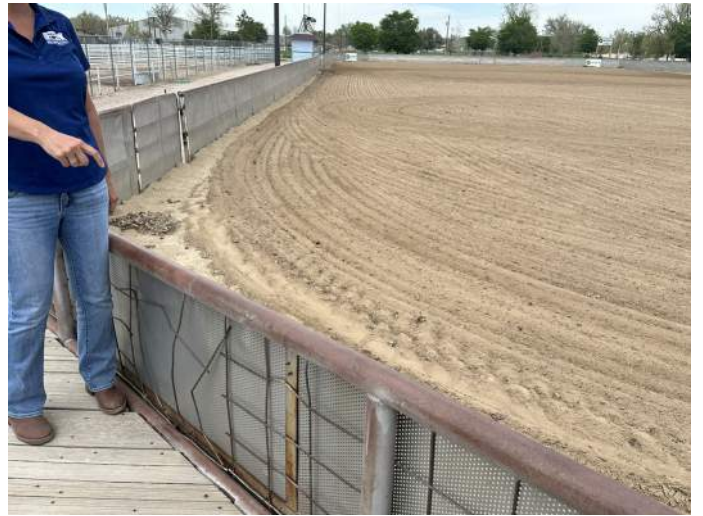
d. Image of damaged welded wire fence panel. This panel poses a tripping and snagging hazard.

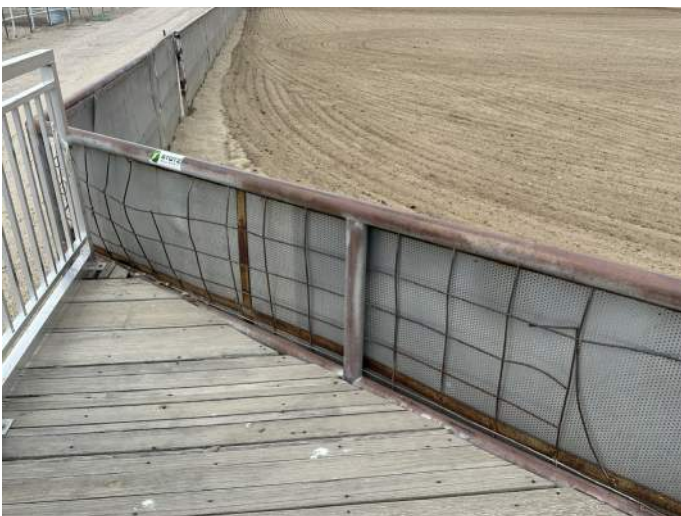
e. Image of damaged welded wire fence panel. This panel poses a tripping and snagging hazard.

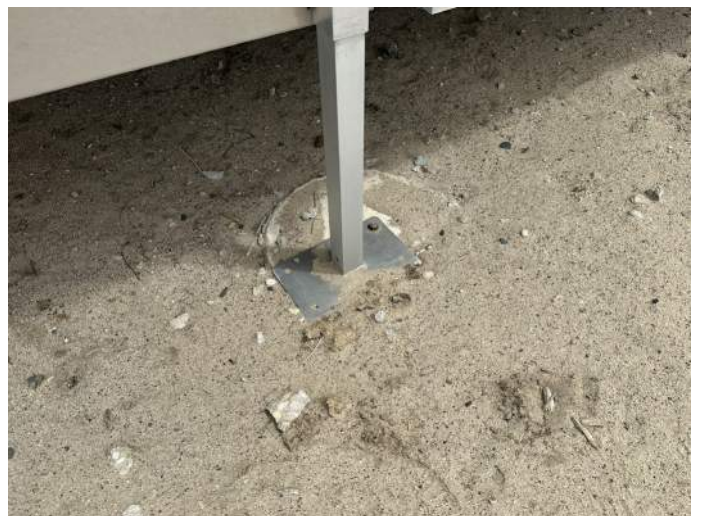
f. Image of concrete foundation with off centered base plate for the aluminum ramp system. Note, the base plate is only attached with a single fastener.

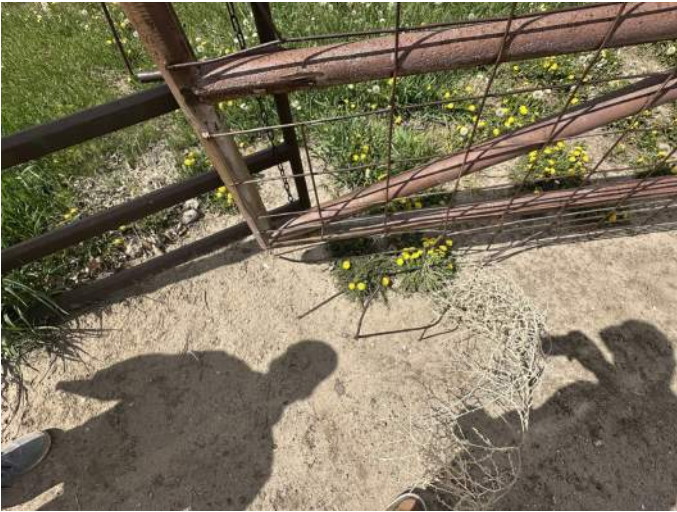
g. Image of damaged welded wire fence panel at the collection and working alley at the stock pens at the North end of Stotz Arena.

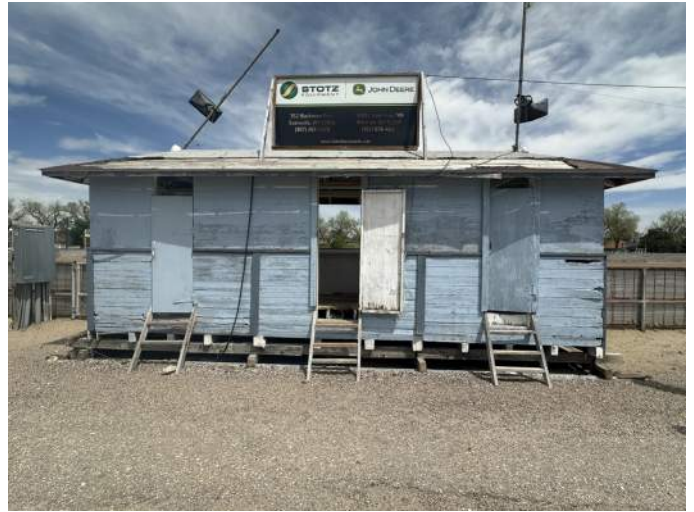
h. Exterior photo of the Press Box.

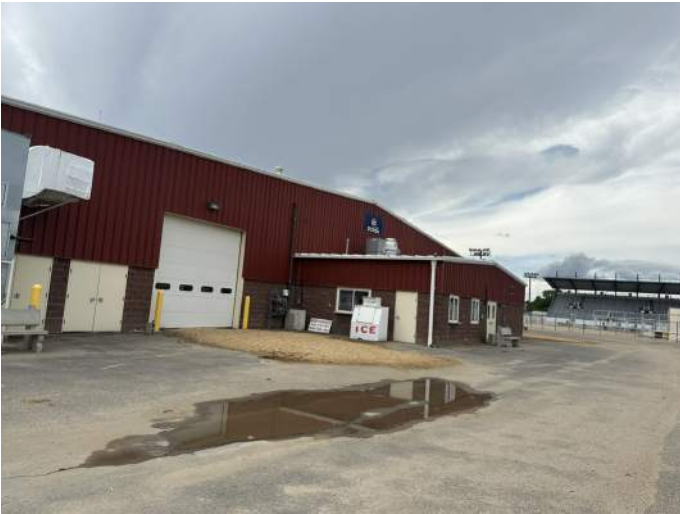
a. Image of North Elevation of the building.

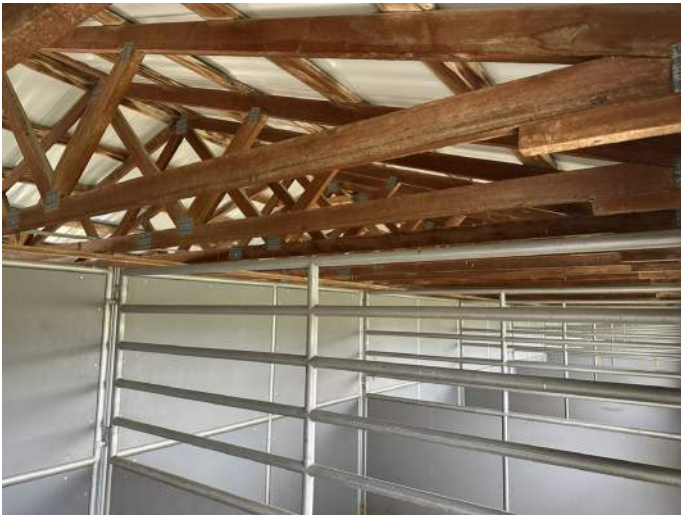
c. Image of pre-engineered wood truss and individual equine stalls. The Red Arrow identifies the exposed conductor noted in the narrative.

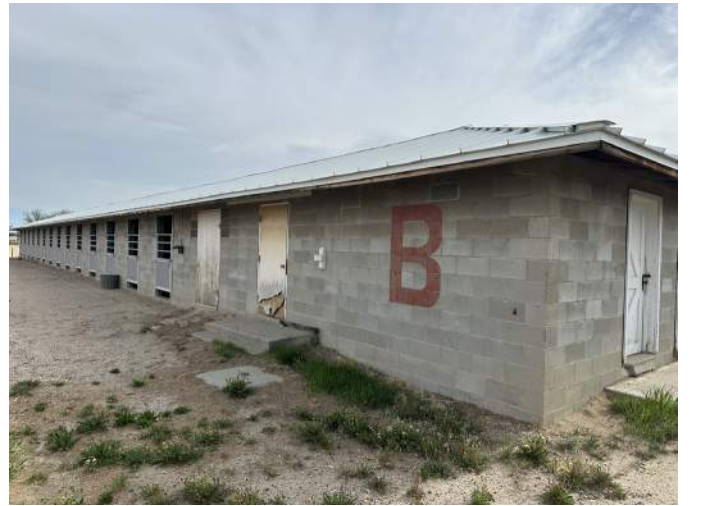
d. Exterior image of Stall Barn 'B'.

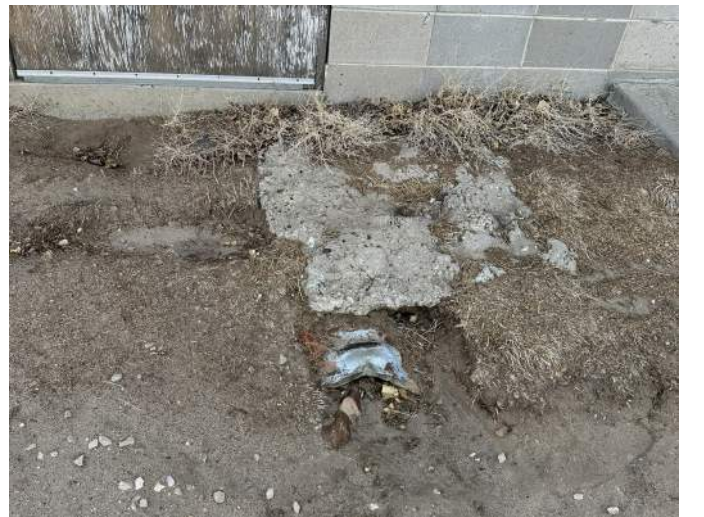
f. Image of a plugged storm drain outlet. Also note the uneven surface in front of the door. c. Image of pre-engineered wood truss and individual equine stalls. The Red Arrow identifies the exposed conductor noted in the narrative.

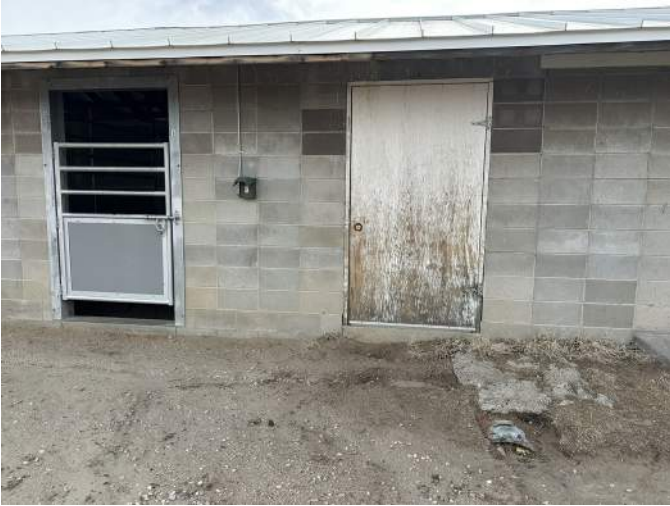
g. Image of wood door and frame, and clogged storm drain.

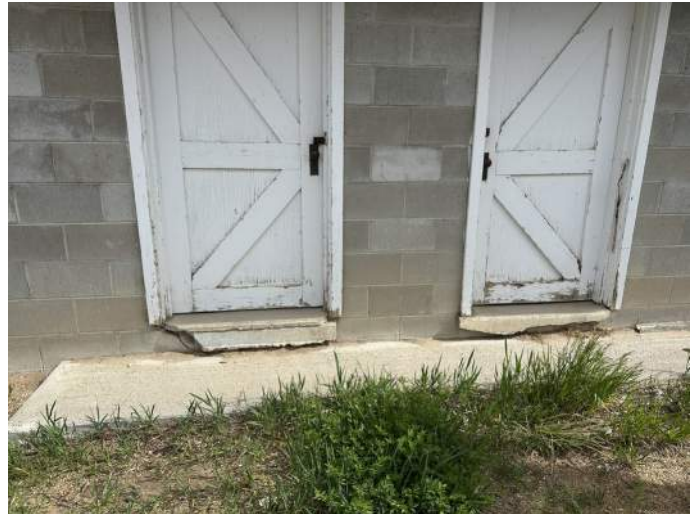
j. Image of additional exterior doors to tack and storage rooms at Stall Barn 'B'. The Red Arrow identifies where the concrete spilled out to the exterior when the interior slab for the tack and storage rooms was poured. This condition poses a tripping hazard and should be removed.

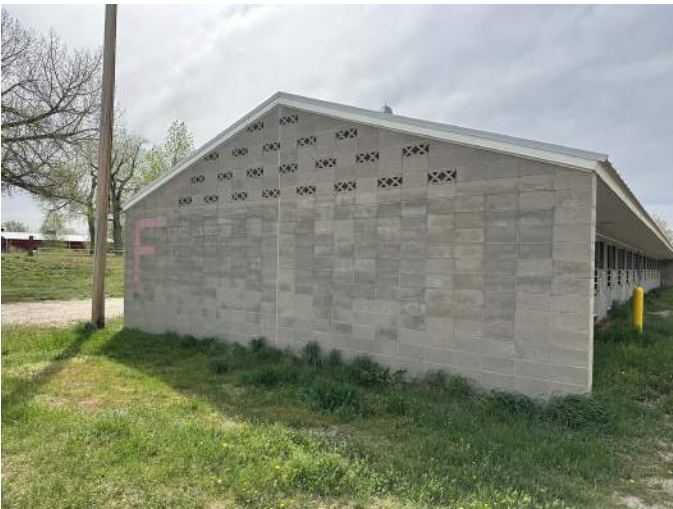
k. Exterior of Stall Barn 'F' as viewed from the North.

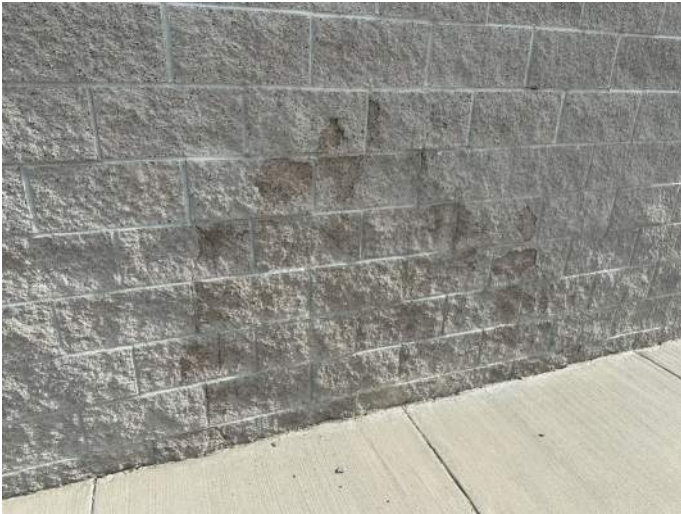
a. Image Split face CMU block spalling at exterior wall of building.

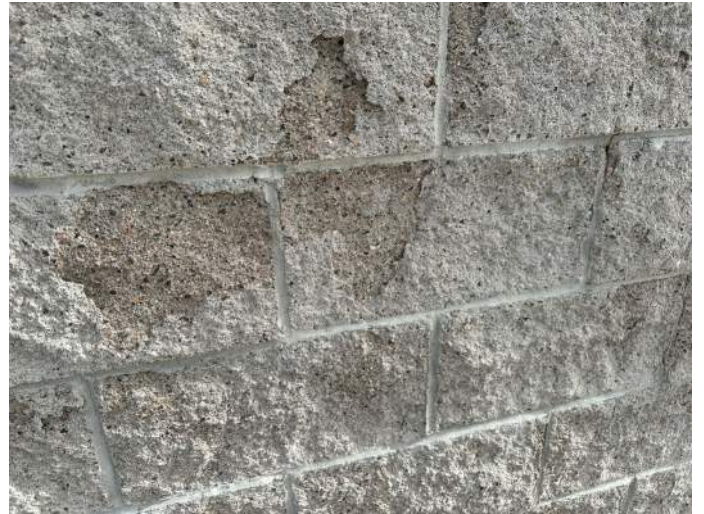
b. Close up image of spalling split face CMU block noted in Image a.

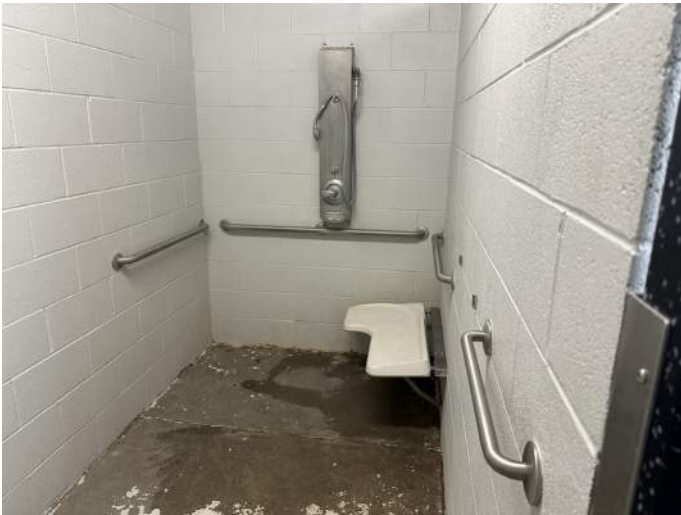
c. Image of accessible shower stall. Note the paint has worn off of the shower floor surface and the damage to the shower seat.

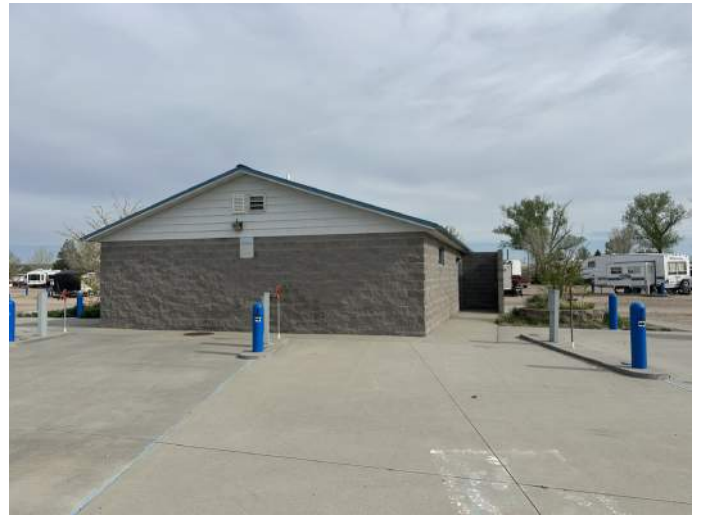
d. Image the exterior of the North Elevation. Note the split face CMU block face is spalling just behind the yard hydrant.

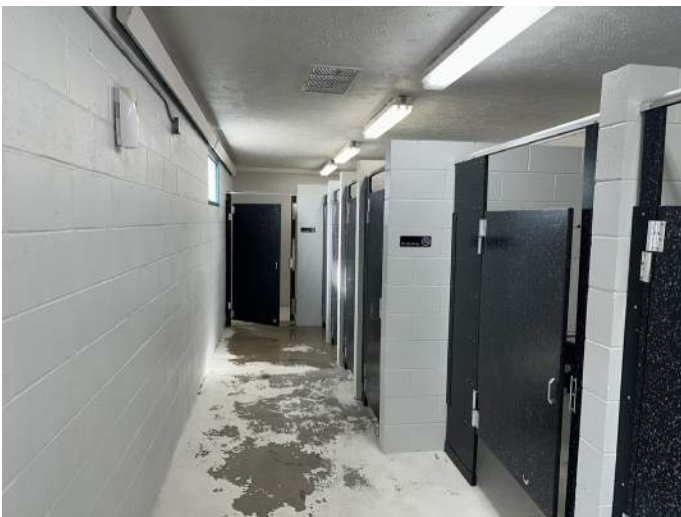
e. Image of the interior of the Women's Restroom.

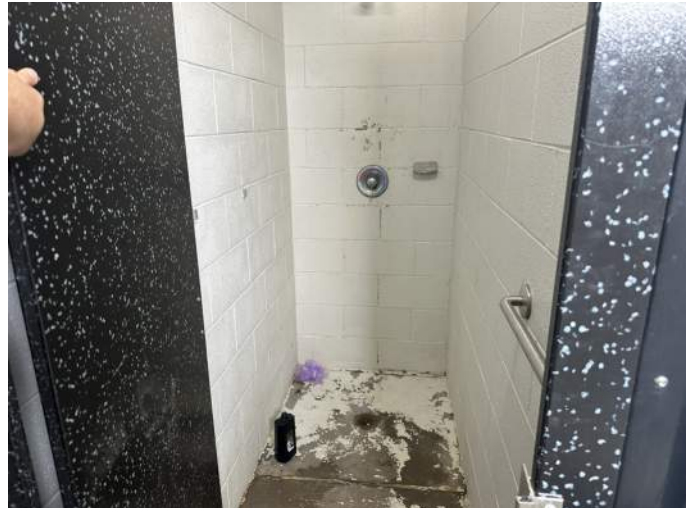
h. Image of a typical shower stall. Note the paint has worn off of the shower floor and is flaking off of the control wall of the stall.

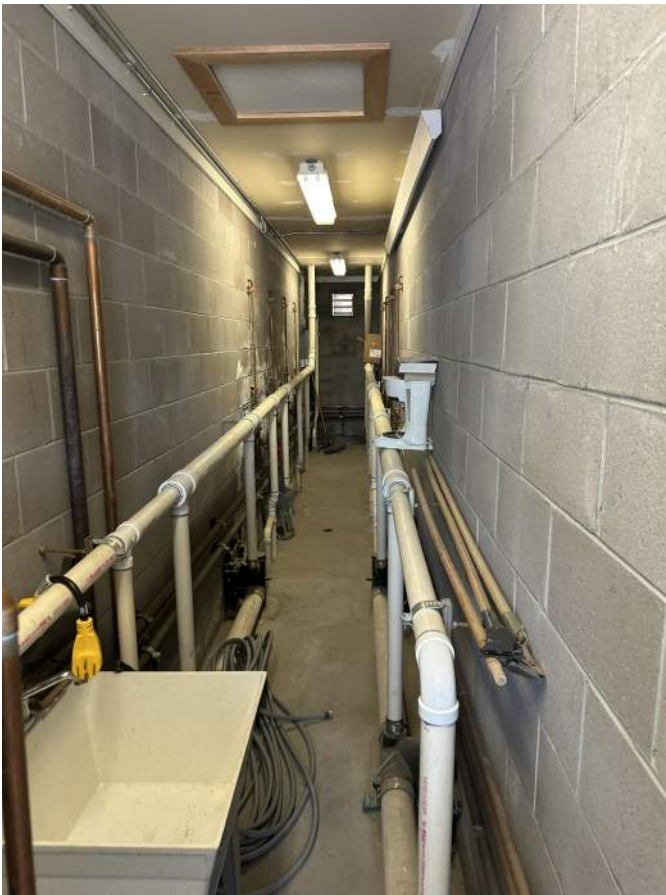
i. Image of the plumbing chase between the Men and Women's restroom.

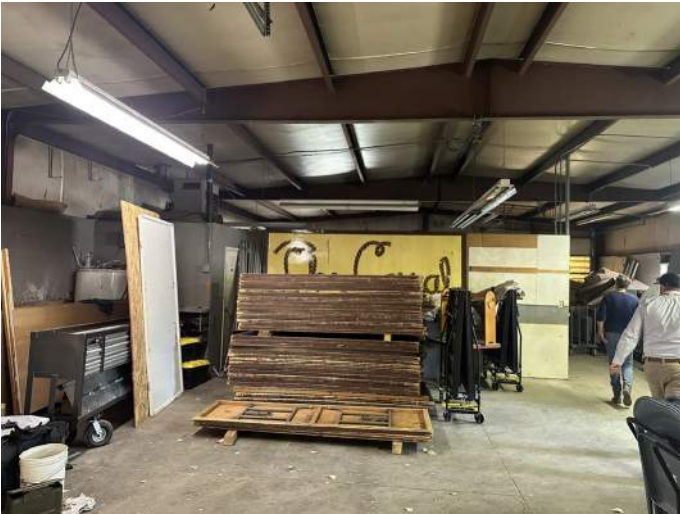
a. Interior of the Storage Building looking South.

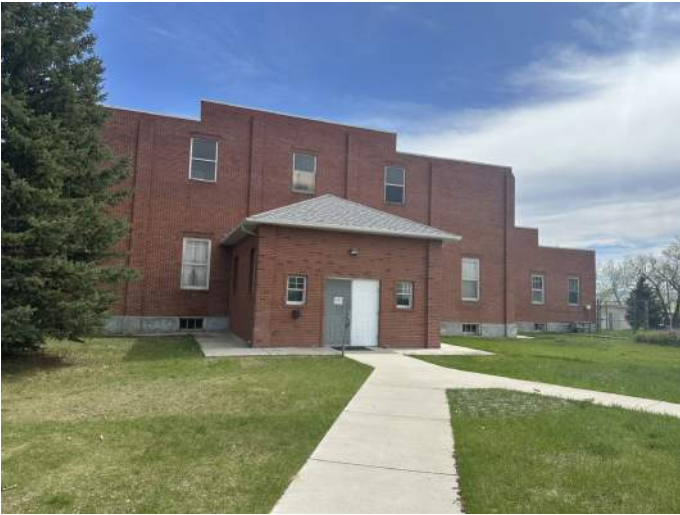
a. Image of entry to the Multi-purpose Room. Note the residential front doors. (North Facing Elevation of the Building.)

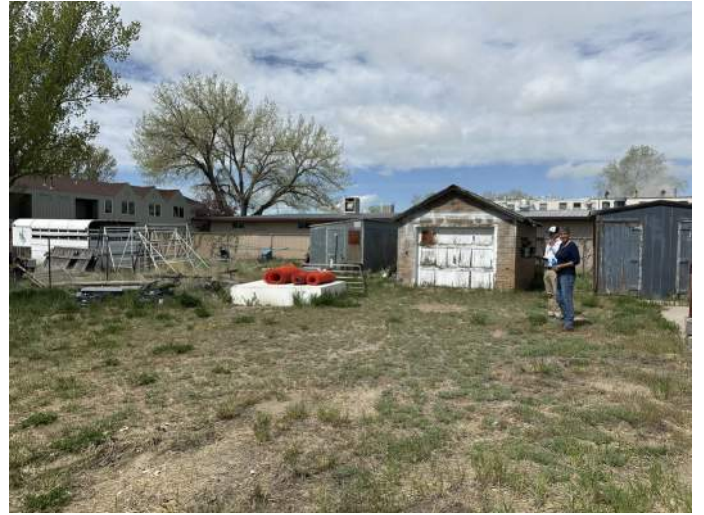
b. Image alternate entry to the Multi-purpose Room. Note the residential patio and front door, improper hand and guard rail, and spalling concrete landing and steps. (North Facing Elevation of the Building.)

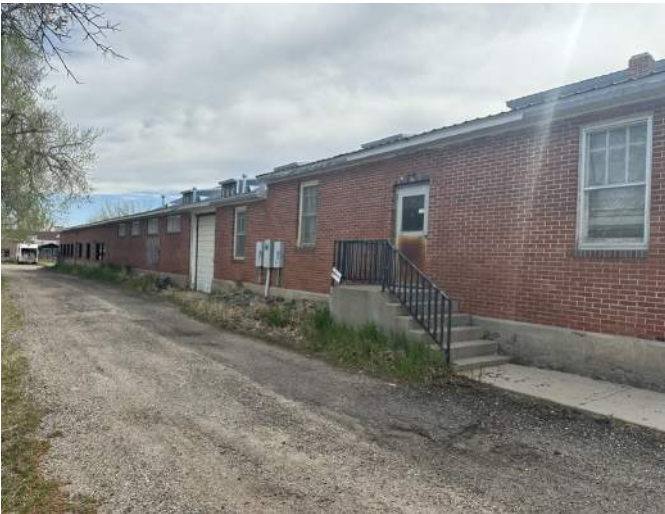
c. Image of the East facing Elevation of the Building. Note the failing paint finish on the metal fascia, improper hand and guard rail at the stair, the exterior hollow metal door that need replaced, stored asphalt paving debris against the building foundation and graffiti.

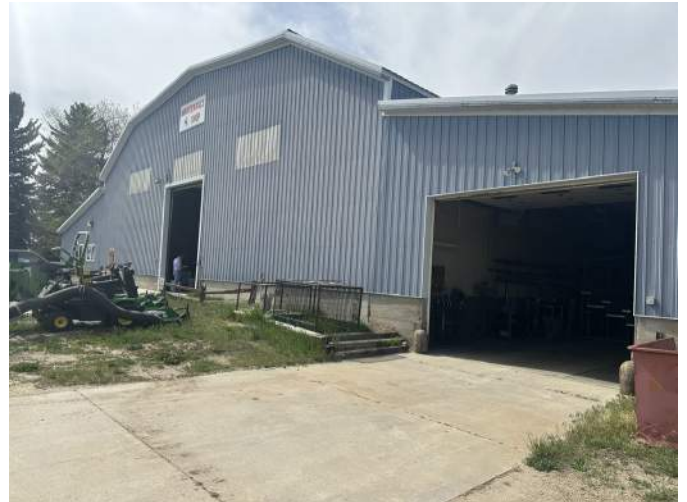
d. Image of the South Facing Elevation of the Vehicle and Storage and Maintenance Bay.

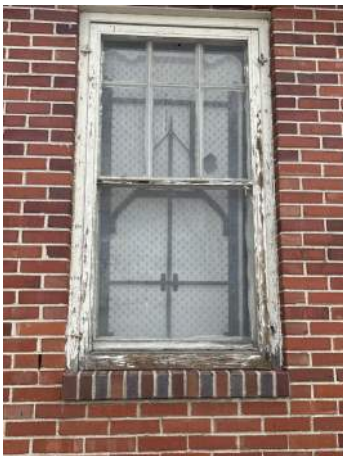
e. Image of typical single pane window with wood frame. Note the deteriorated condition of the wood frame. This is typical of all wood windows.

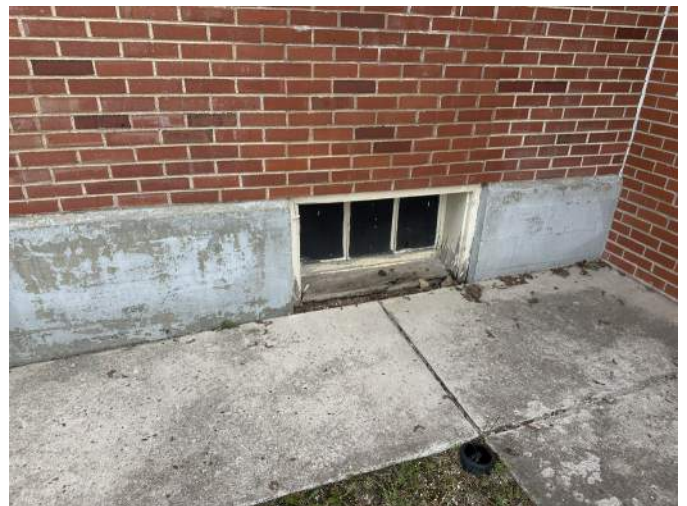
f. Image of typical single pane window with wood frame at grade. Note the deteriorated condition of the wood frame and window glazing. This is typical of all wood windows at this location.

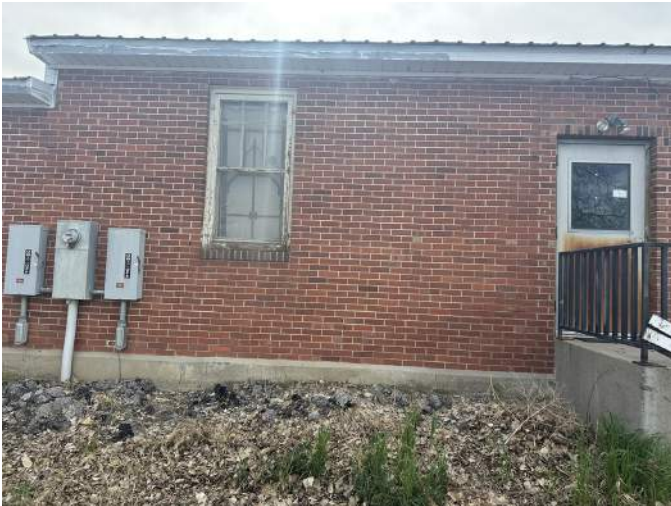
g. Close up Image of the East facing Elevation of the Building. Note in the upper left hand corner of the image the discolored brick masonry and eroded mortar joints, the paint peeling from the metal fascia, and the corrosion on the exterior hollow metal door and frame. These conditions are caused by a lack of rain gutters and down spouts on the building. Also note, in the bottom of the image, piles of asphalt paving that has been removed from elsewhere on the campus.

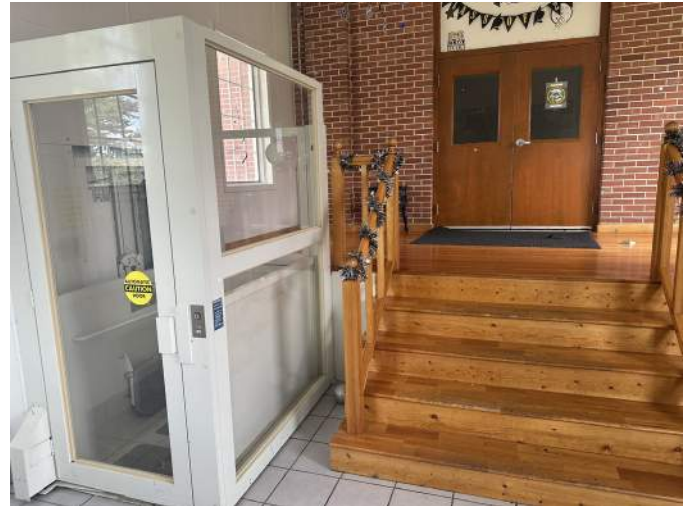
h. Image of the interior Vestibule of the Multi-Purpose Room. Note the wheel chair lift in the left hand corner of the image.

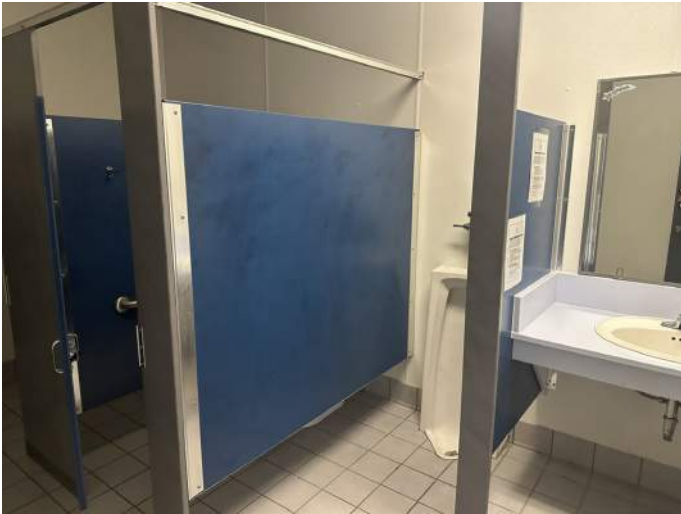
m. Image of Men's Restroom. Note the piping at the Lavatory is missing the protective insulation.

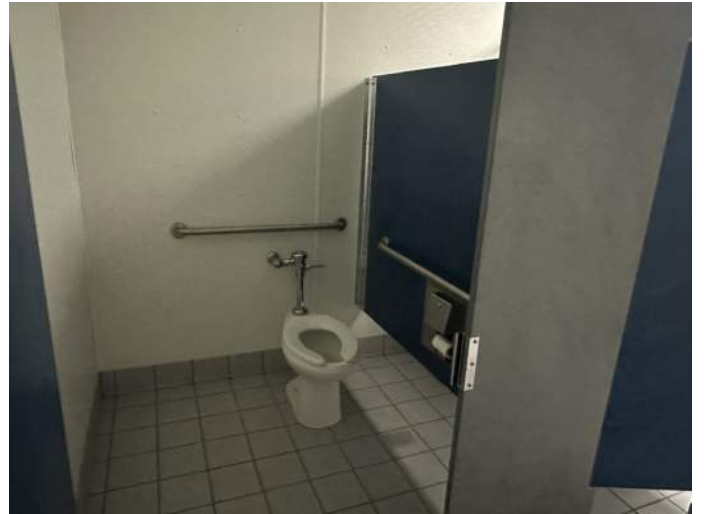
n. Image of the Wheel Chair Accessible Toilet Compartment in the Men's Restroom. Note the flush control faces the wrong direction.

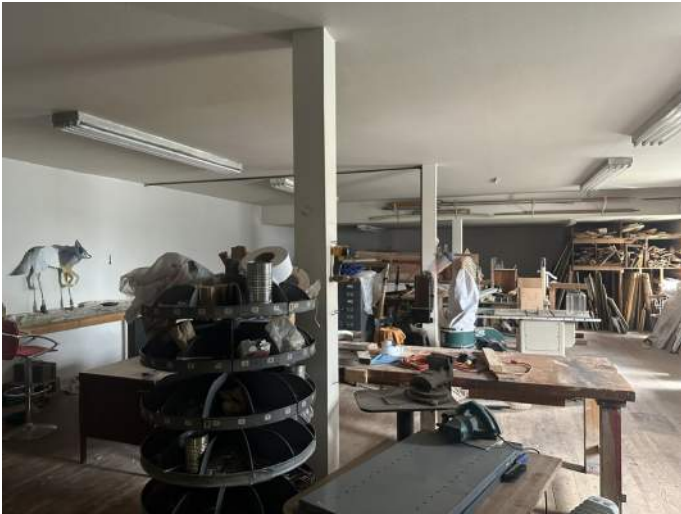
q. Image of Paint & Stain Storage and Work Bench in the Wood Shop.
