Appendices

WYOMING STATE FAIR - MASTER PLAN

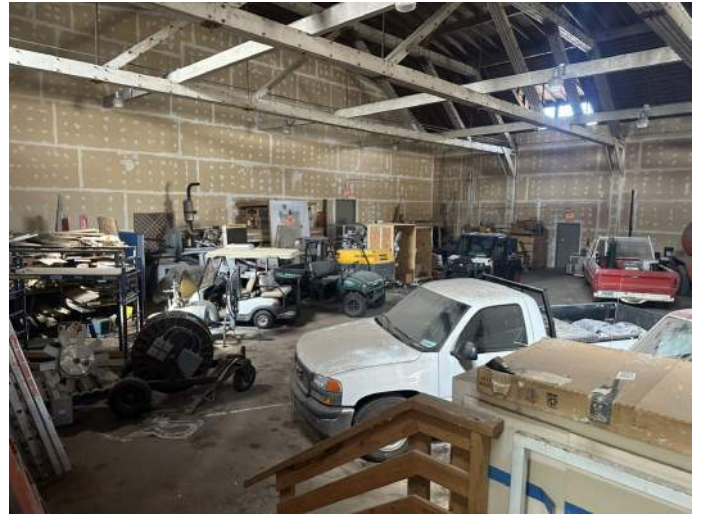
r. Interior image of Vehicle and Equipment Storage looking Northeast.

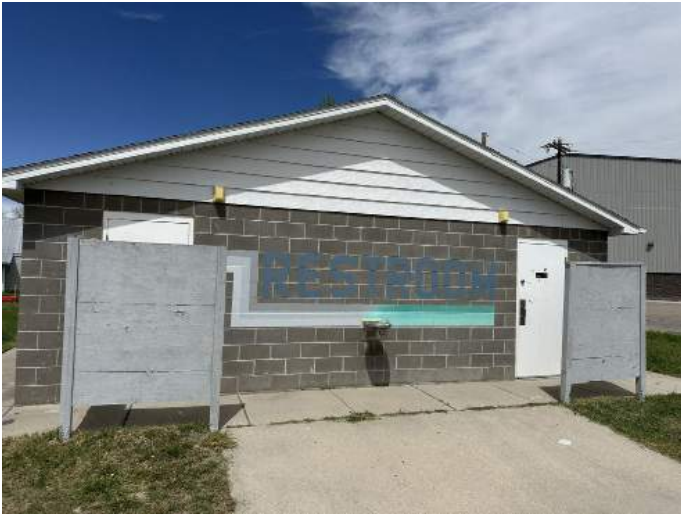
a. Image of the front facade of the Restroom Building which faces Southeast toward the Mid-way.

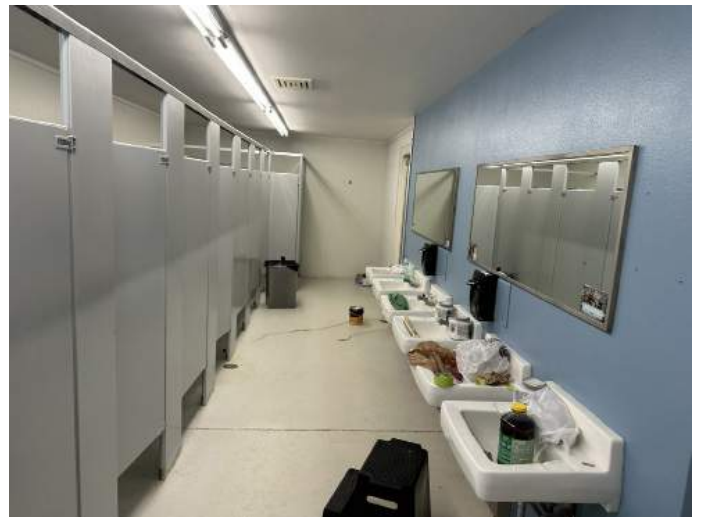
d. Image of the interior of the interior of the Women's Restroom. Note the height of the mirrors, and missing toilet accessories.

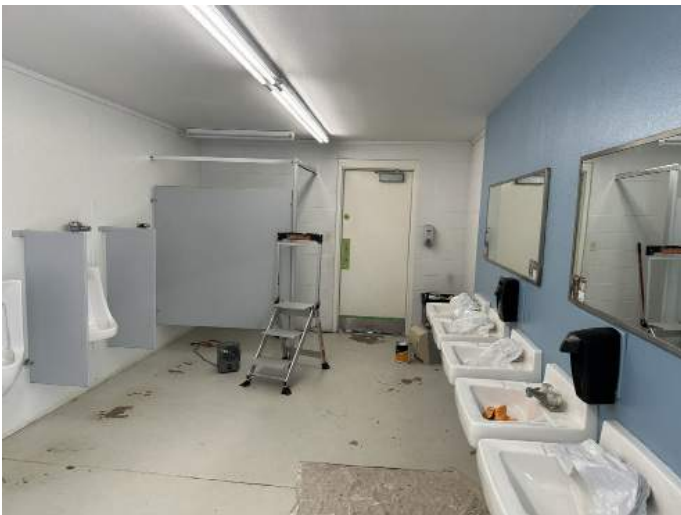
e. Image of the interior of the interior of the Men's Restroom. Note the height of the mirrors, and missing toilet accessories and faucets with handles that require twisting and grasping.

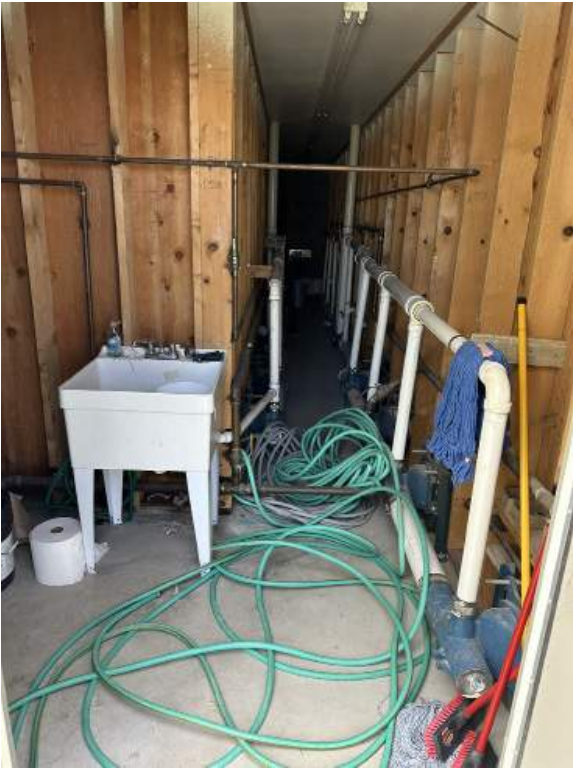
f. Image of the plumbing chase between the restrooms.

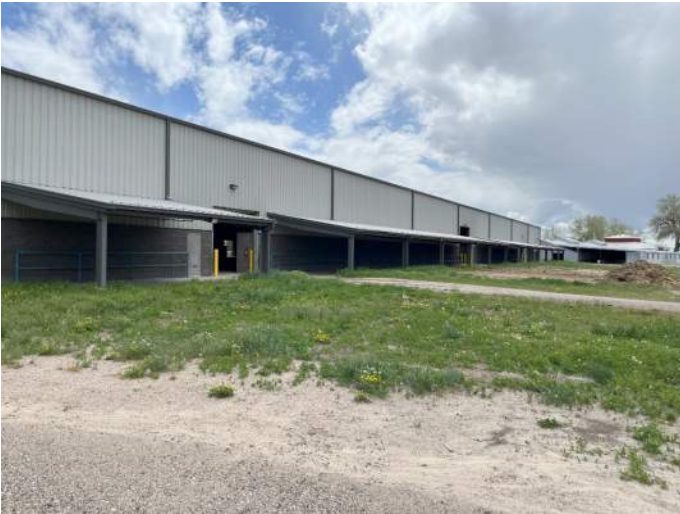
a. Interior of the Wash Bays on the West side of the Ford Pavilion.

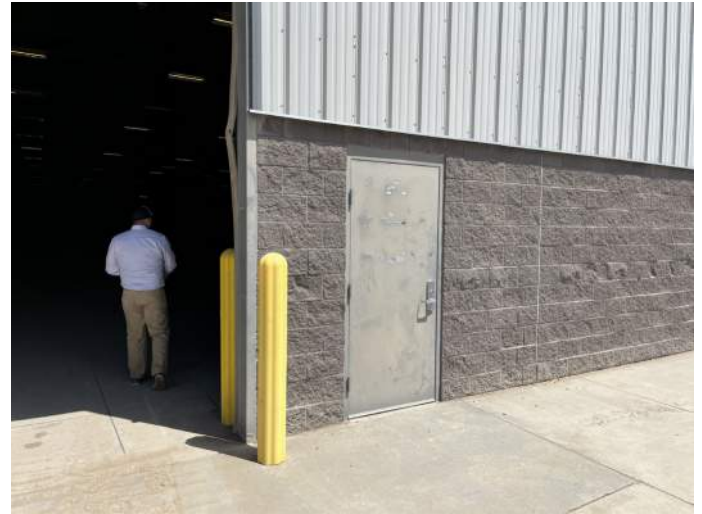
b. Image of damaged side seal at sectional overhead door on the South side of the building.

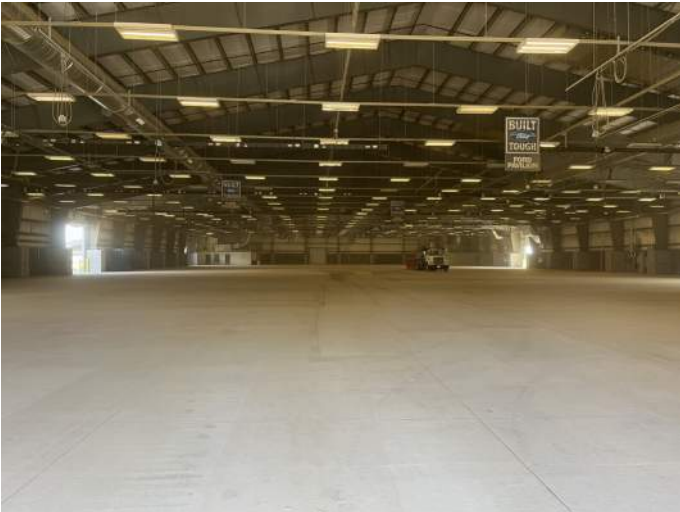
c. Image of the interior of the Ford Pavilion looking North.

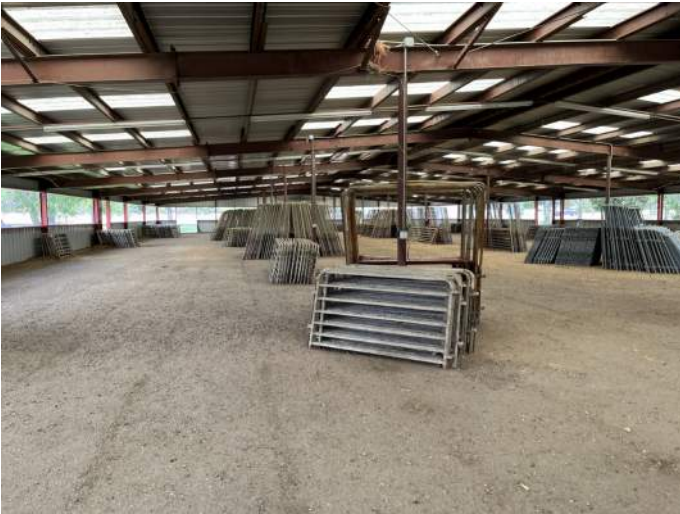
a. Image of the interior of the Sheep Barn looking North.

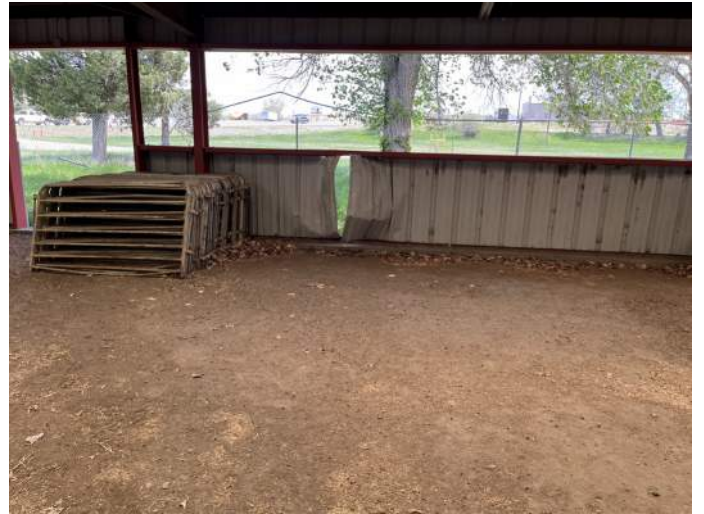
b. Image of damaged metal wall panel looking East.

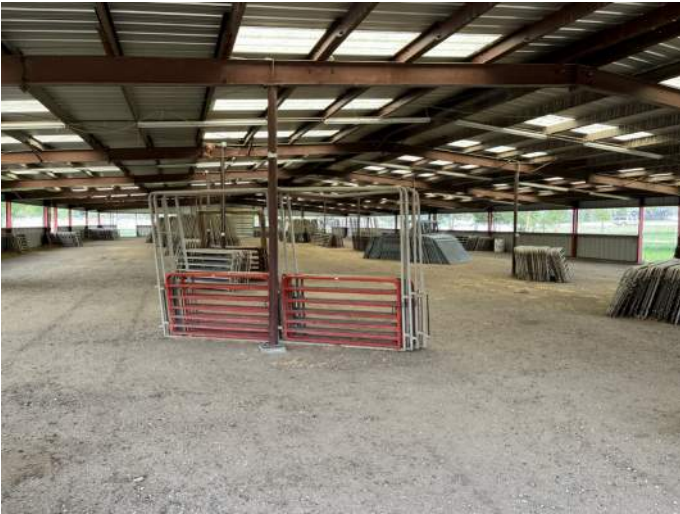
c. Overall image of the interior of the Sheep Barn.

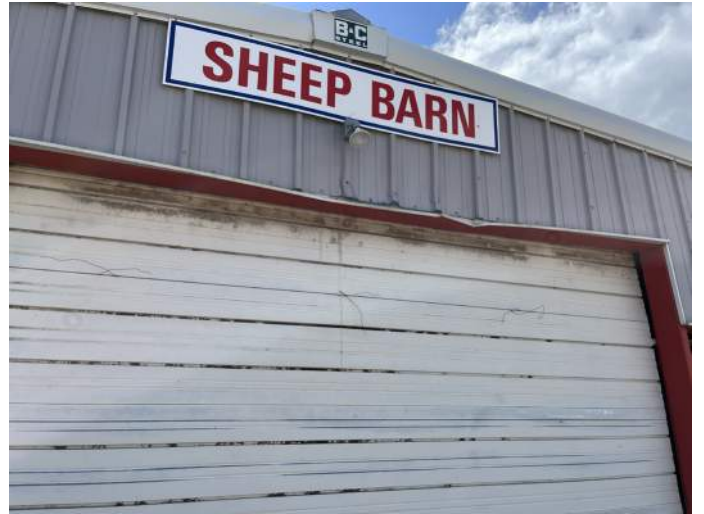
d. Image of damaged head and cover trim and side seal at the sectional overhead door.

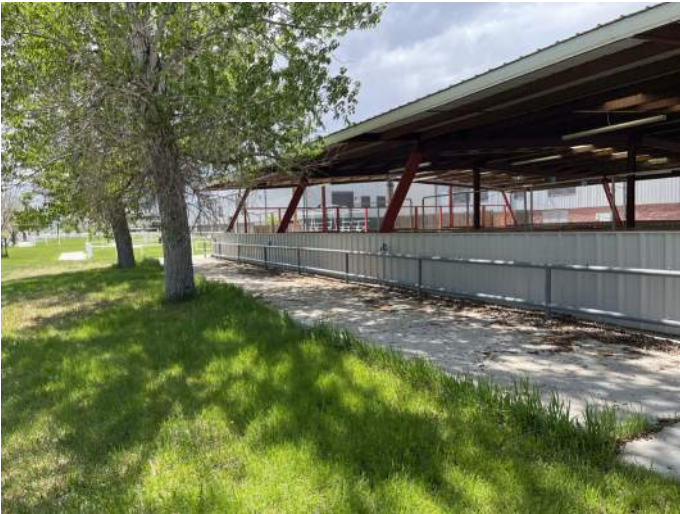
a. Image of the wash rack on the East side of the Goat Barn.

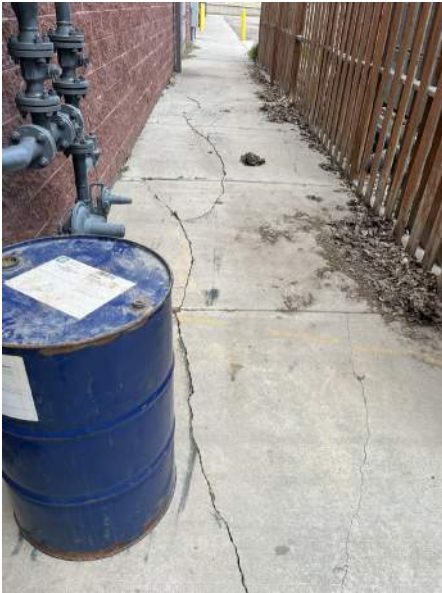
a. Image of 55 gallon oil drum adjacent to the gas meter.

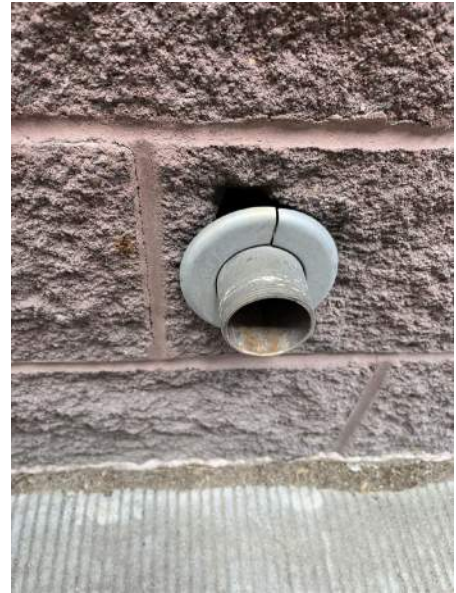
b. Image of CMU block that requires repair in order to keep out pests and the elements.

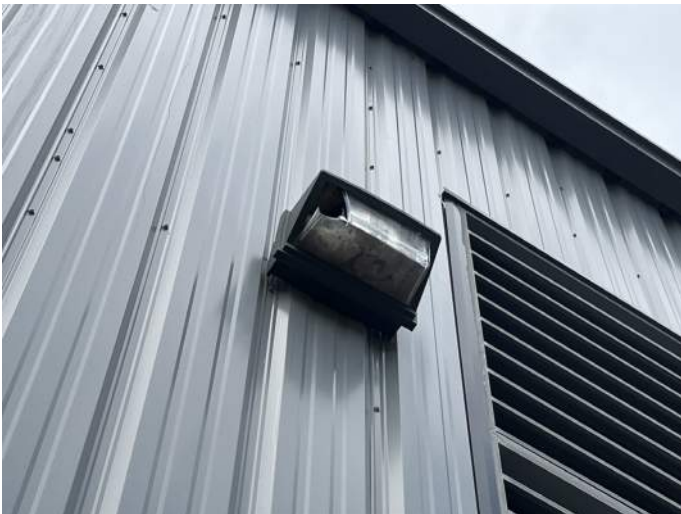
c. Image of damage to the lens of an exterior wall pack.

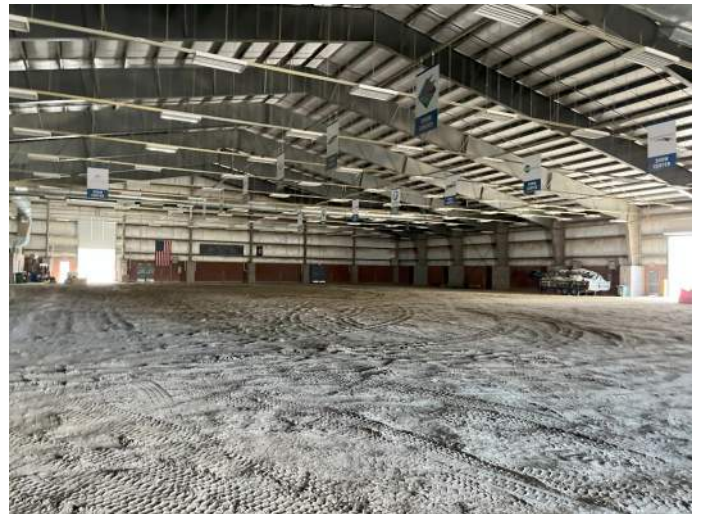
d. Image of the dirt floor within the Touchstone Show Center.

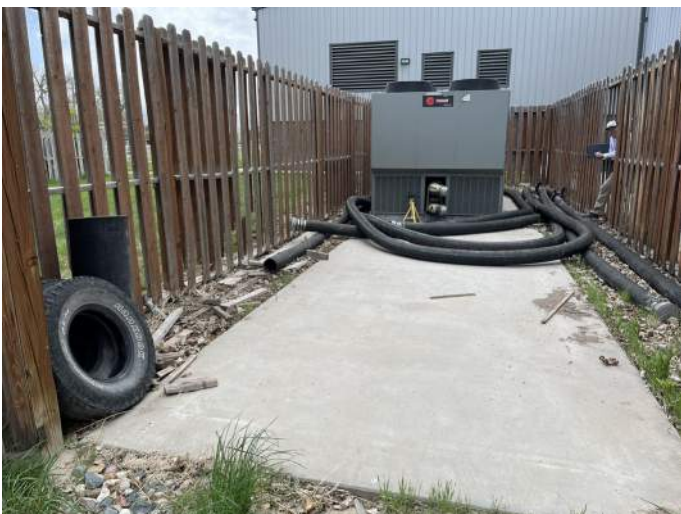
e. Image of damaged enclosure at

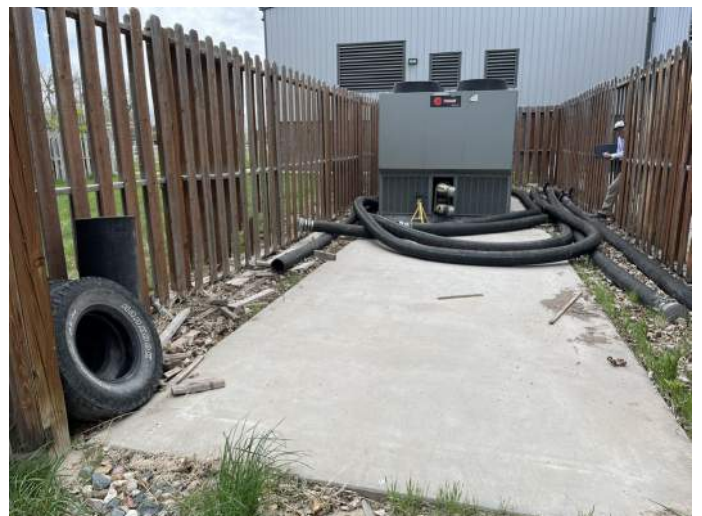
f. Image of damaged enclosure at

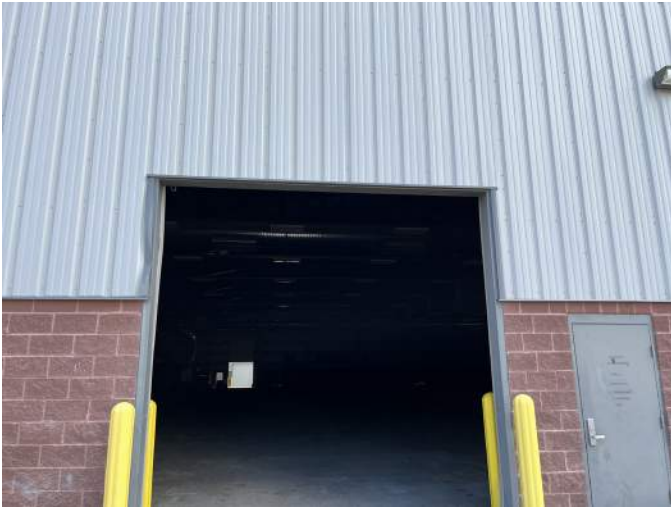
g. Image of damaged metal trim at the jamb of the sectional overhead door.

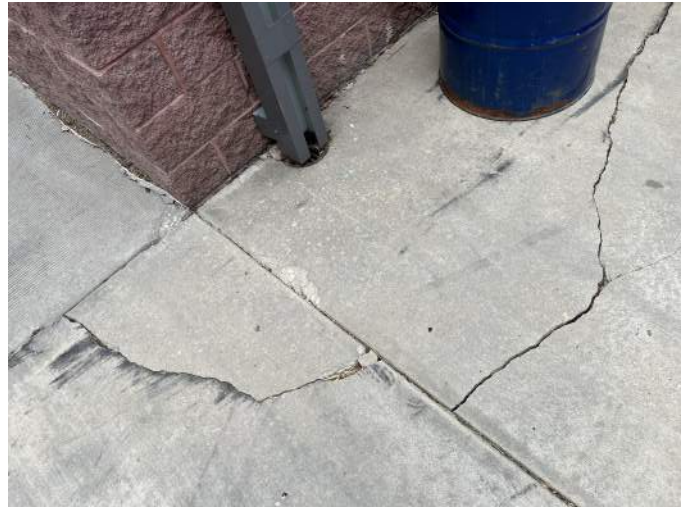
h. Image of cracked concrete at downspout.

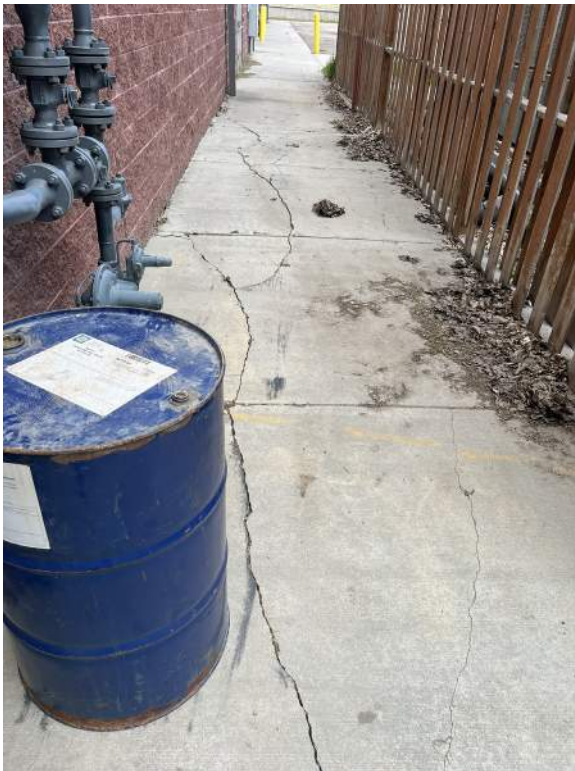
i. Image of cracked concrete at between East facing elevation at the mechanical equipment enclosure.

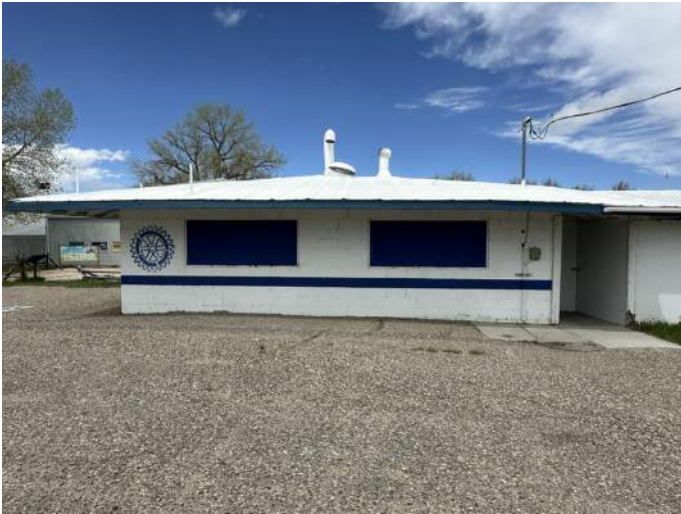
a. Image of the Southeast facing facade of the building.

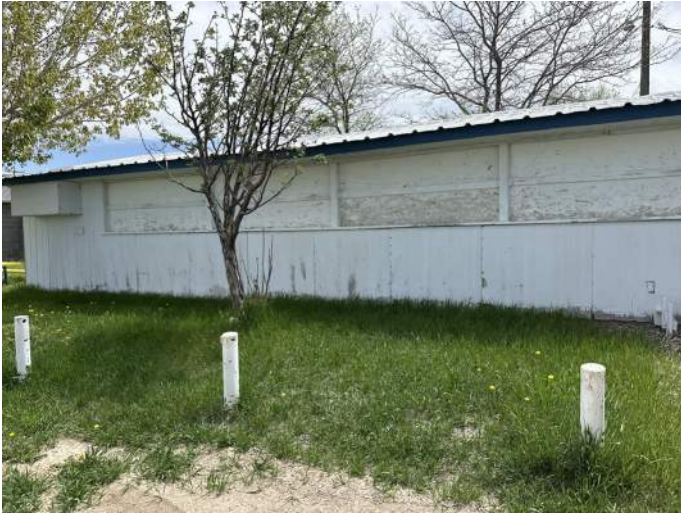
i. Image of TI-II plywood siding panels. Notice the paint finish beginning to fail, the relationship of the siding panel relative to grade and the condition of the wood, and the visible location of the fasteners.

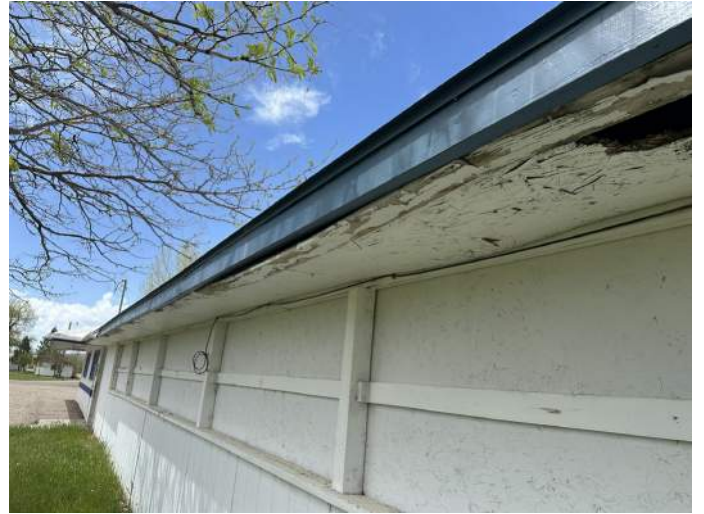
j. Image of the Northwest facing facade with Storage Buildings and adjacent Dining Pavilion.

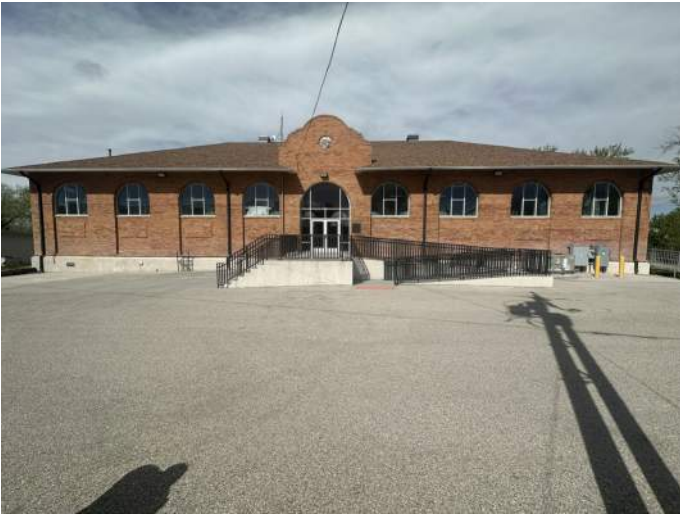
a. Image of the West facing elevation of the building.

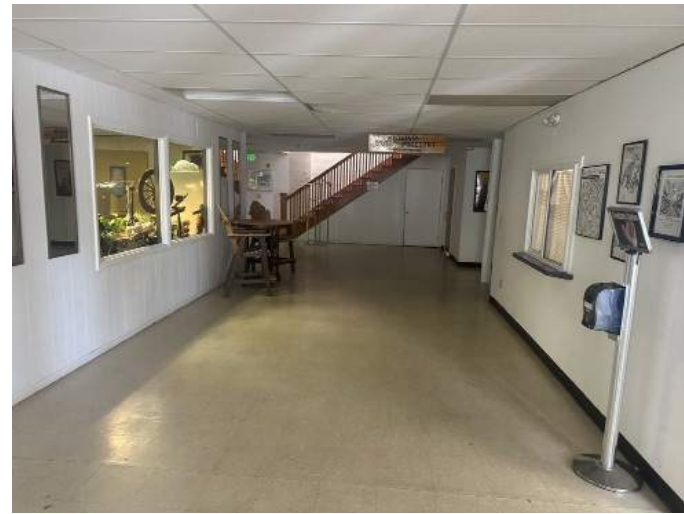
f. Image of the deteriorated OSB soffit panel on the Dining Pavilion adjacent to Pioneer Rd.

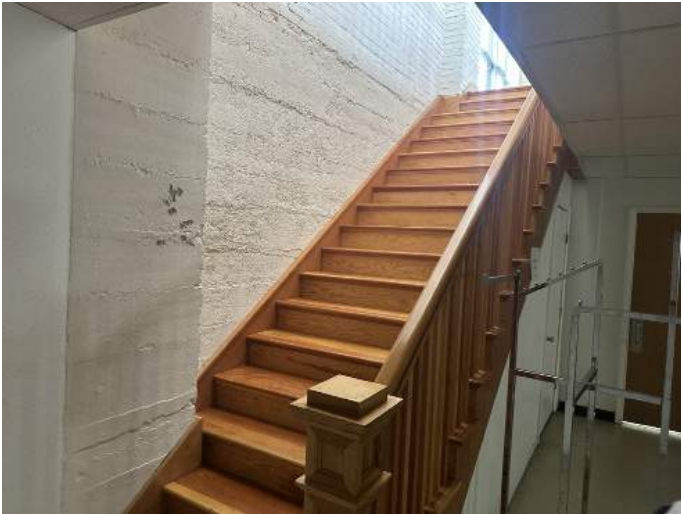
g. Close up image of stairs leading from the Main Level to the Upper Level Ag Hall.

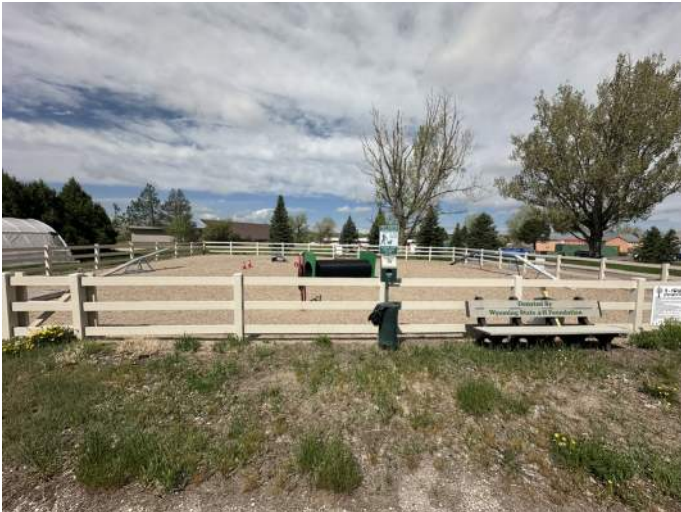
a. Overall image of the Dog Agility Park looking North.

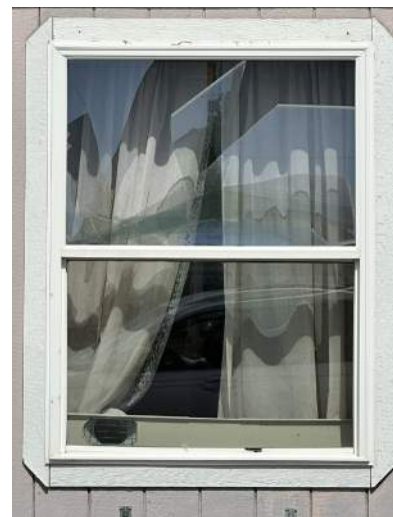
f. Image of a broken window in Intern Housing Unit #2.

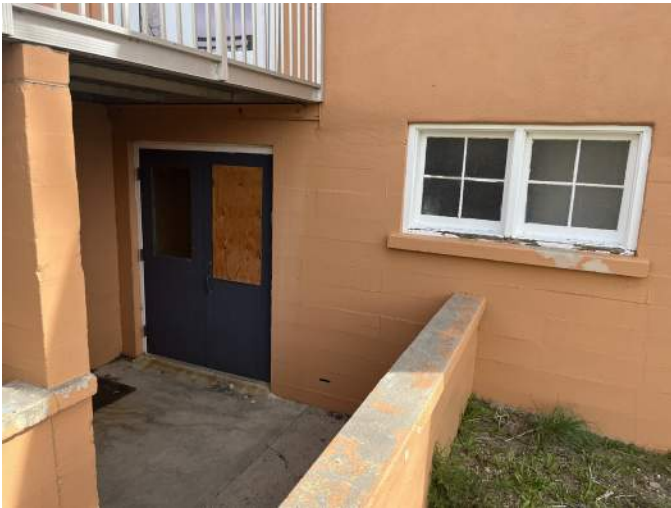
e. Image of ground floor level door on the North facing elevation. Note the broken glass lite.

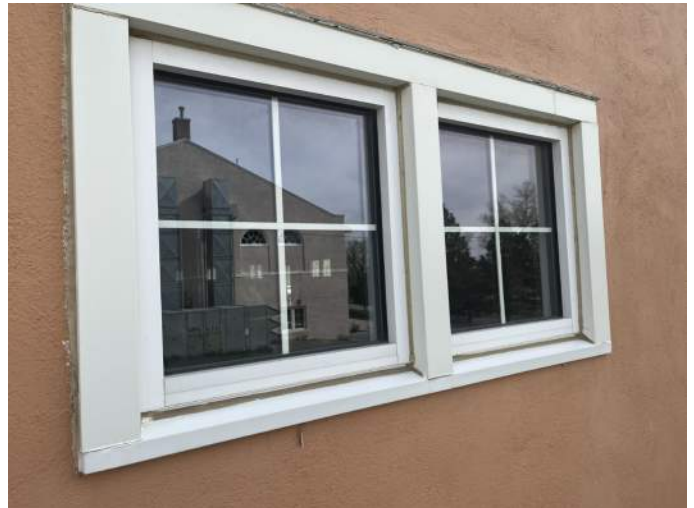
f. Image of a new vinyl window. Note the exposed wood at the head of the window and sealant which has peeled away.

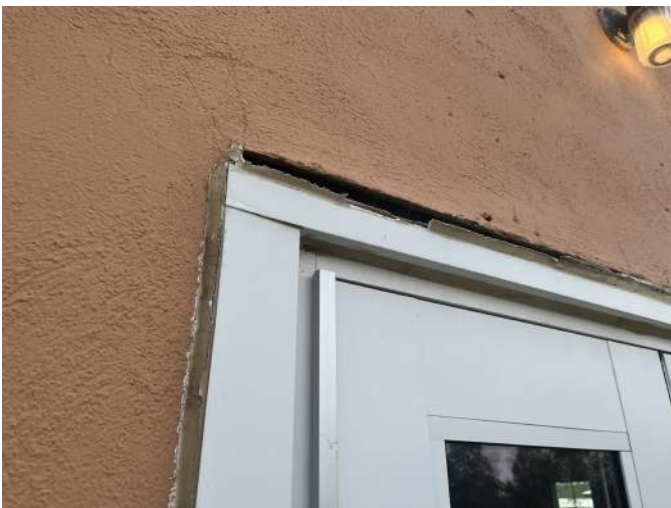
g. Image taken at the head of the aluminum storefront door. Note the sealant has completely failed allowing the elements into the wall and building.

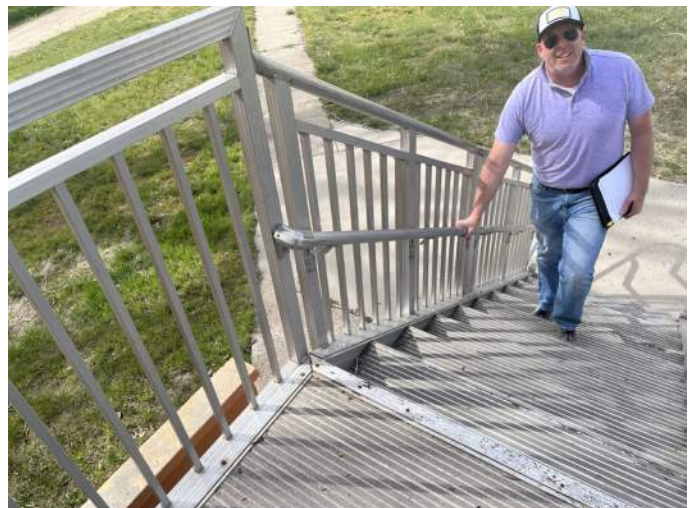
h. Image of the handrail at the stair on the North facing elevation of the building. Note the height of the handrail shall be not less than 34" and not more than 38."

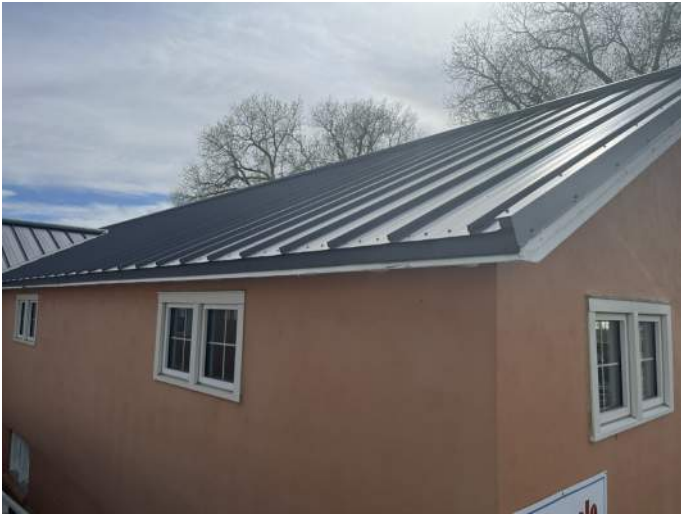
i. Image of paint peeling from the wood fascia. This is a typical condition for all fascia members.

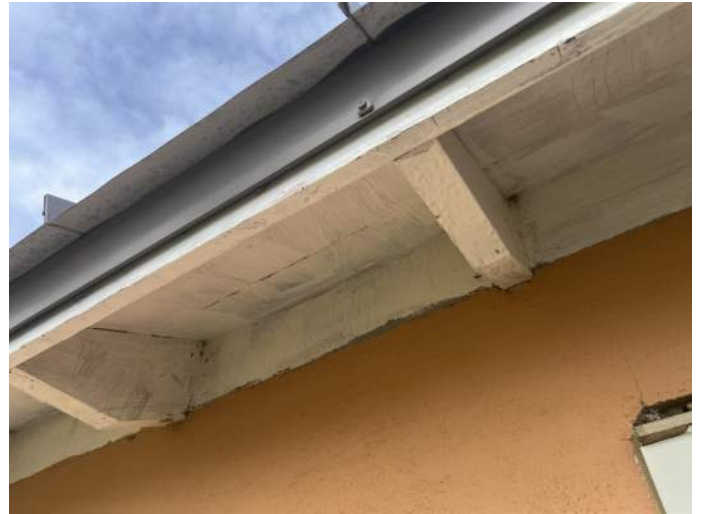
j. Image of paint application on beams and soffit.

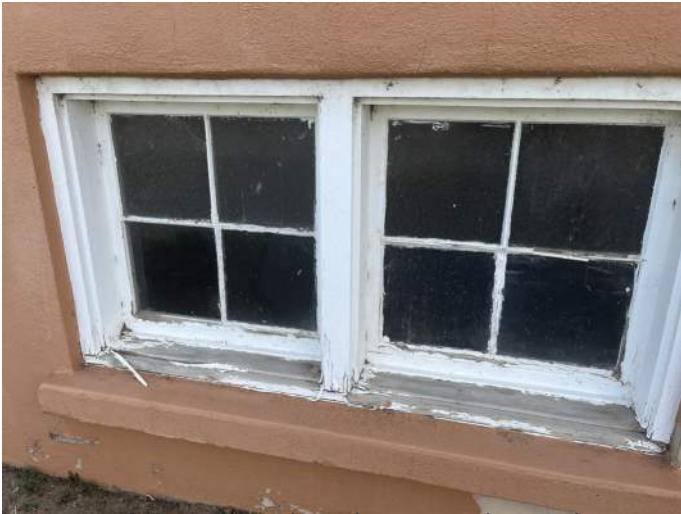
k. Image of typical wood window. Note the window glazing has failed and is falling off of the window.

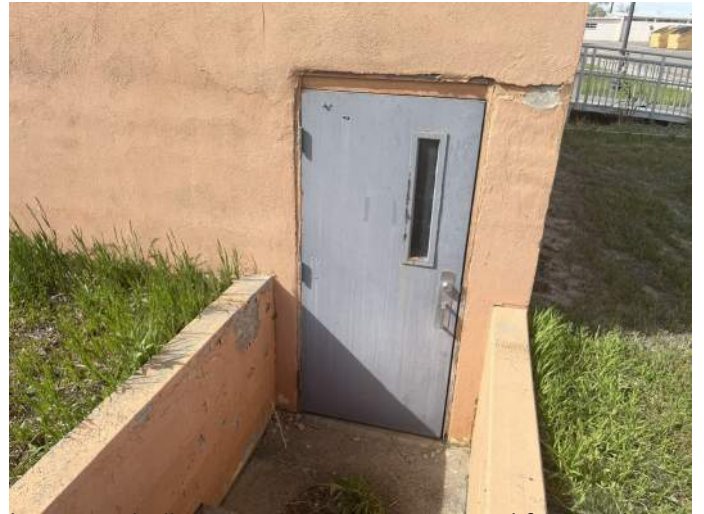
l. Image a hollow metal door set in a wood frame. The frame has rotted misaligning the door in the rough opening. The door is currently inoperable and is unable to open.

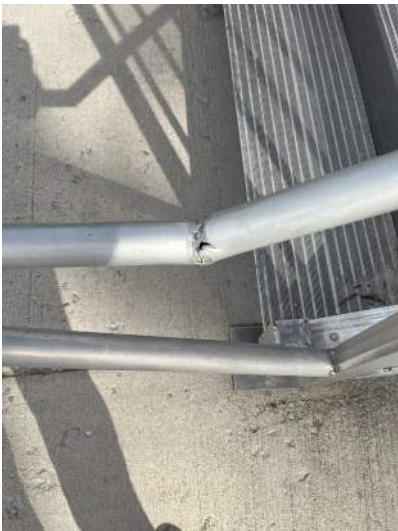
m. Image of damage to the handrail on the North Elevation facing Fort Reno. This is hazardous to patrons as it has the potential to catch a ring, or article of

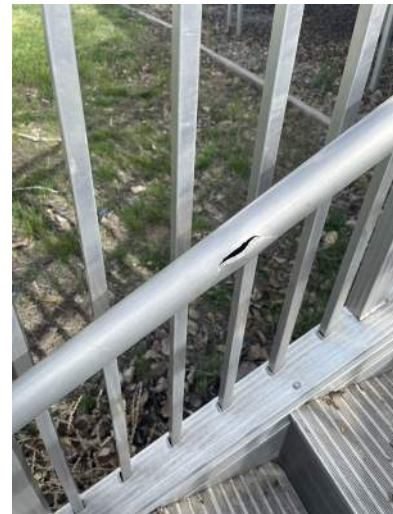
n. Image of damage to the handrail on the North Elevation facing Fort Reno. This is hazardous to patrons as it has the potential to catch a ring, or article of clothing.

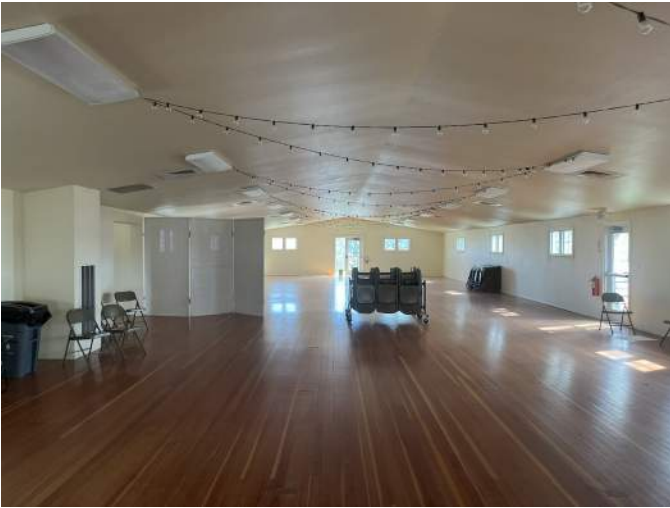
o. Overall image of the interior of Steele Hall looking South. The cased opening on the left hand side of the image leads to the Men and Women's restrooms.

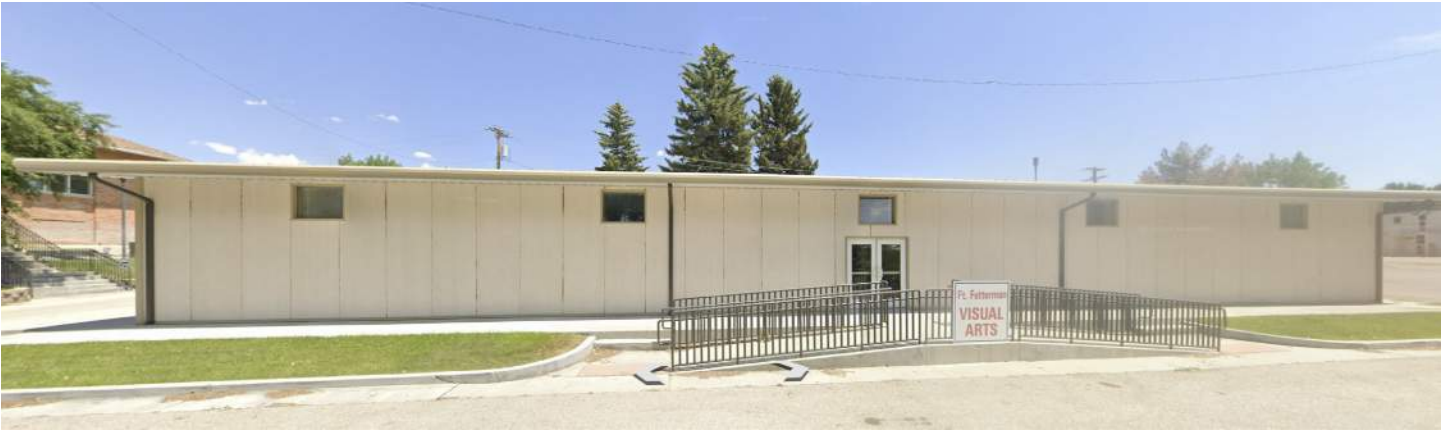
a. Image of the West Facing Elevation

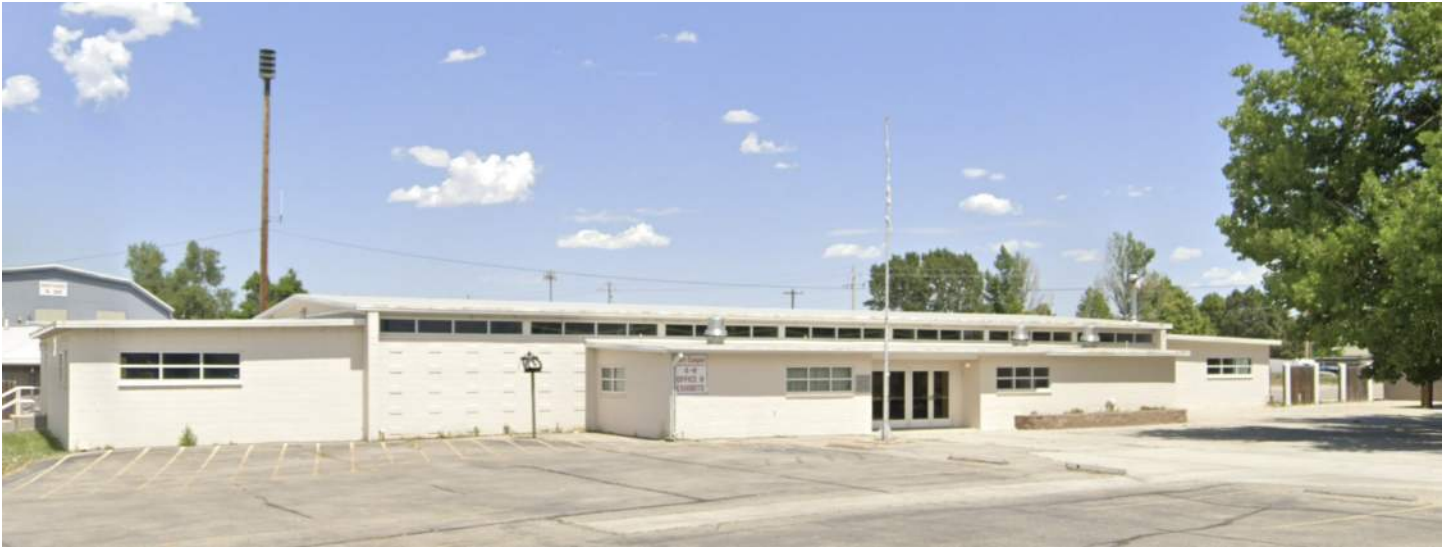
a. Image of the South Facing Elevation

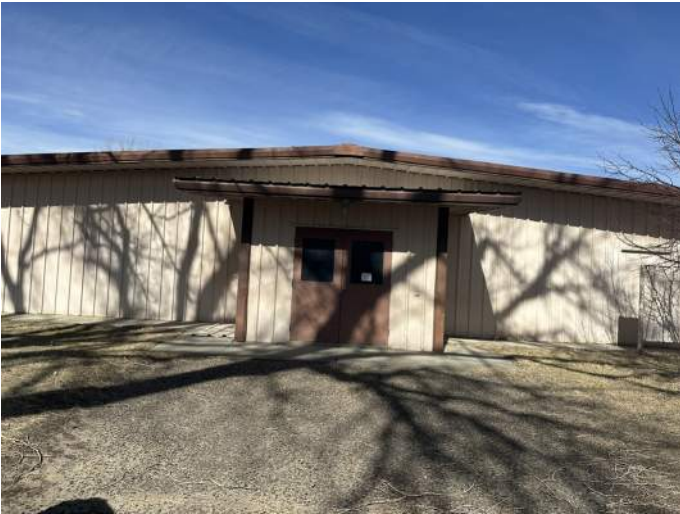
a. Image of the South Facing Elevation.

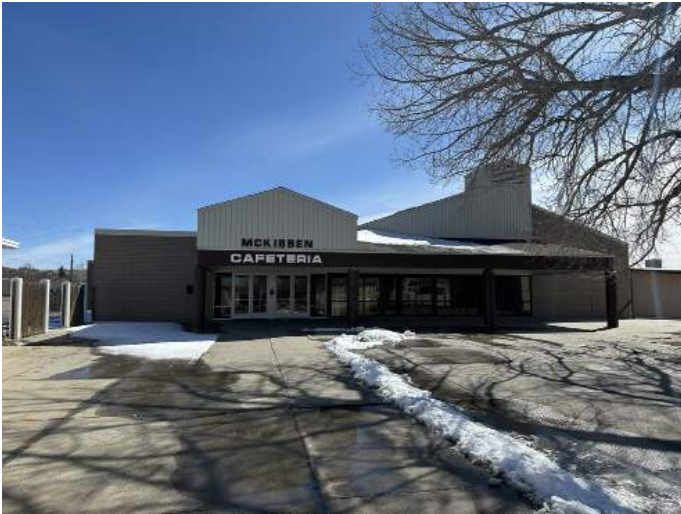
a. Image of the West Facing Elevation (Main Entrance) to the McKibben Cafeteria.

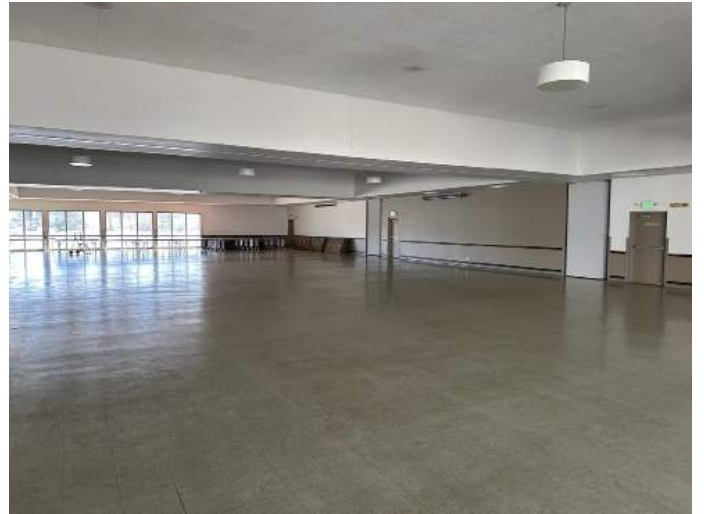
b. Image of the multi-purpose space within McKibben Cafeteria. Note the condition of the VCT tile floor.

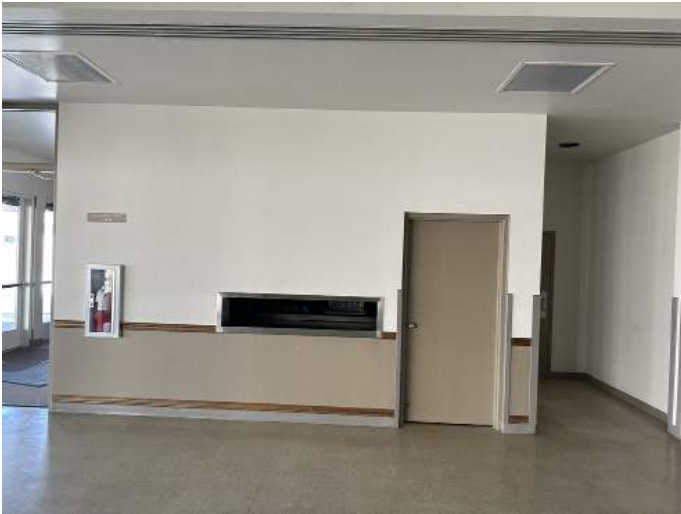
c. Image of the dish return in the multi-purpose space.

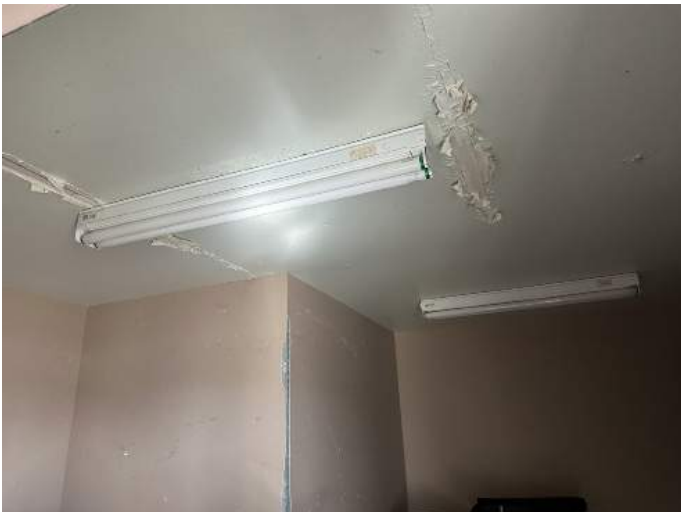
e. Image of damage to the gypsum board ceiling in the Storage Room due to a roof leak.

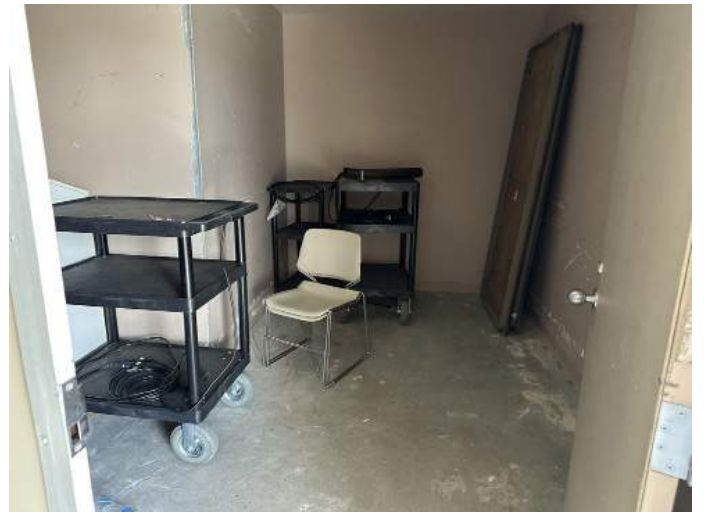
f. Image of damage to the interior walls of the Storage Room.

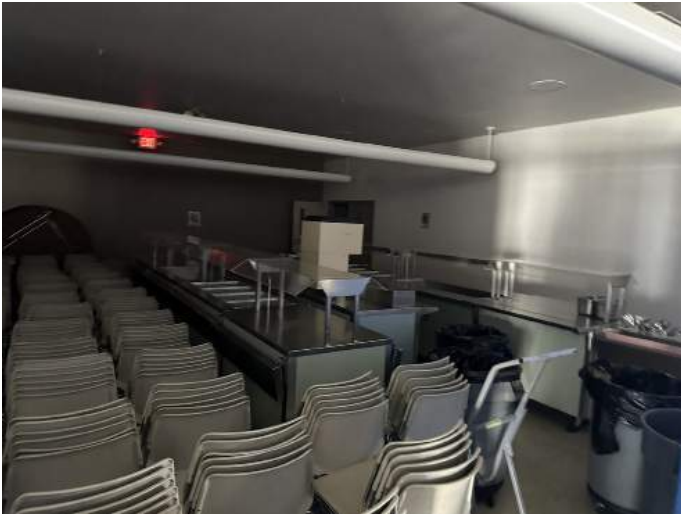
g. Image of chairs being stored in the buffet line.

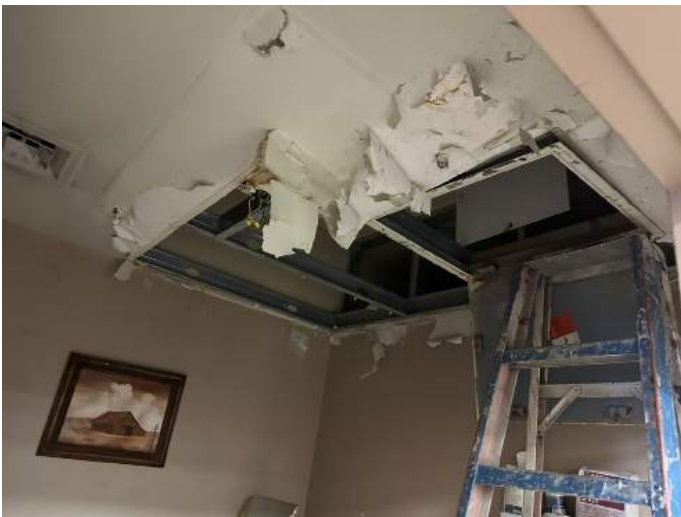
o. Image of the damage to the gypsum board ceiling in the Kitchen Office.

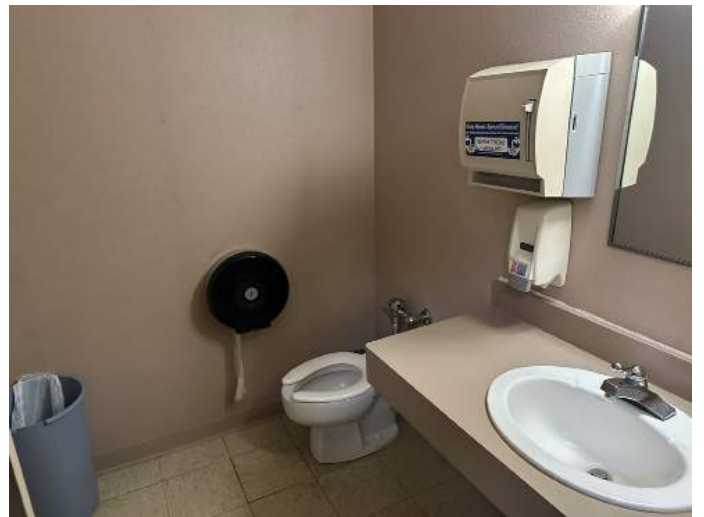
p. Image of the Staff Bathroom adjacent to the Kitchen.

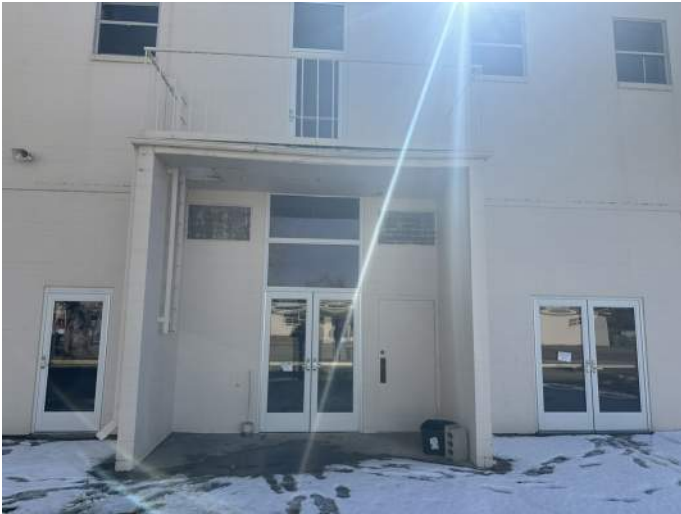
a. Image of the North Facing Elevation.

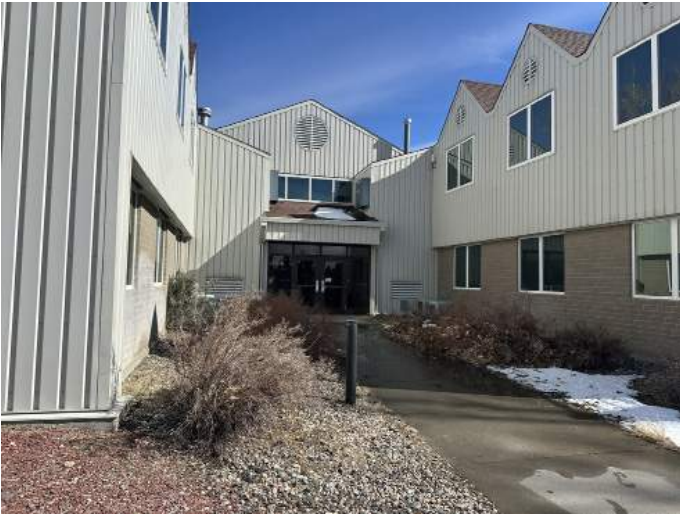
a. Image of the West Facing Elevation.

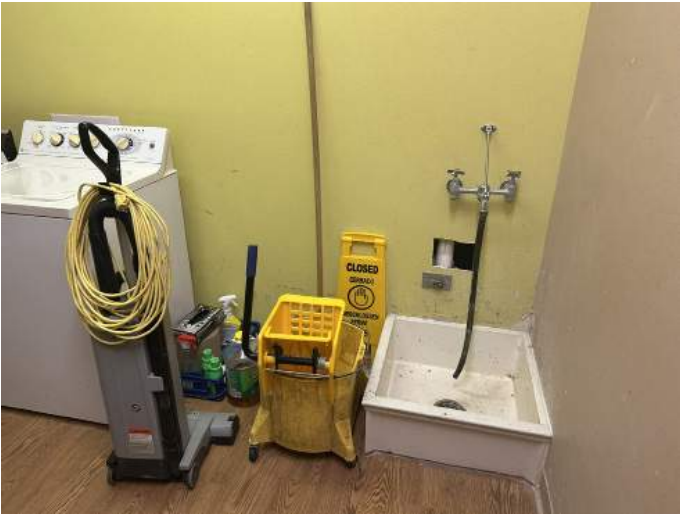
g. Image of the Laundry Room. Note the damage to the gypsum wall board above the mop sink. Also note the improper wall finish at this location.

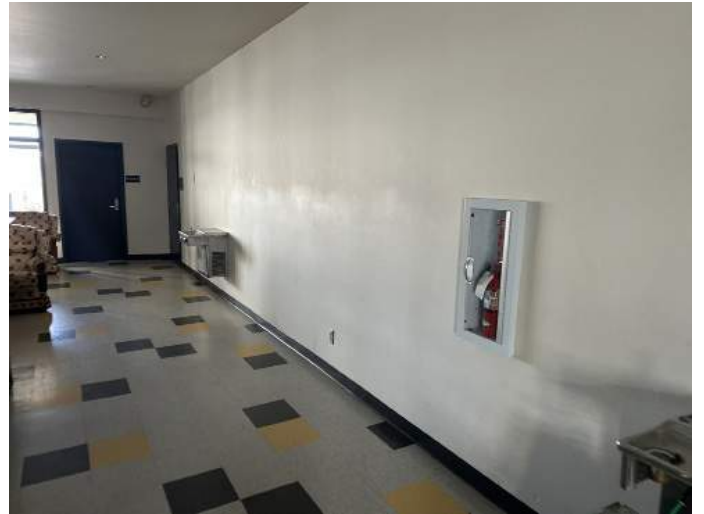
h. Image of one of the walls where the finish coat of the paint was either incorrectly applied, or the wall is due to be re-painted.
