Appendices

WYOMING STATE FAIR - MASTER PLAN

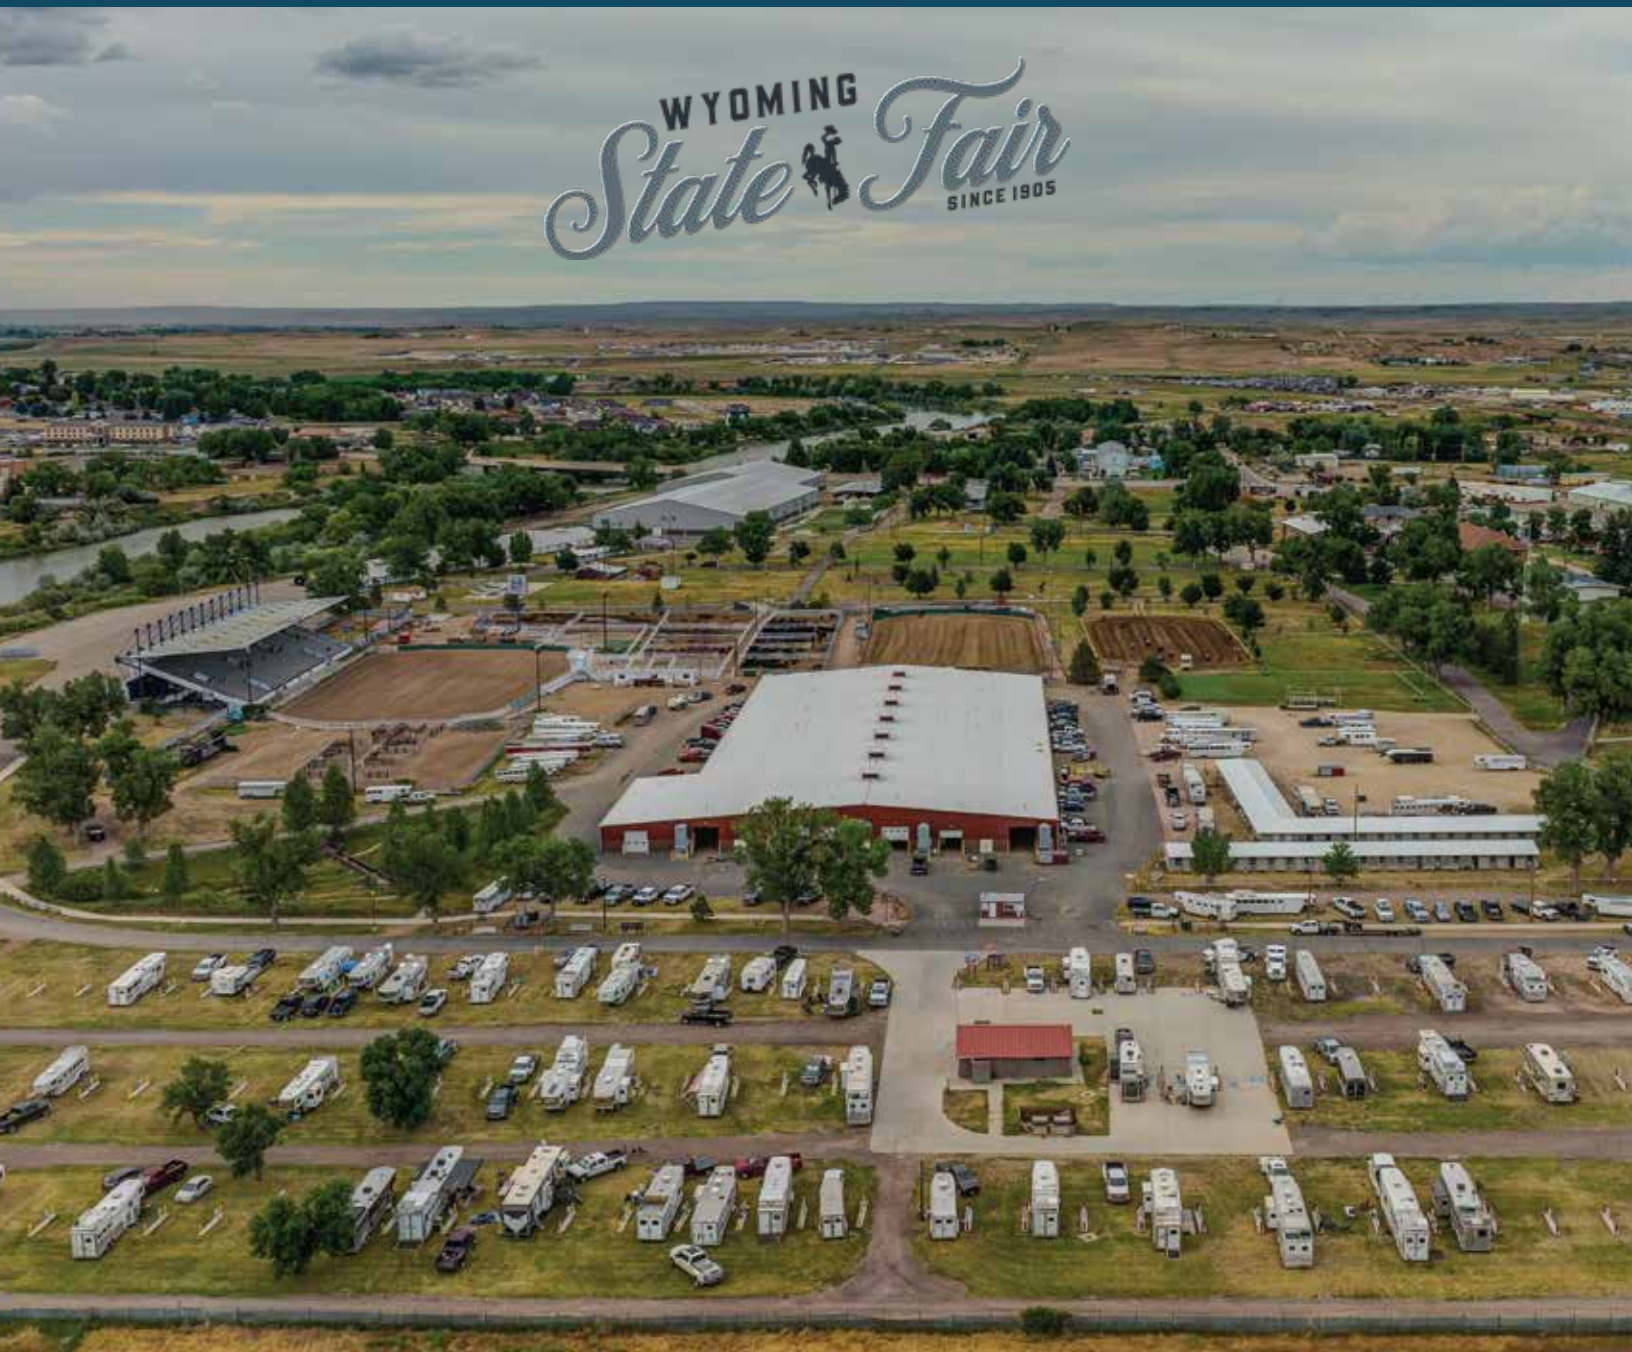
Presented to the Wyoming State Fair

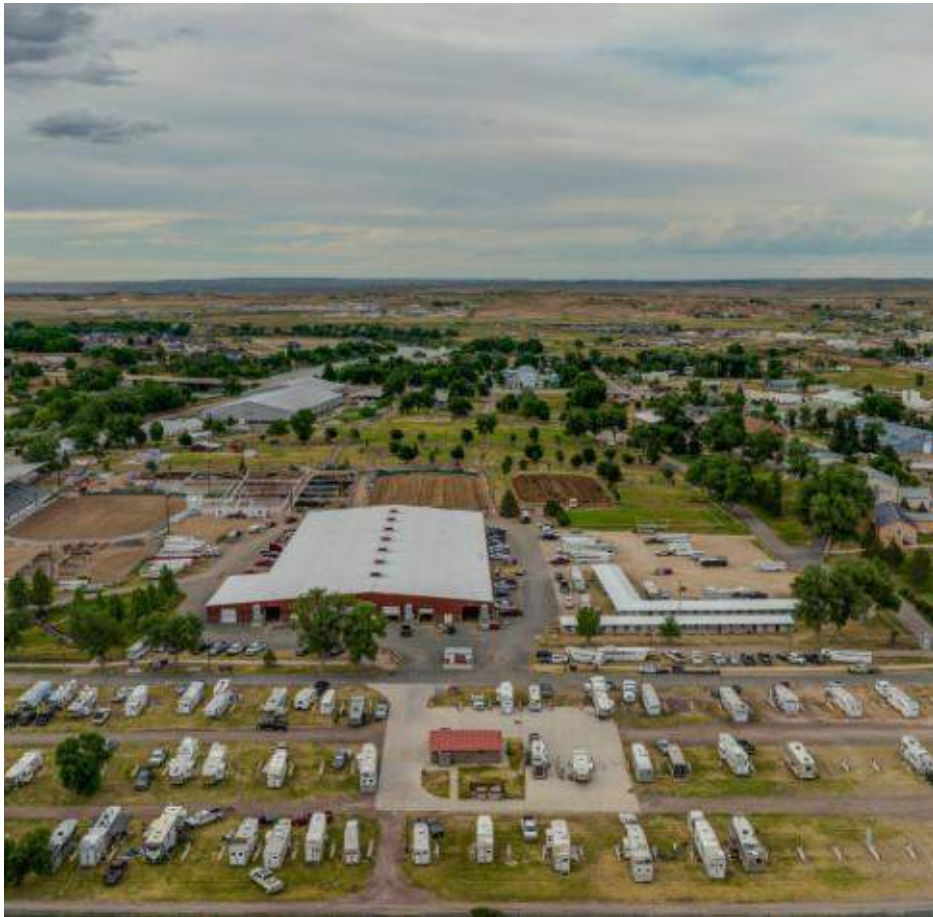
1.	Introduction	pg 259
2.	Local Market Conditions	pg 262
3.	Overview of Fairgrounds Operations	pg 274
4.	Competitive Landscape	pg 285
5.	Market Assessment	pg 293
6.	Financial Analysis	pg 301
7.	Economic Impact Analysis	pg 309

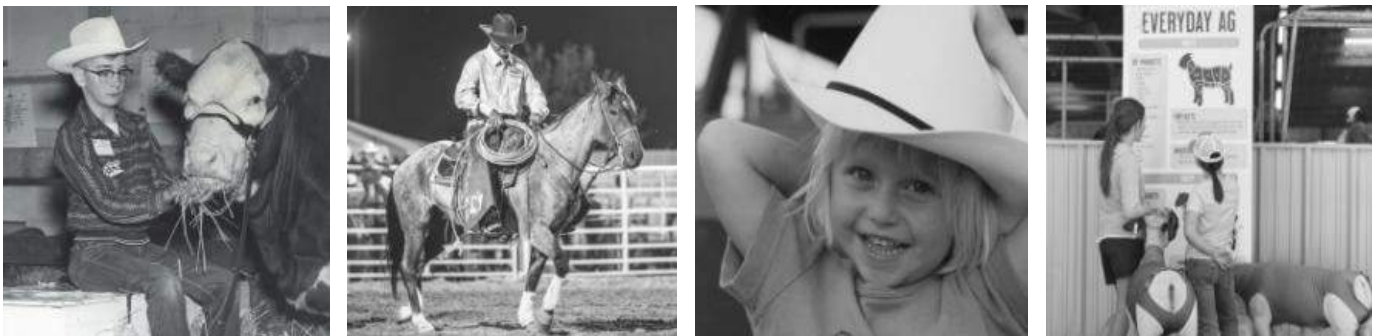
In 2025, the Wyoming State Fair engaged Plan One/Architects, Crossroads Consulting Services LLC (“Crossroads” or “Crossroads Consulting”) , K/O Fairground Planners, KL&A Engineers & Builders, and STUDIOPLAATS to develop a Master Plan that expands upon the previous planning effort and optimally positions the Fairgrounds to meet the needs of the Fair, community and visitors into the future. Crossroads was tasked with conducting a high-level market assessment and preparing estimates of financial and economic impacts associated with the proposed Master Plan. While acknowledging that a Master Plan was completed relatively recently, Crossroads approached this effort as an opportunity to build upon that foundation while doing so without preconceived notions, ensuring an objective and data-driven process.

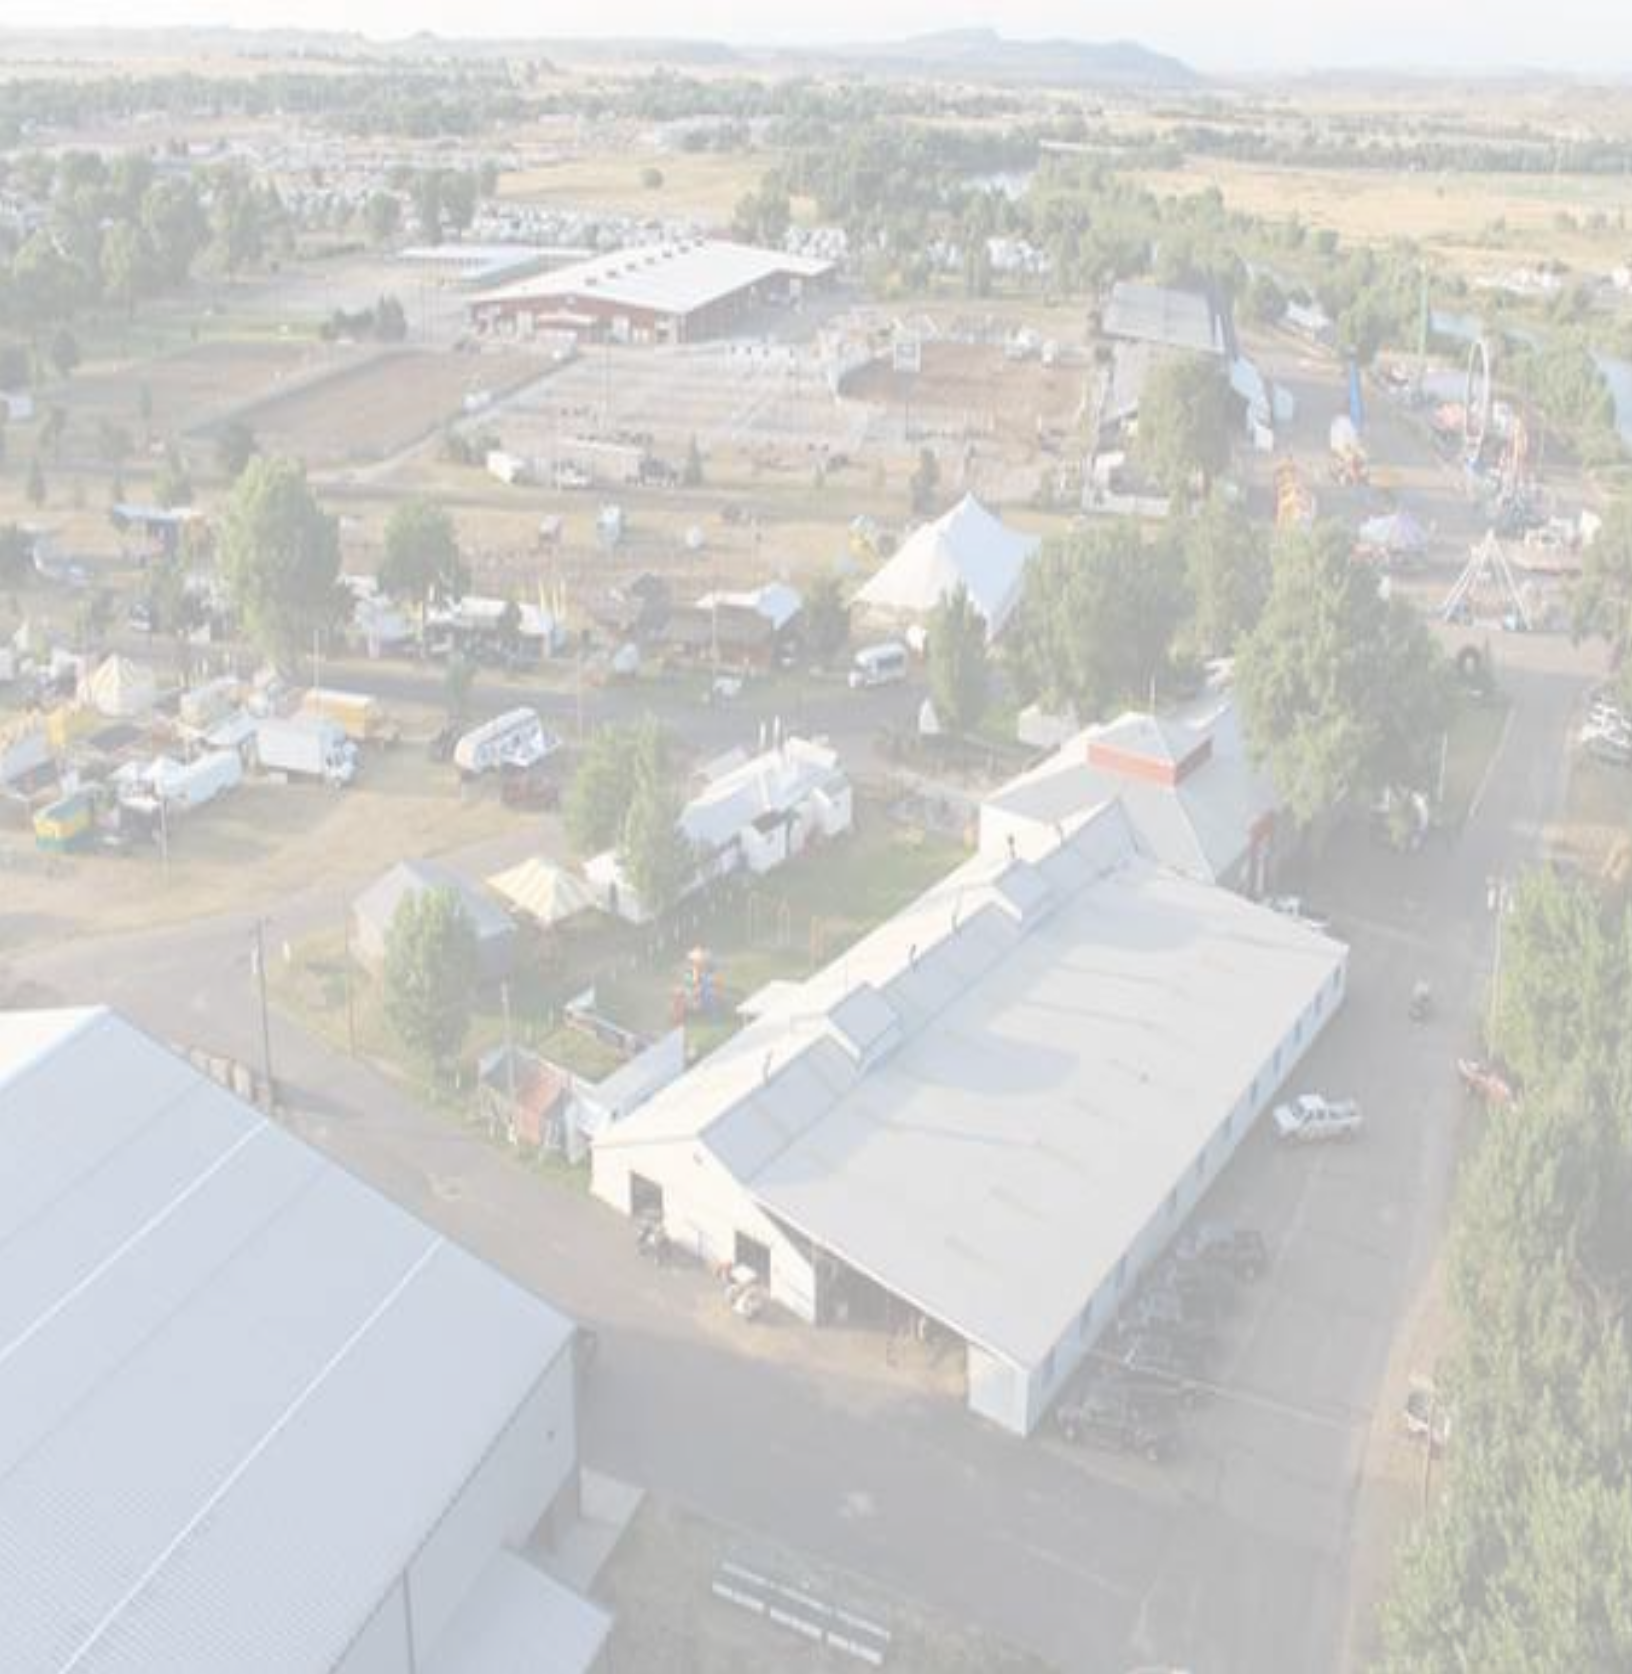
LOCAL MARKET CONDITIONS

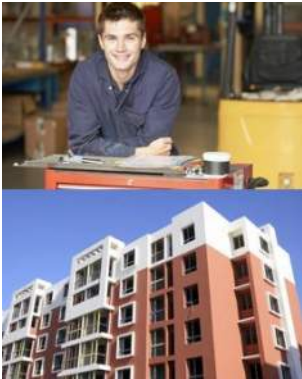
Old and Newcomers (15.8% of 2024 Households): This market features singles' lifestyles, on a budget. The focus is more on convenience than consumerism, economy over acquisition. Old and Newcomers is composed of neighborhoods in transition, populated by renters who are just beginning their careers or retiring. Some are still in college; some are taking adult education classes. They support charity causes and are environmentally conscious. Age is not always obvious from their choices.

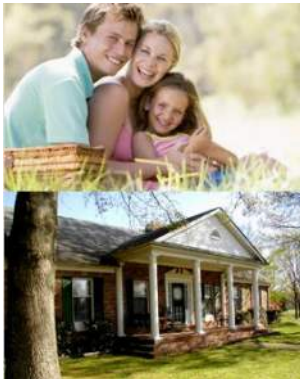
Middleburg (12.3% of 2024 Households): Middleburg neighborhoods transformed from the easy pace of country living to semirural subdivisions in the last decade, as the housing boom spread beyond large metropolitan cities. Residents are traditional, family-oriented consumers. Still more country than rock and roll, they are thrifty but willing to carry some debt and are already investing in their futures. They rely on their smartphones and mobile devices to stay in touch and pride themselves on their expertise. They prefer to buy American and travel in the US. This market is younger but growing in size and assets.

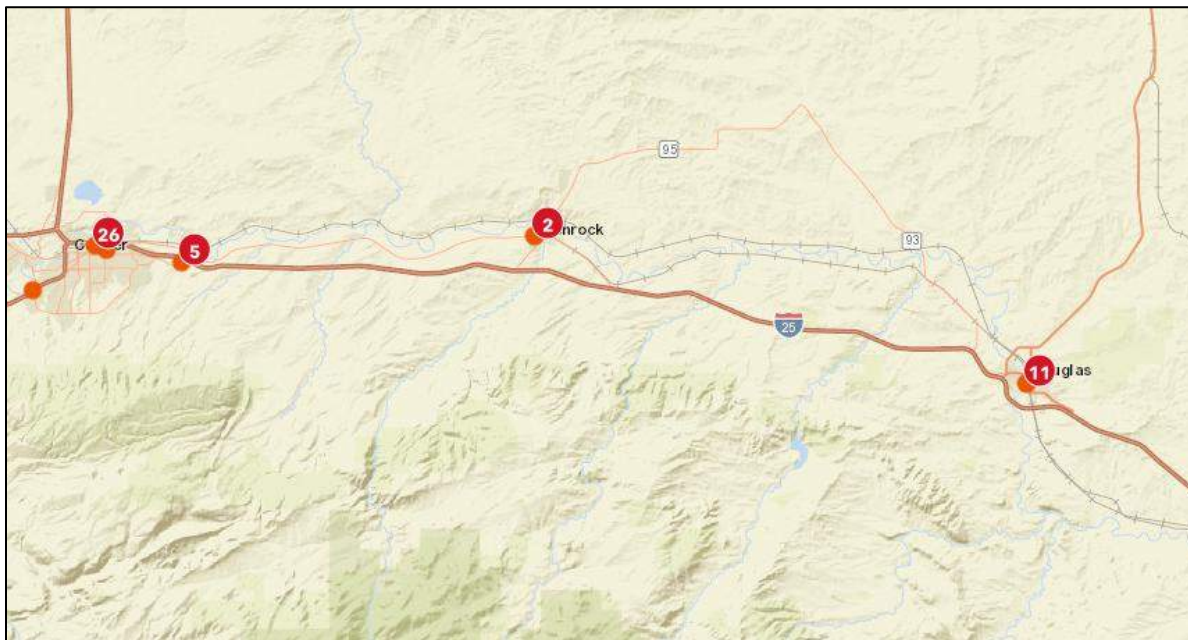
Notes: The number in the circle reflects the number of hotels in that area.
 Total number shown in Douglas differs from that shown in the table due to the inclusion of multiple properties with minimal rooms.
 Source: Esri.

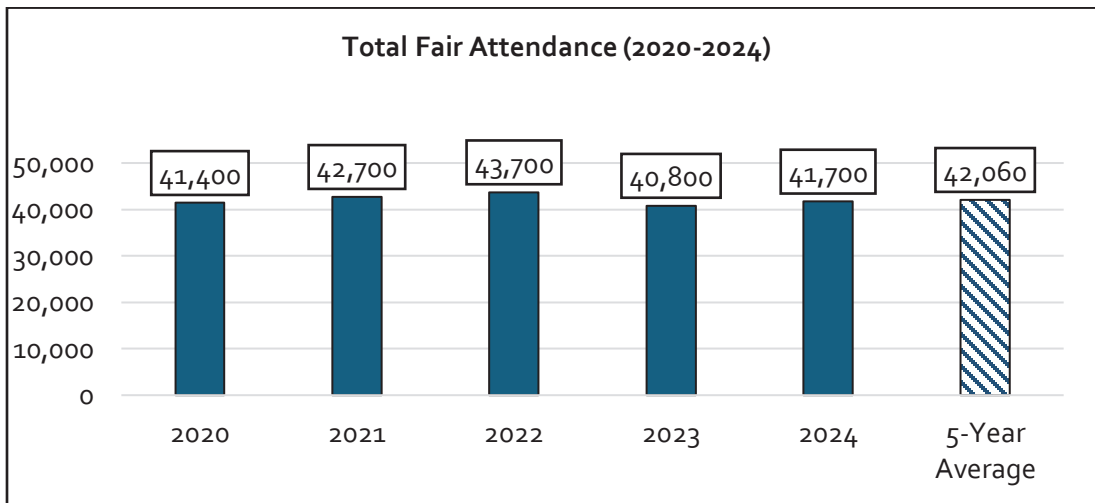
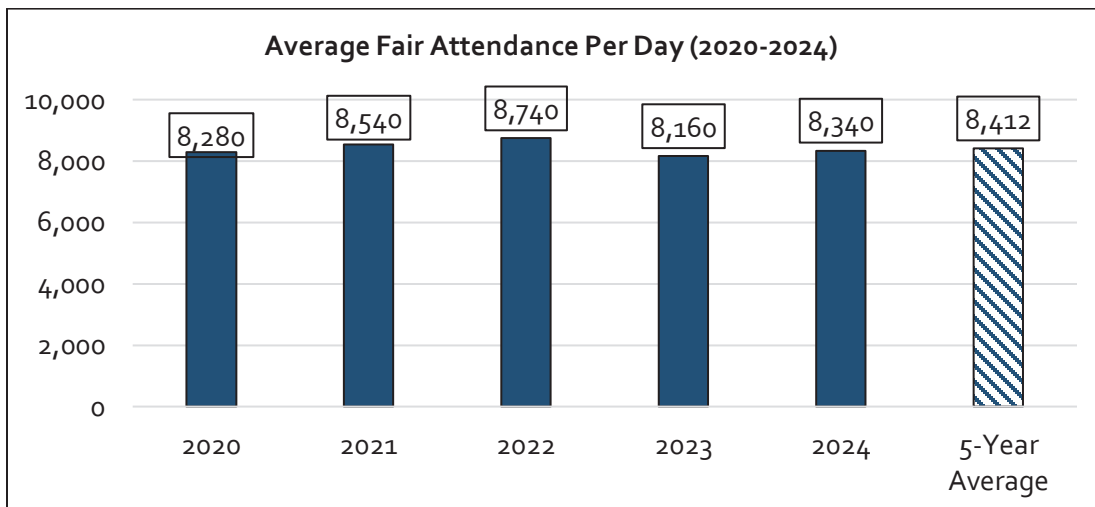
Source: Facility management; Placer.ai.

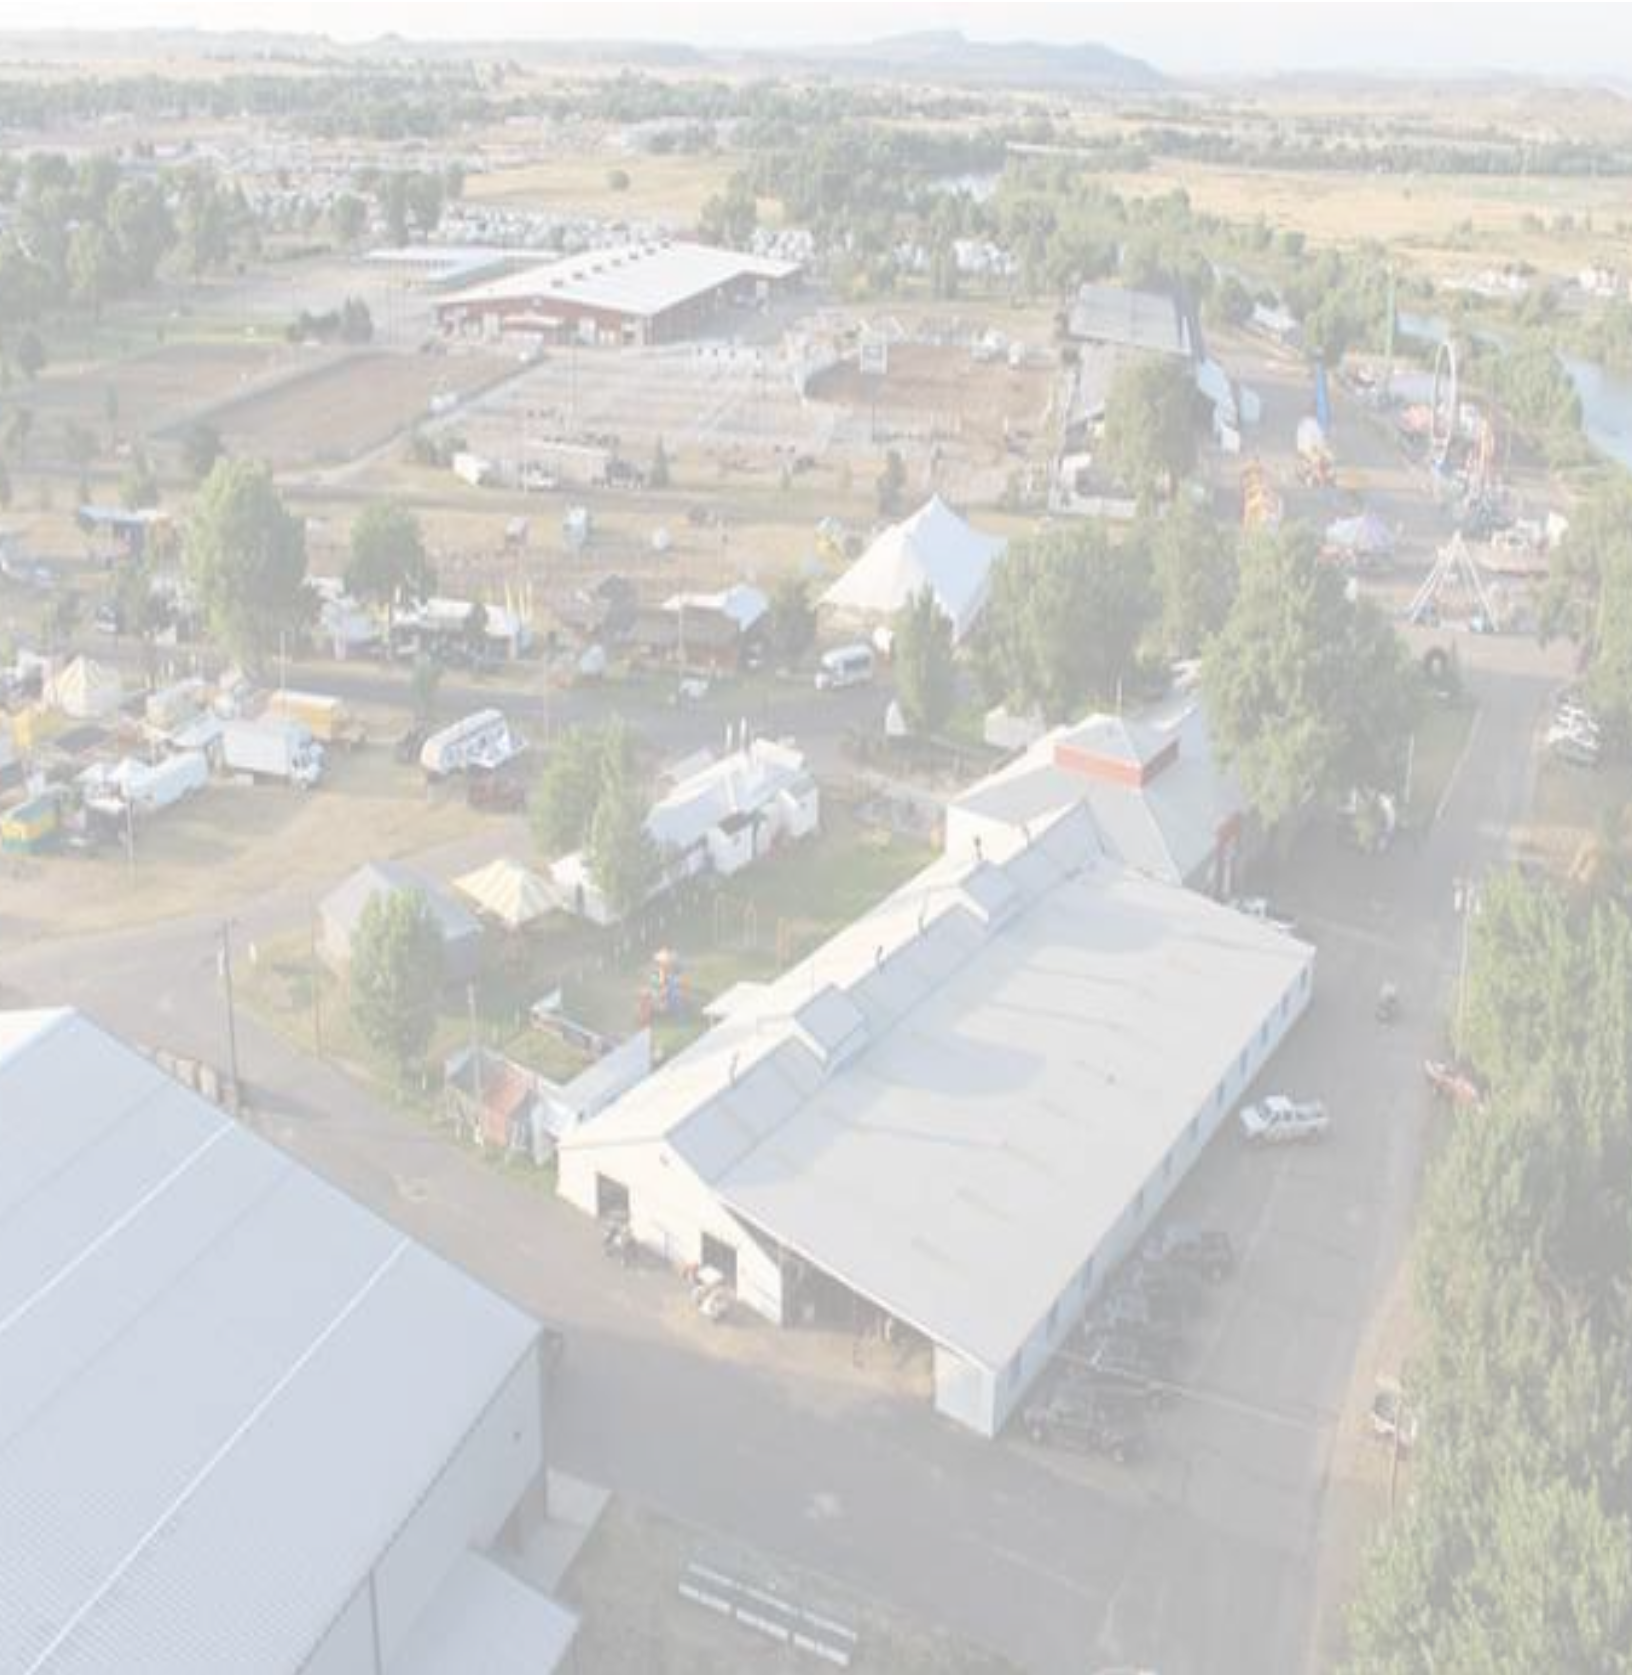
COMPETITIVE LANDSCAPE

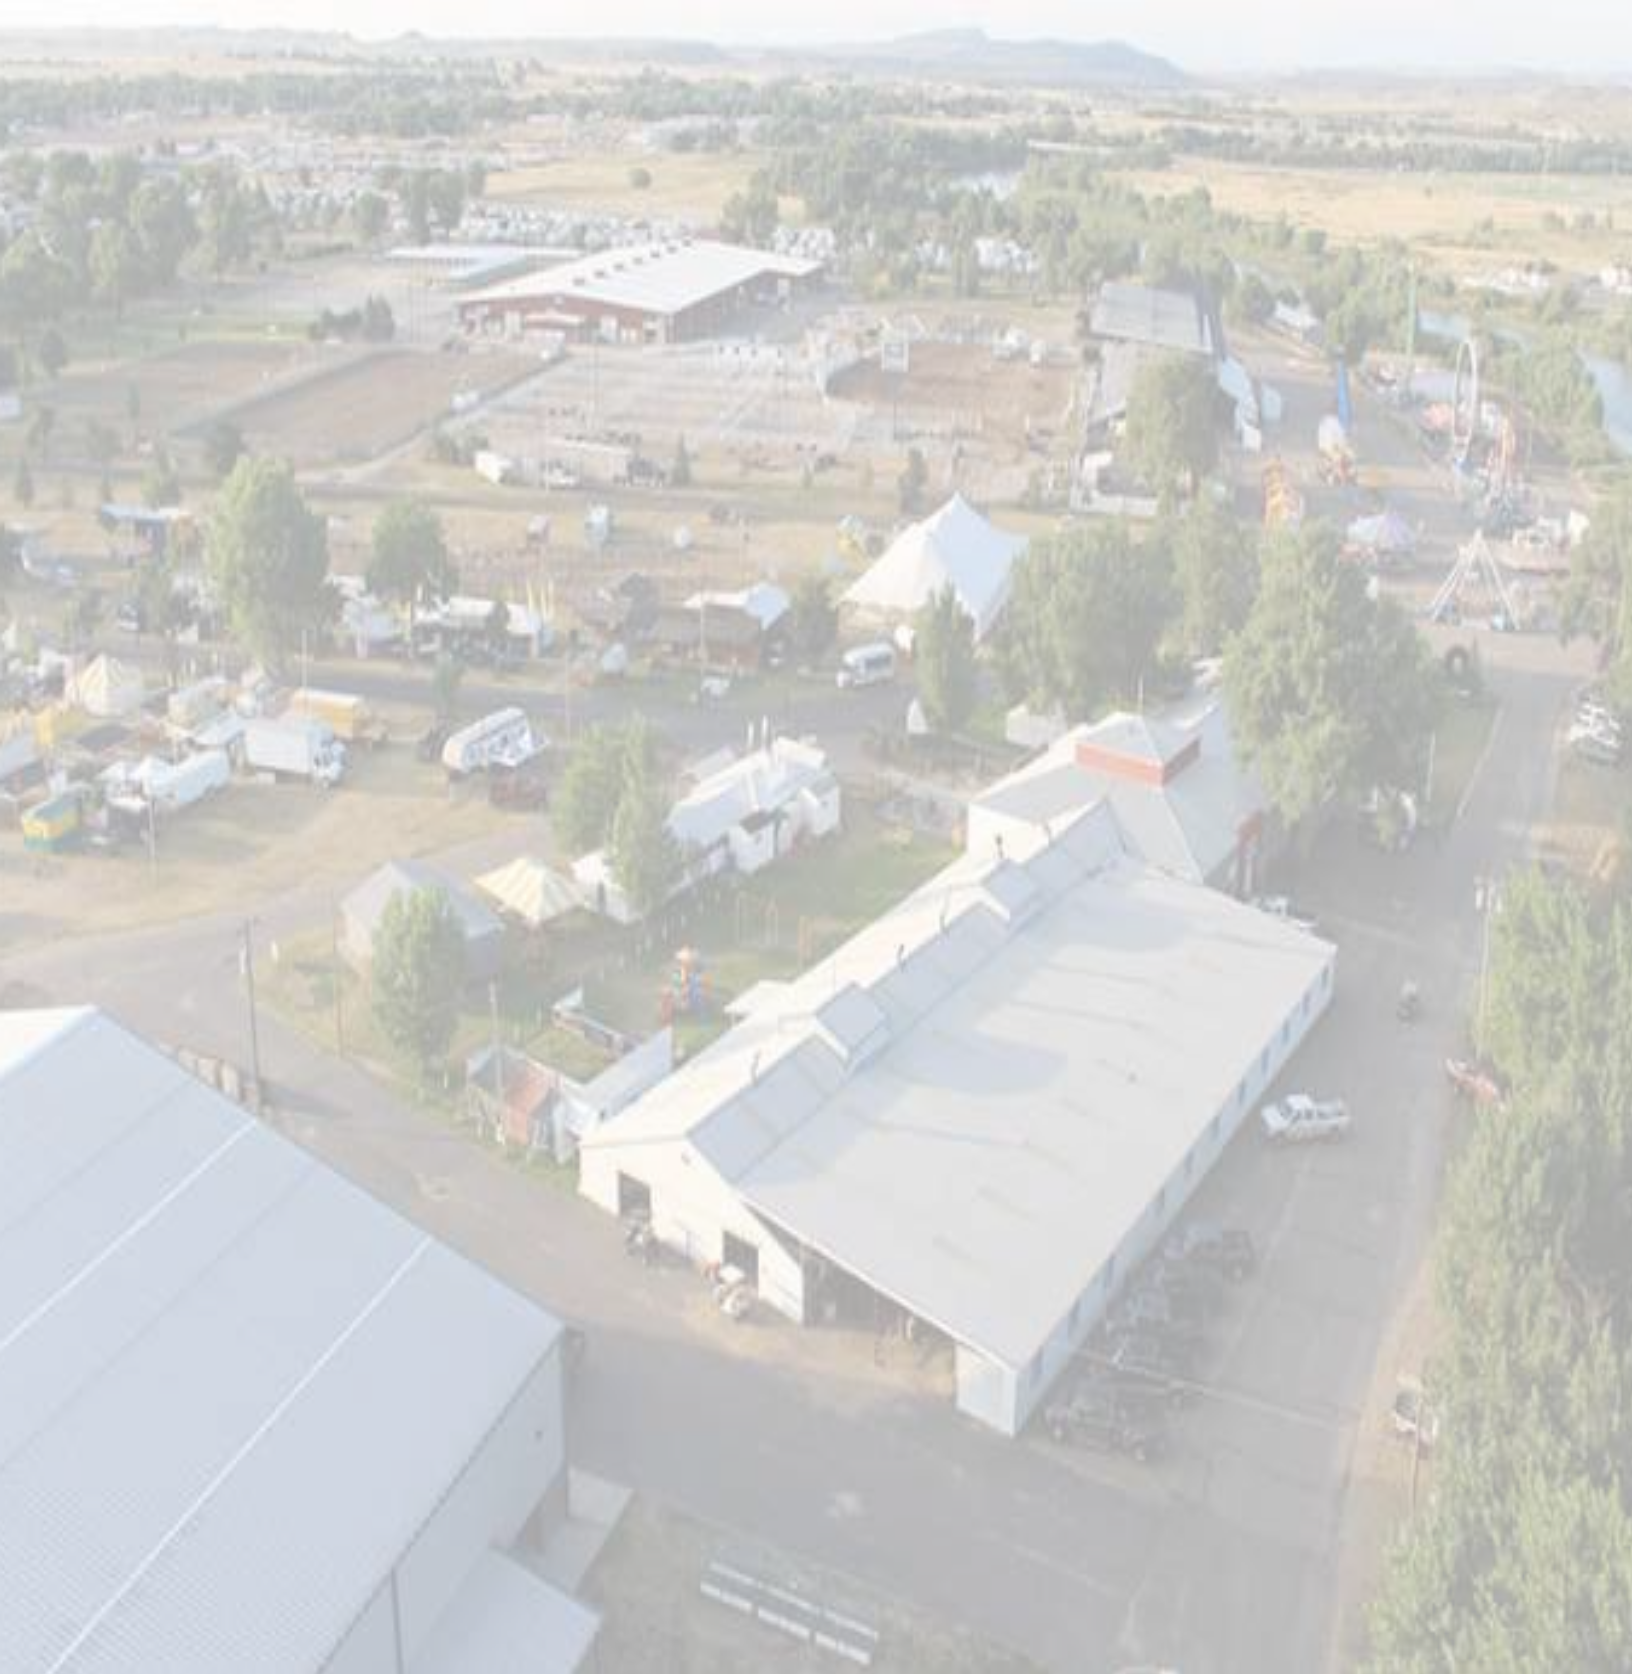
5. MARKET ASSESSMENT

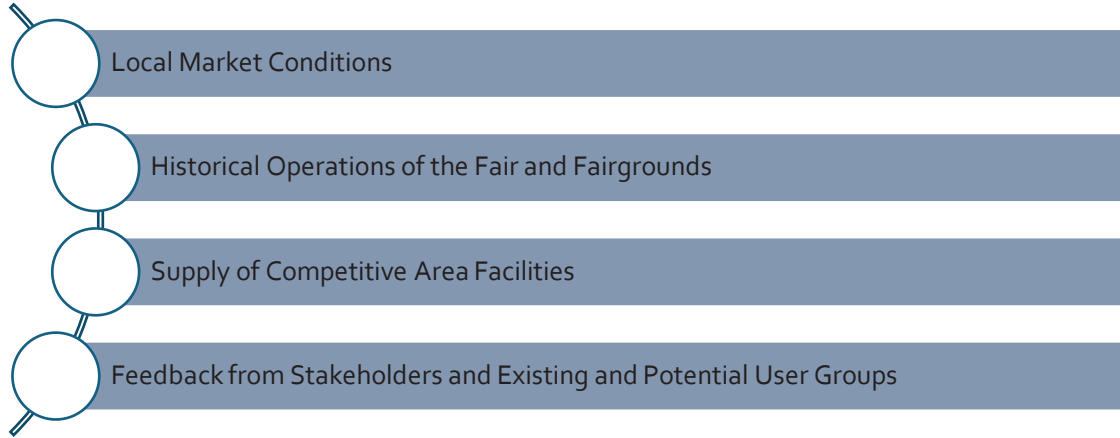
The remainder of this section summarizes key findings based on the market research conducted and identifies market supportable programming opportunities and related building program recommendations to enhance year-round utilization and the Fair.

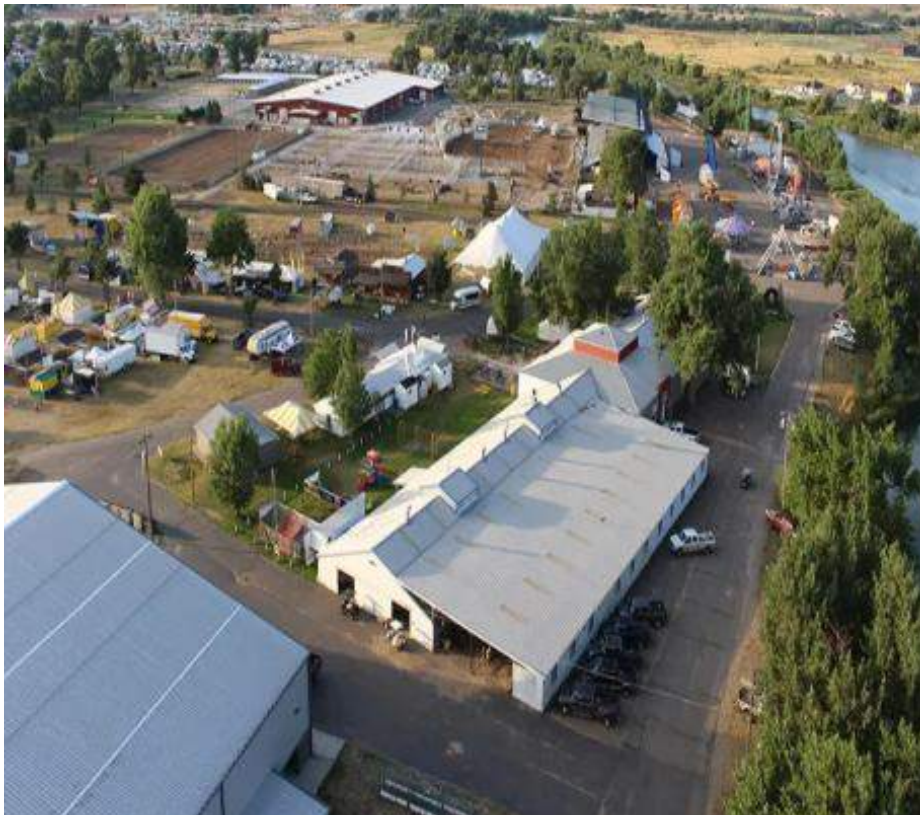
Based on the research conducted for this study, the following summarizes relative strengths and opportunities as well as challenges and threats associated with the Fairgrounds' market environment and current physical program.

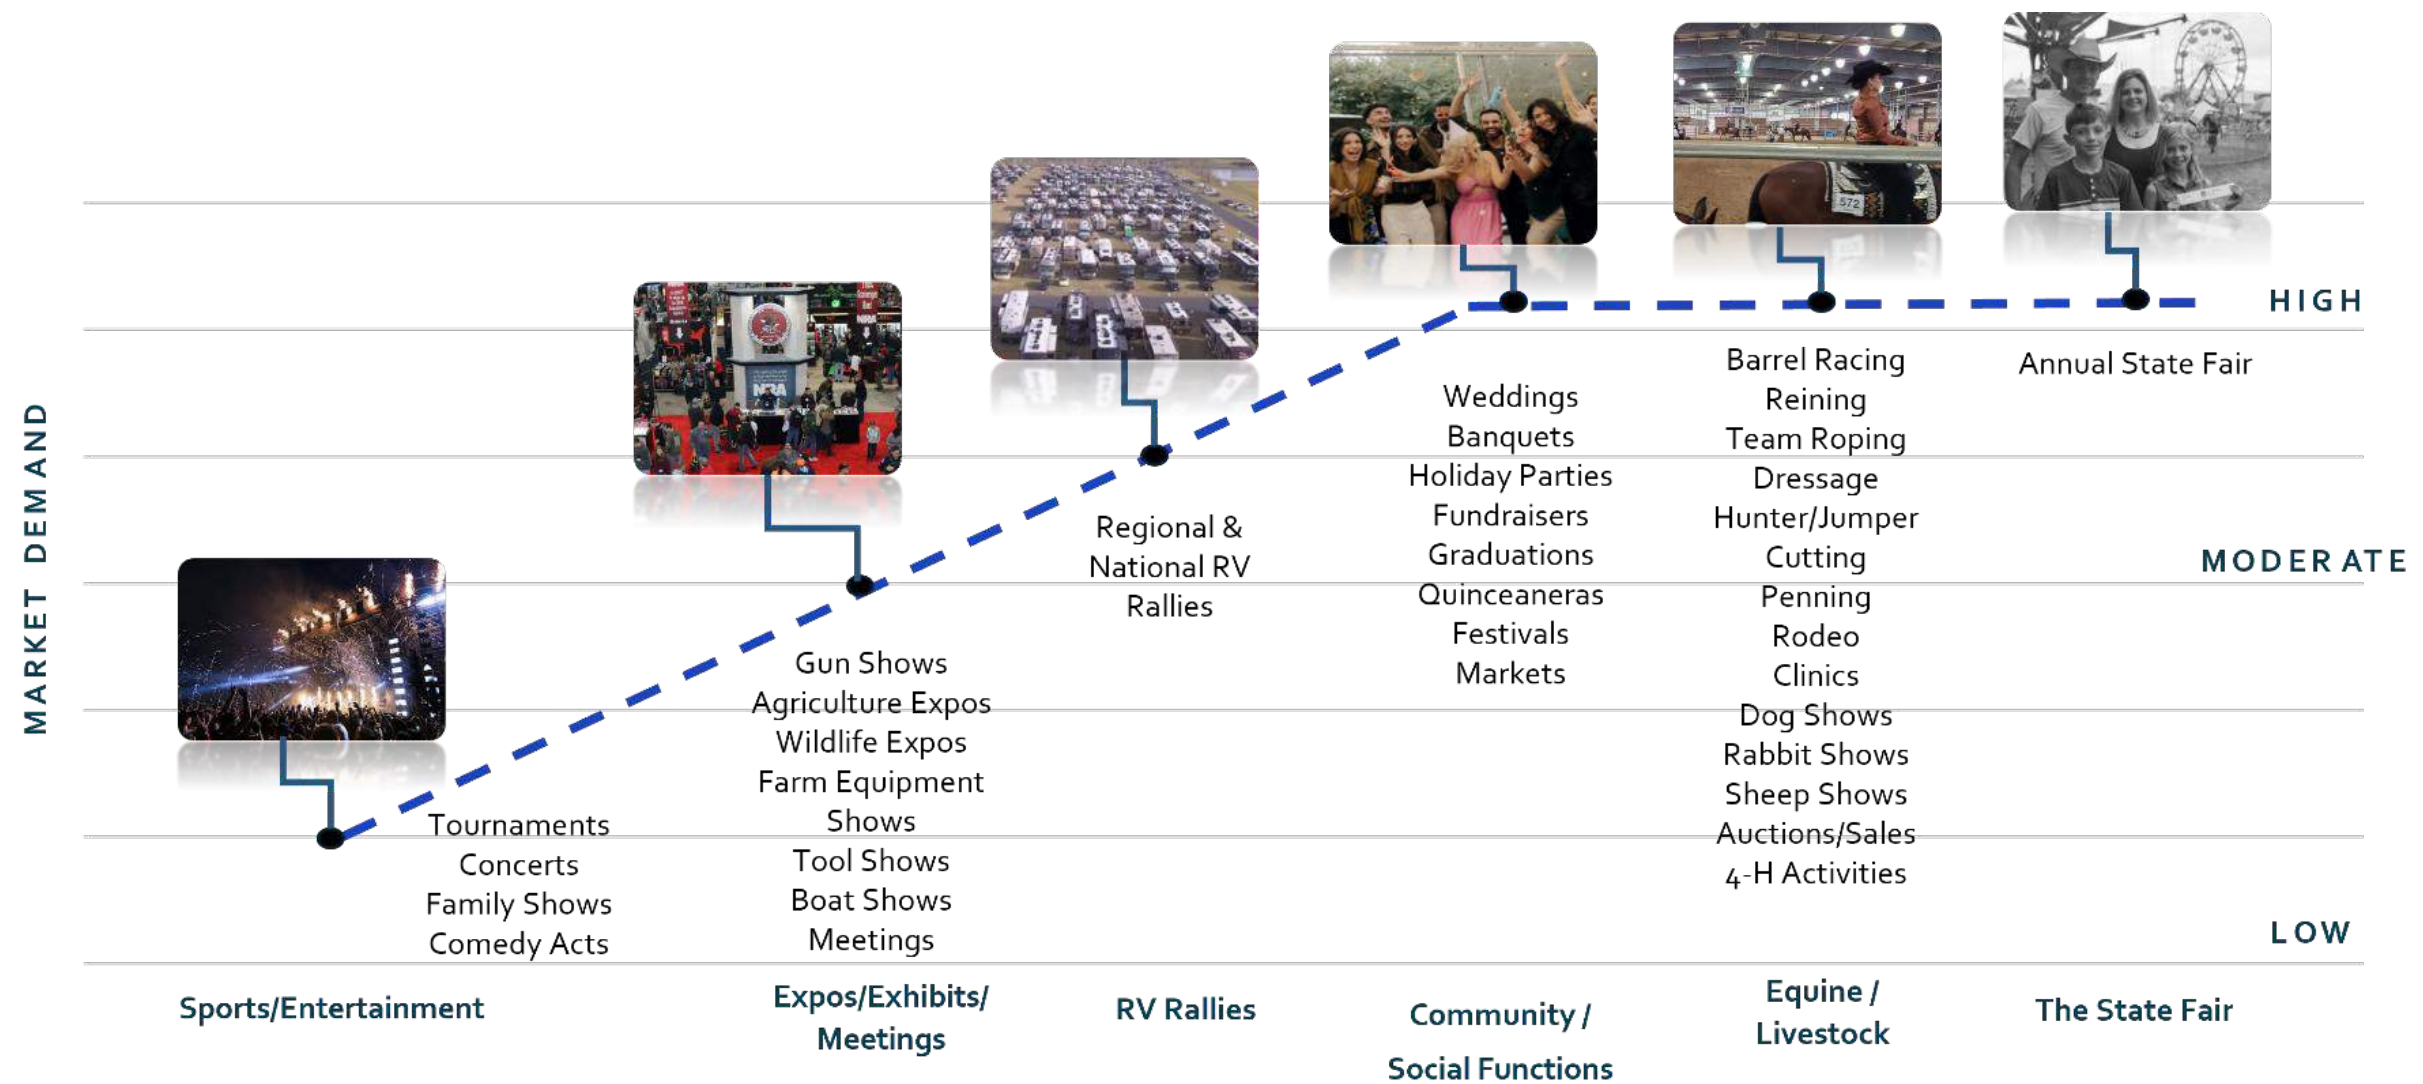
Recommended Building Program Improvements

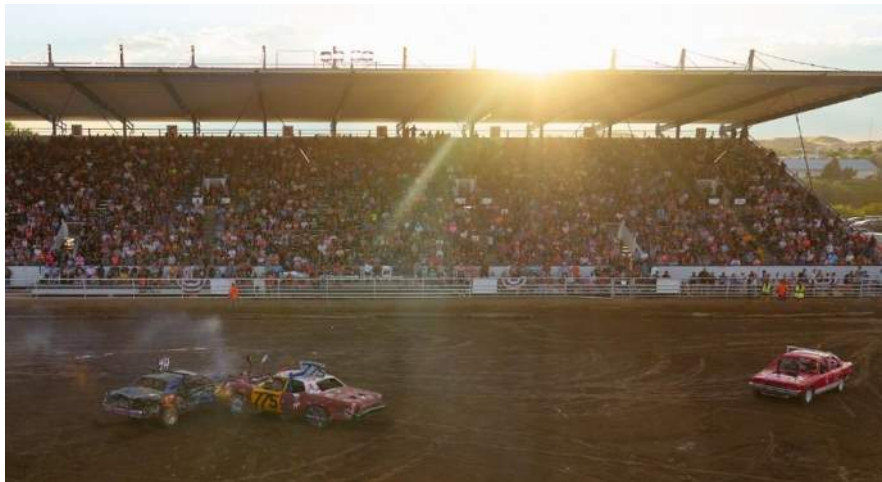
Financial Analysis - Assumptions

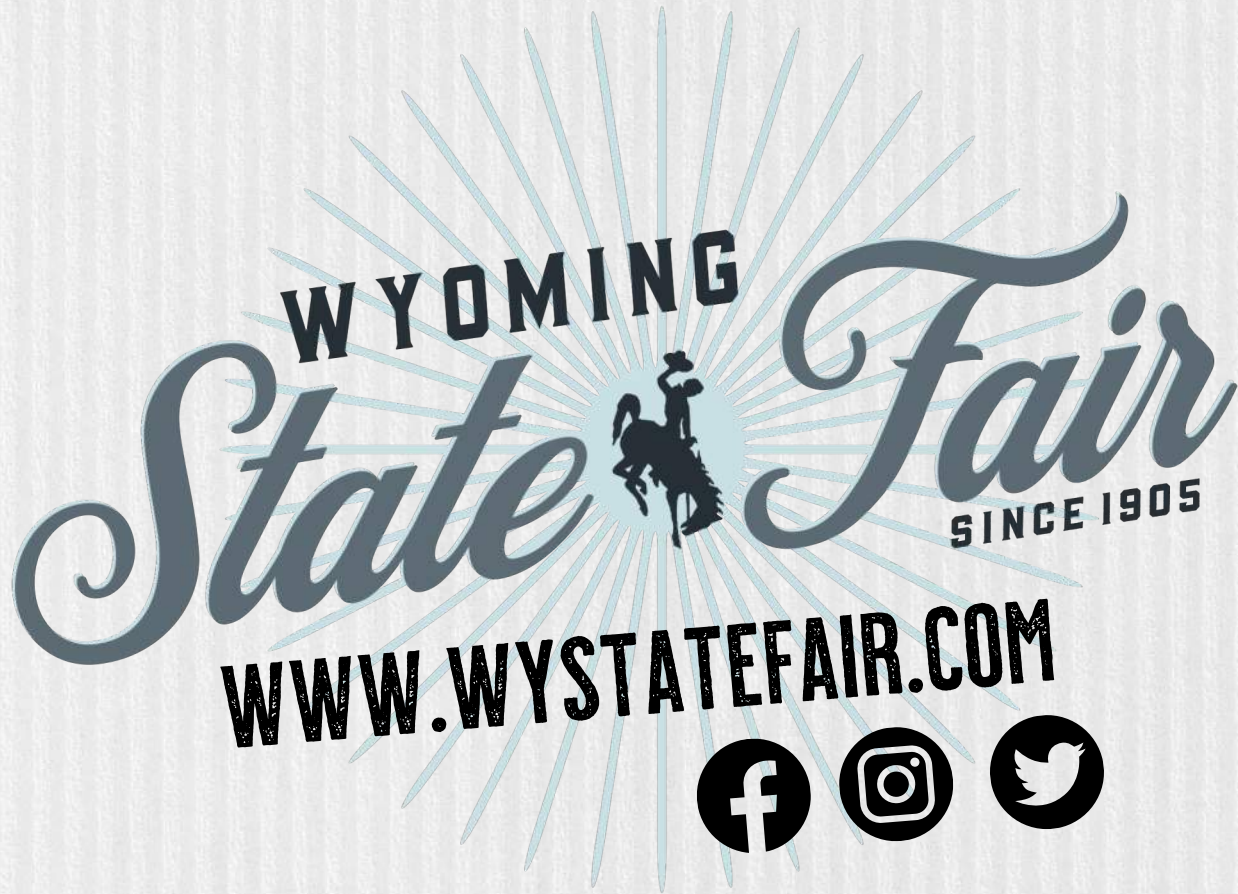
*N/A: Not enough data yet in Abramson et al. (2005). Note that data from Akalin (1978) for these categories may be outdated and not statistically relevant. Use these data with caution until enough updated data are accumulated in Abramson et al.
