# WYOMING STATE FAIR - MASTER PLAN

Plan One/Architects | K/O Fairground Planners | Crossroads Consulting  
STUDIOPLAATS | KL&A

## 1.6 FACILITY CONDITIONS ASSESSMENT

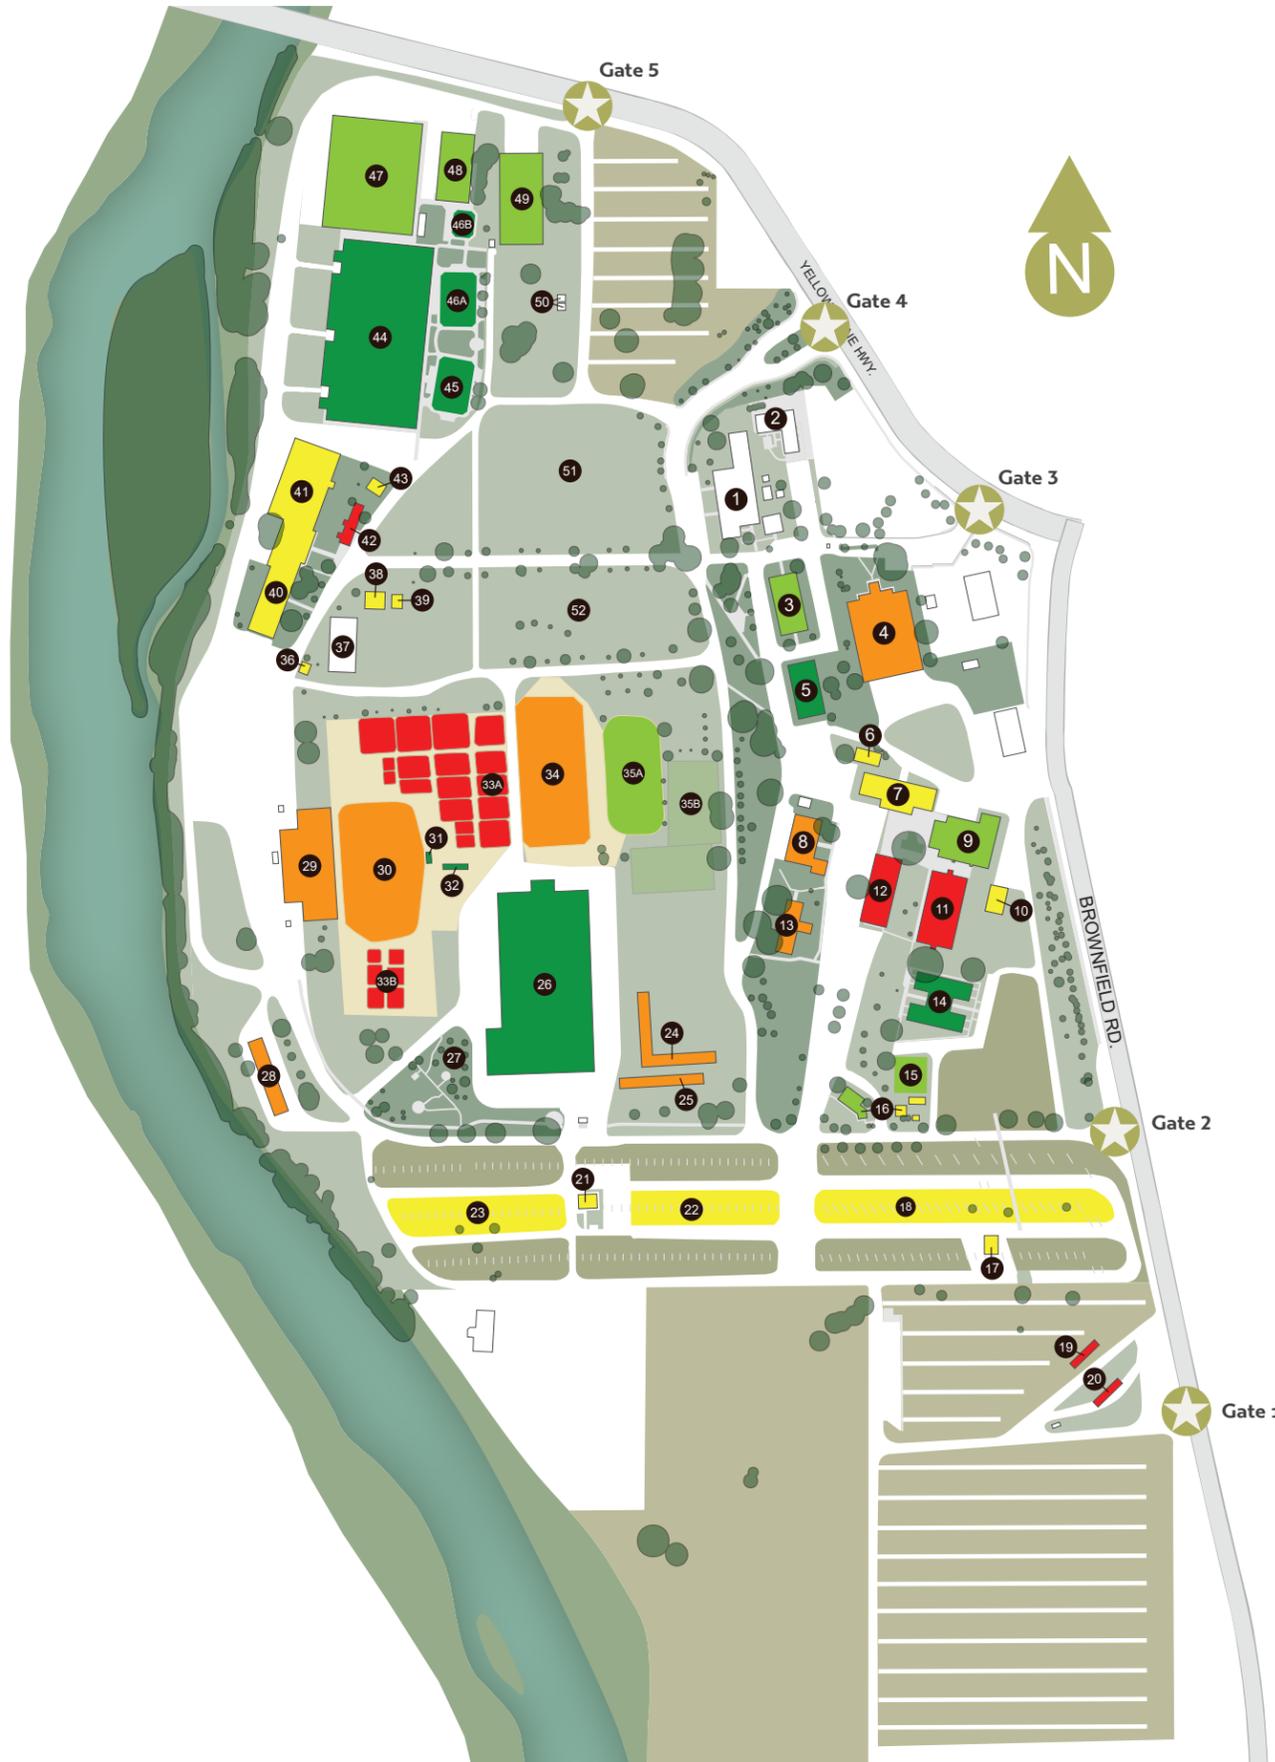
### 3.1 EXISTING BUILDINGS & SPACES

The map to the left shows a conditions assessment of the 52 buildings, structures, and points of interest.

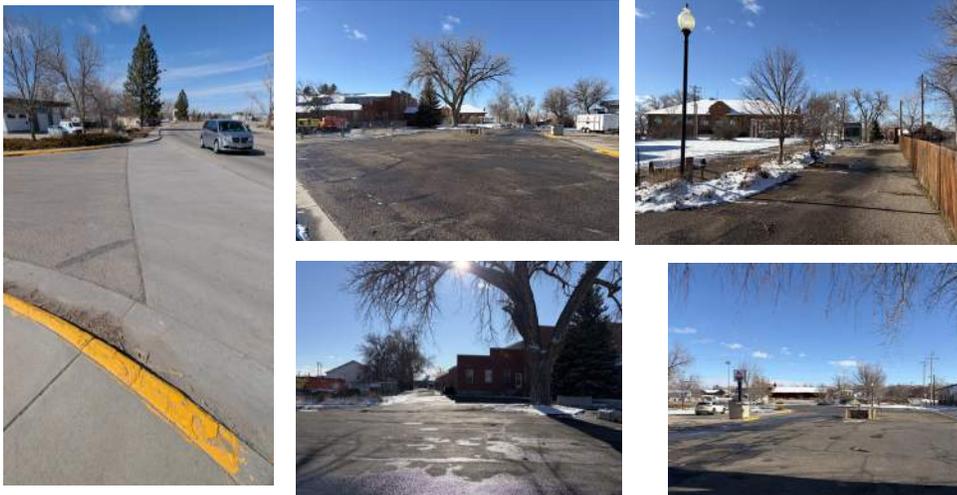
## IE - Conditions At Gate 3

- Conditions at Gate 3: At Gate 3, existing conditions include an asphalt roadway with turf along the south side, a ticket booth, and a jersey barrier. Ground-level plantings are incorporated into a landscaped island within the roadway, guiding fair patrons toward the ticket booth.
- Recommendation: Gate 3 Improvements: Remodel Gate 3 to improve visibility from the highway and strengthen its identity through clear, coordinated signage and wayfinding. Given limited parking and constrained access, Gate 3 should function as a pedestrian-oriented or secondary entry, with signage directing public parking to other gates better suited to accommodate vehicles.

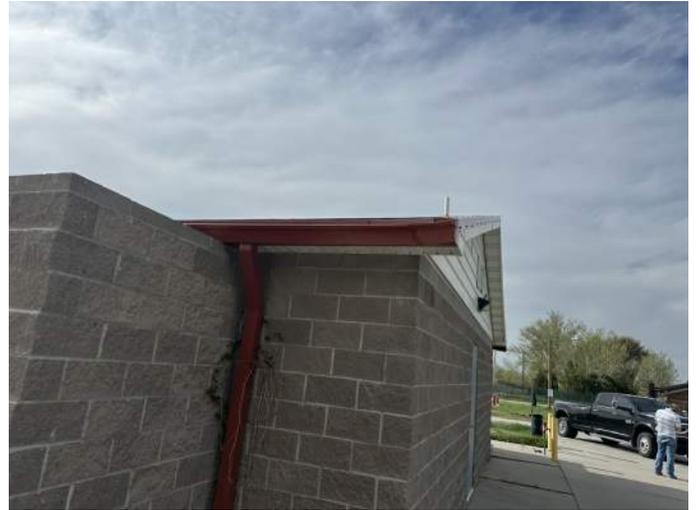
b. Image of damaged rain gutter.

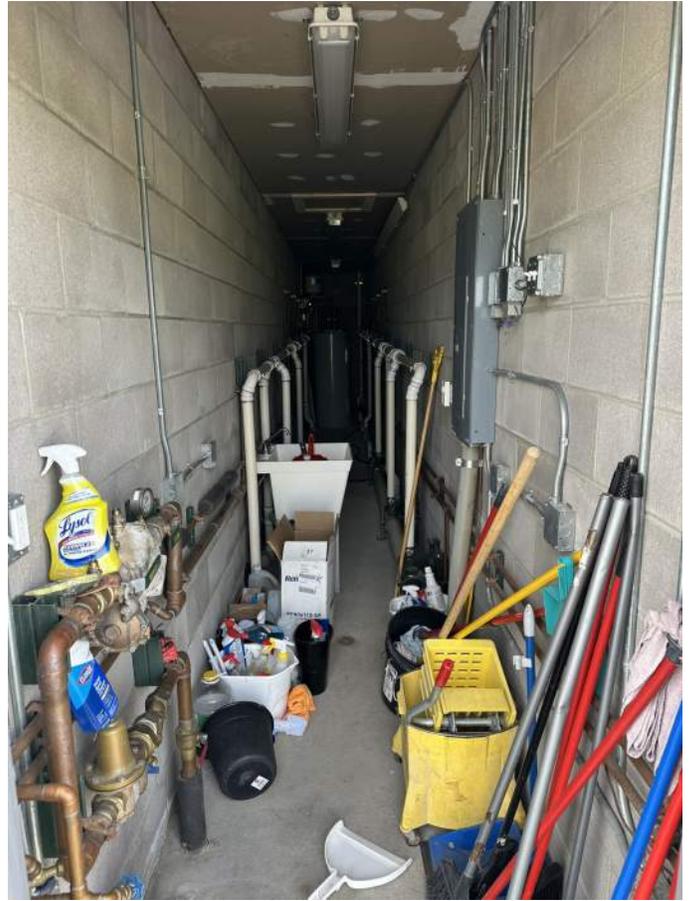
h. Image of plumbing chase and electrical panel.

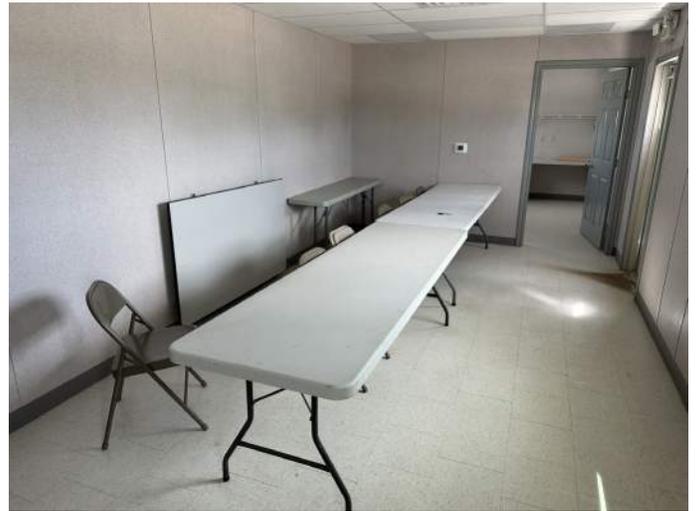
d. Image of the main meeting space at the Rodeo Office. Note the dirt that appears to have blown in under the door. Inspect the seals and sweep where the bottom of the door and sill meet and replace if needed.

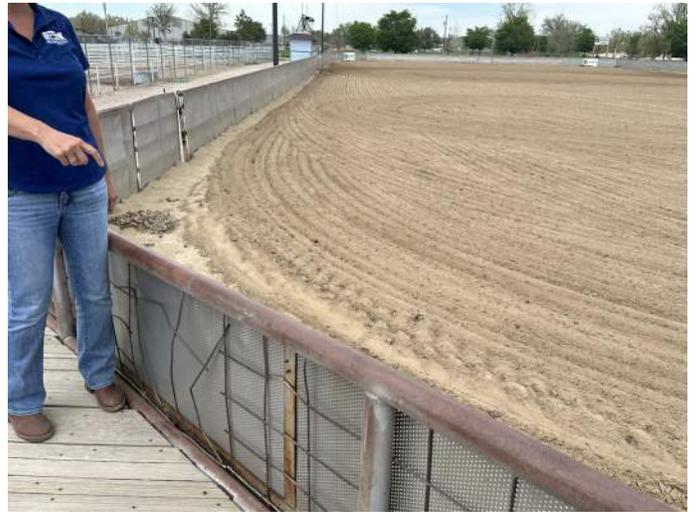
d. Image of damaged welded wire fence panel. This panel poses a tripping and snagging hazard.

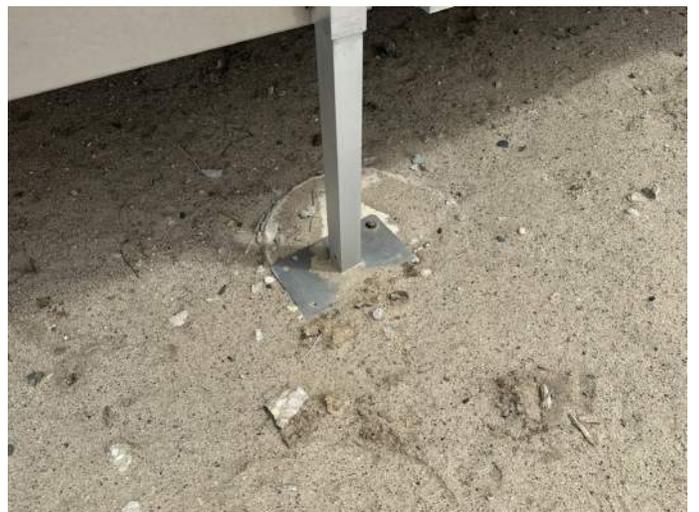
f. Image of concrete foundation with off centered base plate for the aluminum ramp system. Note, the base plate is only attached with a single fastener.

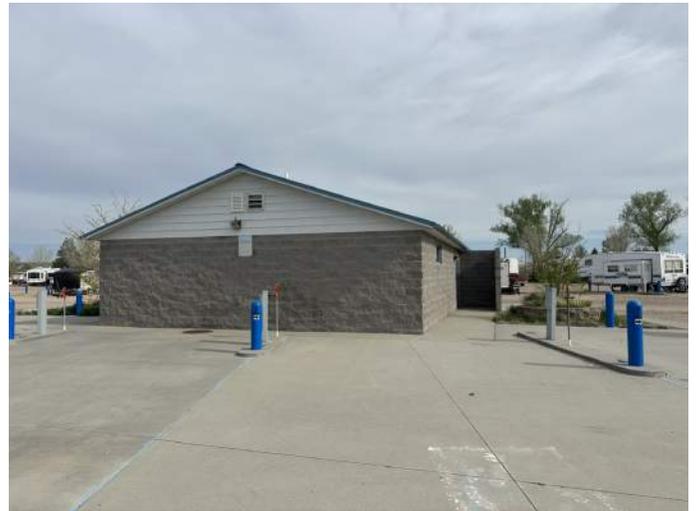
d. Image the exterior of the North Elevation. Note the split face CMU block face is spalling just behind the yard hydrant.

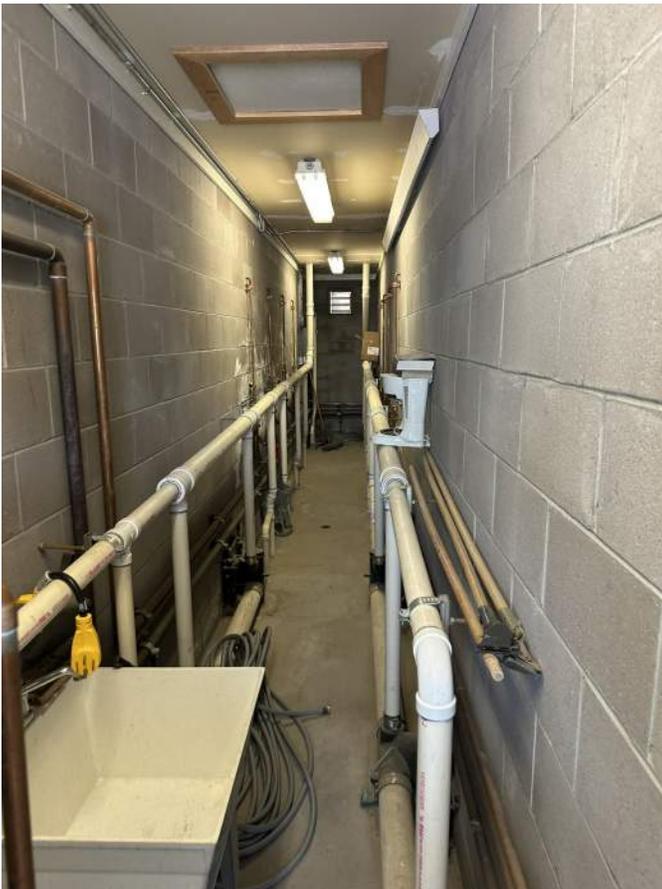
i. Image of the plumbing chase between the Men and Women's restroom.

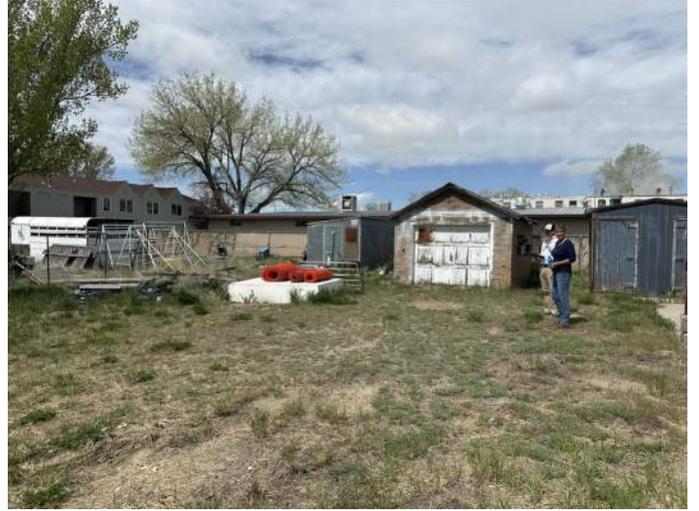
b. Image alternate entry to the Multi-purpose Room. Note the residential patio and front door, improper hand and guard rail, and spalling concrete landing and steps. (North Facing Elevation of the Building.)

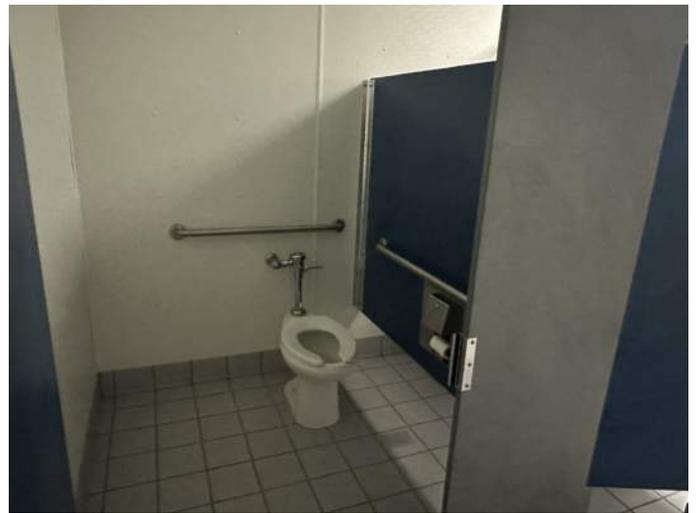
n. Image of the Wheel Chair Accessible Toilet Compartment in the Men's Restroom. Note the flush control faces the wrong direction.

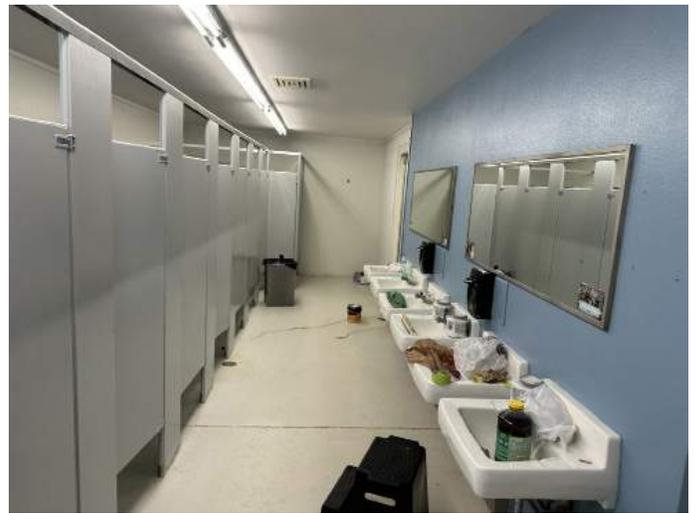
d. Image of the interior of the interior of the Women's Restroom. Note the height of the mirrors, and missing toilet accessories.

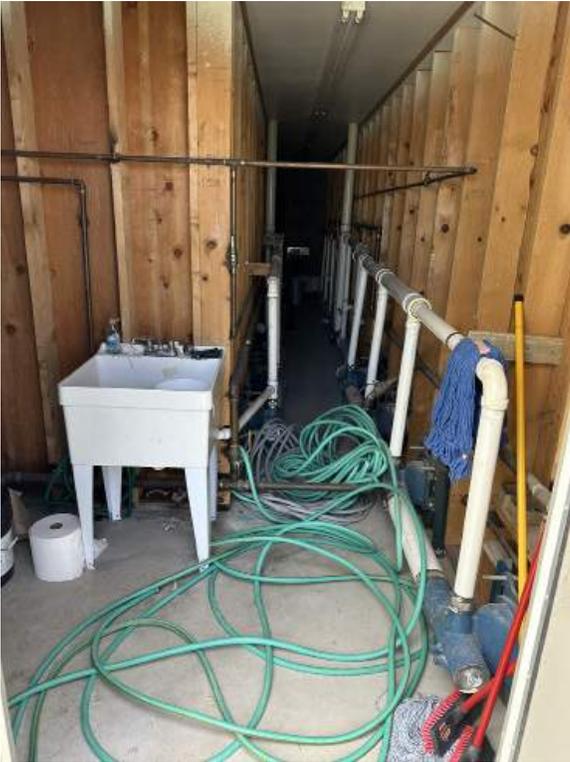
f. Image of the plumbing chase between the restrooms.

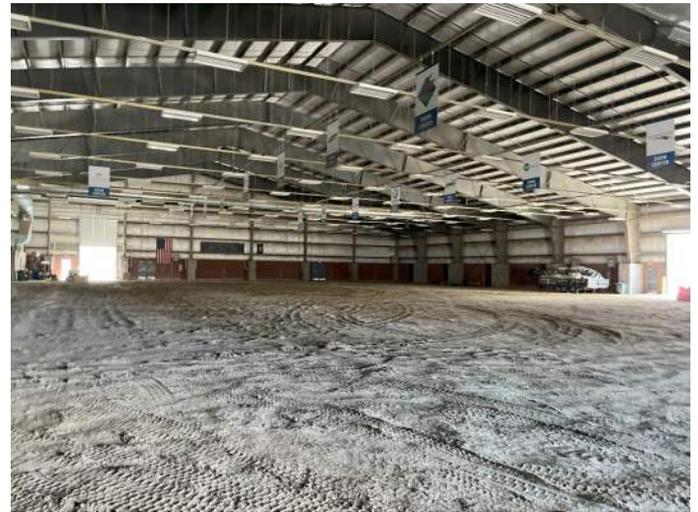
d. Image of the dirt floor within the Touchstone Show Center.

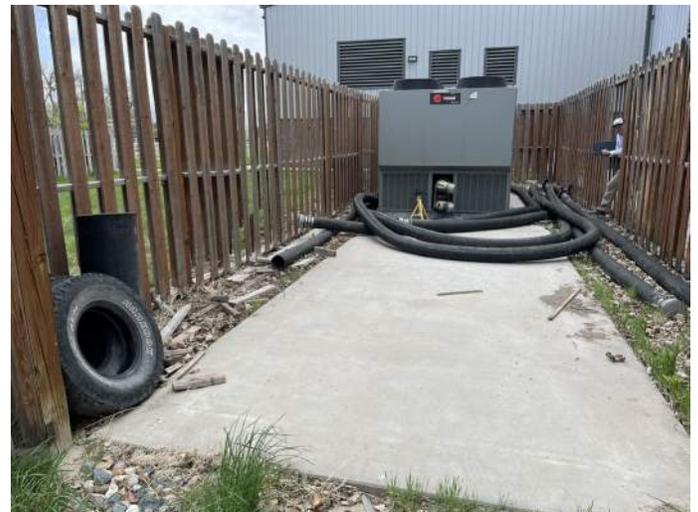
f. Image of damaged enclosure at

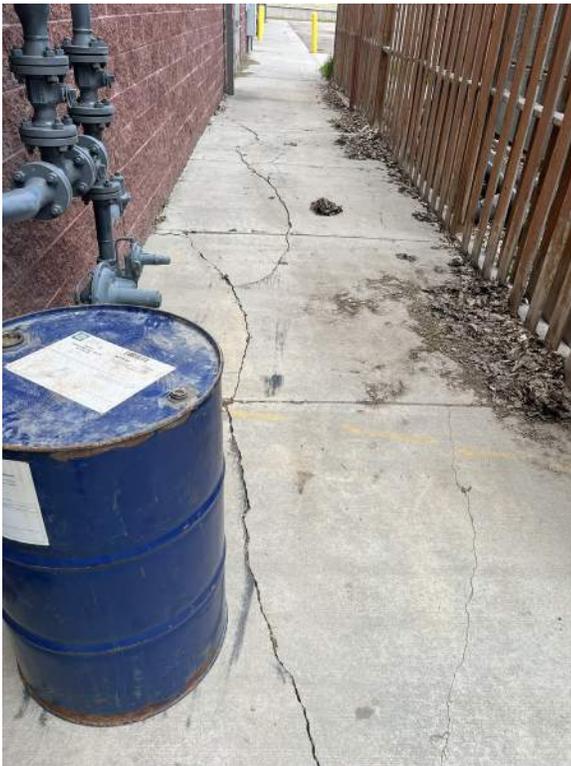
i. Image of cracked concrete at between East facing elevation at the mechanical equipment enclosure.
